Integrated Approach for Stabilisation of Varunavat Parvat Landslide – A Case Study

R. S. T. Sai
THDC Ltd., Rishikesh, India

INTEGRATED APPROACH FOR STABILISATION OF VARUNAVAT PARVAT LANDSLIDE – A CASE STUDY

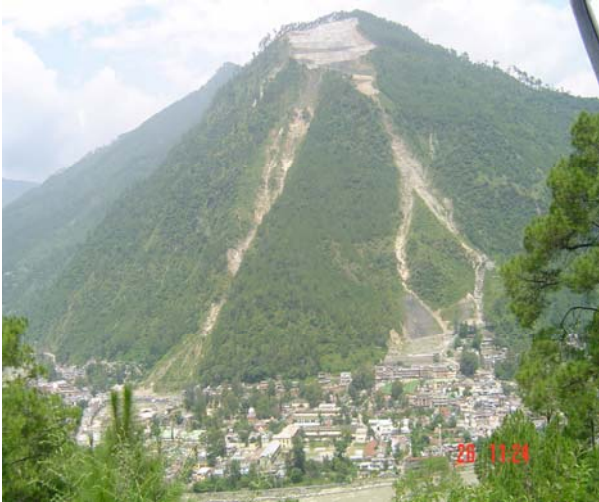
Fig.1 view of Varunavat Parvat post- landslide

On 23rd September 2003 a landslide struck the hill of the Varunavat and endangered the Uttarkashi Township. Varunavat Parvat the mountain is situated on the right bank of Bhagirathi River. At the foot of the mountain lies the Uttarkashi Township. The Varunavat Parvat is a typical example of ‘debris slide’ with rock fall and rockslide in the middle of the slope. The slide occurred in two distinct phases. The first phase involved rotational sliding of about 20-25 m thick slab of Quaternary material on 23 September 2003 along a prominent joint plane, while the second phase involved the toppling of block that disintegrated and initiated a rock fall and rockslide in the middle portion of the slope. The slide

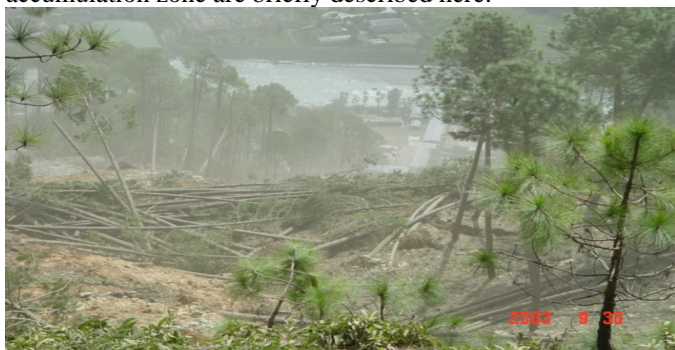
Fig.3 View of tilted and fallen pine trees in the slided Area.

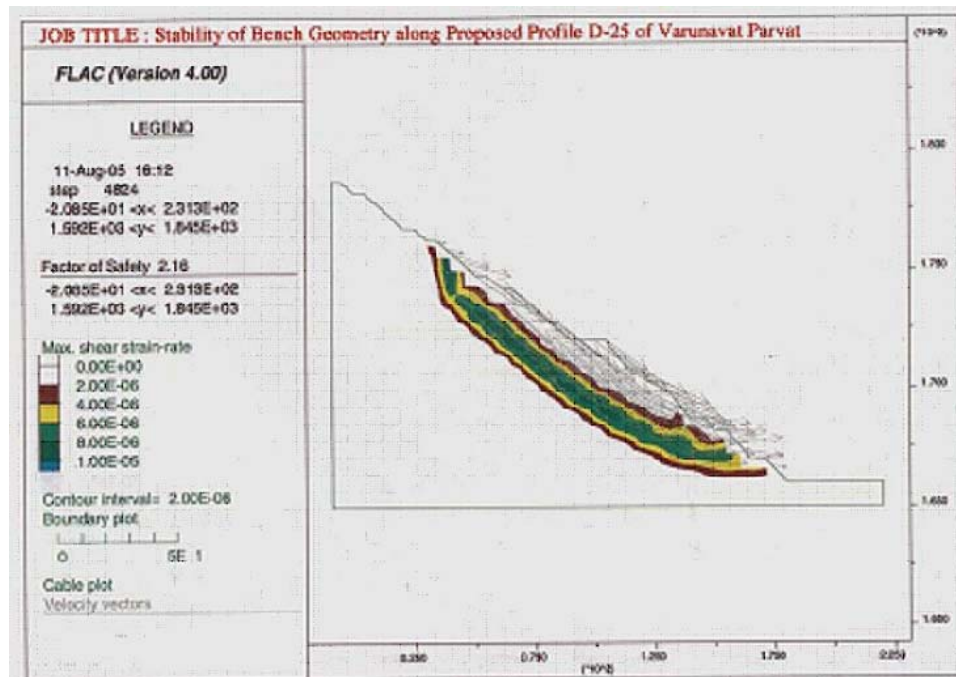
The results of analysis in terms of factor of safety of the overall slope along the proposed profiles for different cases showed the failure envelope and factor of safety value for the slope with bench width of 4m / 5.5 m with 10m thick weathered rock layer(beyond 50m from the crown). The simulation was also carried out with 5m long rock bolts of 32mm diameter at 3m spacing. The factor of safety did not change significantly as the failure envelope passed below the rock bolts .The factor of safety reduced by about 20 percent when the thickness of the weathered rock beyond 50m from the crown was increased to 20m. The results of analysis shown in figure.4 revealed that factor of safety is always more than 2.

Fig.4- Results of 2D Analysis showing shear strain & Factor of safety

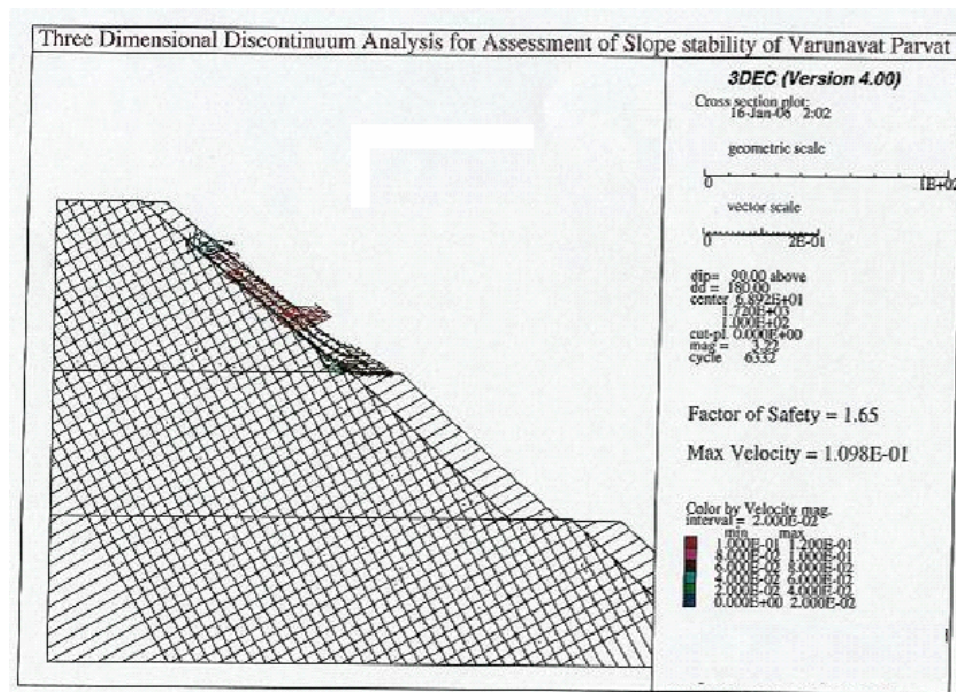
failure is identified by the software, by identifying the abrupt rise of the velocity vectors of the blocks along a failure surface. The failure surface, along which the shear strain rates are maximum, is identified by the software automatically. The shear strength reduction techniques applied to three dimensional stress analyses, yielded a factor of safety of 1.65. The velocity vectors along the profile D50 are shown in figure- 5. It can be seen that the large velocity are observed at EL. 1720 and at EL.1740, indicating unstable mechanism, if the shear strength is reduced by 1.65.

Fig.5- Results of 3D Analysis showing velocity vectors & Factor of safety

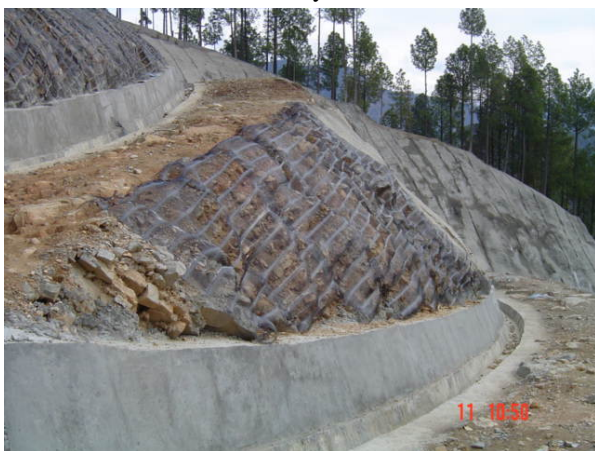
Fig.7-Slope stabilisation measures & construction of side drain on the benches in Crown Area

The slopes of about 10 m to 25 m height with 5.5m berm width were excavated. All the berms were connected fig-6 The excavated muck was then disposed off to the identified dump yards. The slopes and berms so created by modification of the profile were covered with shotcreting/geo-grid/geo-jute to protect against the erosion and weathering actions. Shotcreting was used for the berms and slopes on the weathered rock. The gentle slopes and berms on soil were protected by soil reinforcement with Geo-grid whereas the flatter soil slopes were covered with bio-degradable geo-textiles which can support the growth of the vegetation. The toe of the soil slopes were also stabilized with Gabions wall. The slopes were reinforced with rock bolts to reduce the possibility of local failure of the slopes if any. Pre-stressed cable anchors are being installed on the toe of the steeper rock slopes of greater height or at any other locations where there is wedge formation due to intersection of joints as advised by the geologists of GSI.

undertaken through the network of side drains on the benches, intercepting catch drains, contour drains and its disposal through the available natural water courses namely the Tambakhani, Ramlila and Masjid Mohalla chutes. This is being done by constructing cement concrete open drain on each of the interconnected benches as well as the network of contour drains on the slopes between El.1650 m and toe of the hill slope. Similarly the Subsurface drainage is being managed by providing 6m to 9m long perforated pipes of 75mm diameter on each of the treated slope for releasing the pore water pressure. The drainage pipes are being installed in the predrilled holes into the hill at a negative gradient of about 10 degree to the horizontal to ease the release ground water

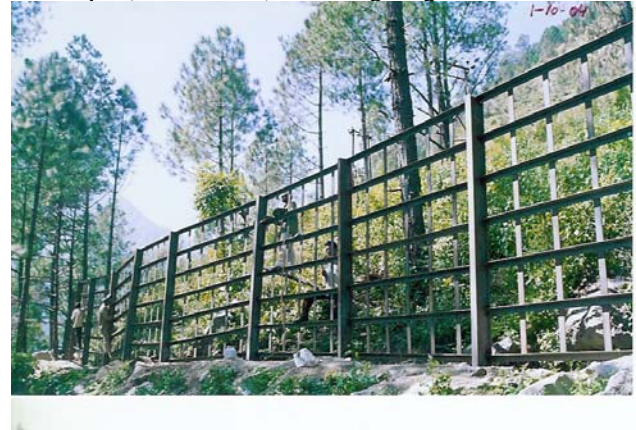
Fig.8 Restraint measures by construction of Steel barricading structure

Toe Treatment: The possibility of rockfalls can not be ruled out inspite of precautions taken during stabilisation measures. Berms though created are effective means of catching rock falls and are frequently used on permanent slopes yet as they are excavated from the top downwards, they are of limited use in minimizing the risk of rockfalls during construction. Therefore, in order to restrain rockfalls, which may occur, the following measures are being implemented at the toe of the hill slope (three chutes) for mitigating the rock fall hazards.
