## Investigation and Repair of a Leaking Earthfill Dam

**Erik J. Nelson, P.E.**  
Geosyntec Consultants  
Tampa, Florida 33637

### **ABSTRACT**

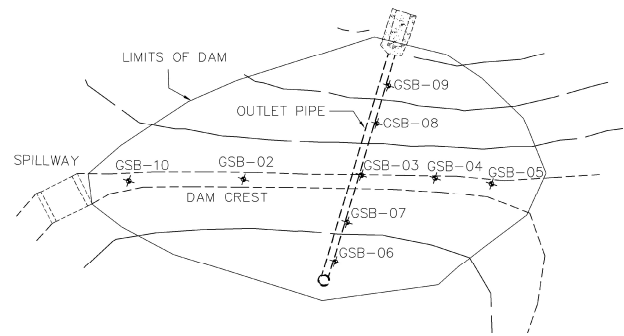
*Figure 2 – Boring Locations*

Three of the borings GSB-01, GSB-02, and GSB-04 were installed along the main axis of the dam. These borings encountered medium dense silty sands down to a depth consistent with the native soils underlying those points.

The forth boring, GDB-03, was located where the pipe alignment crossed the main axis of the dam. This boring encountered the same silty sands to a depth of approximately 10 feet at which time a large void was encountered. This void extended for an additional 10 feet. Very soft soils were encountered after the void extending to approximately the invert elevation of the pipe. Below the pipe invert, dense silty sand was encountered.

All borings were backfilled with grout to avoid leaving a void in the dam structure. The first two borings were backfilled with 11 bags of grout. The third boring took over 40 bags of grout and was never filled up. Grout levels would reach within eight feet of ground surface, and settle to 11 feet below ground surface shortly thereafter. This observation confirmed the presence of a large continuous void in the dam.

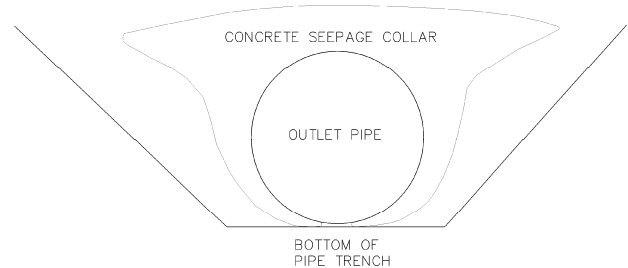
*Figure 3 – Seepage Collar (as installed)*

The seepage collar installed by the contractor was not in accordance with the project specifications. The contractor had replaced the bolt-on steel collar with a large mass of concrete. The contractor had excavated around the pipe after it was backfilled and poured concrete around the pipe. The mass of concrete that was removed during the excavation was approximately ten feet by six feet at the top. The top of the concrete was approximately 12 inches thick over the top of the pipe. The concrete mass narrowed as it went deeper around the pipe to the point where it pinched out under the pipe leaving a gap of approximately six inches (Figure 3).

The piping void that was encountered along the springline of the pipe had reached the cutoff collar from the upstream side and then dove down under the pipe through the gap in the cutoff collar before running back up the pipe to the spring line.

- Clayey soil was to be placed for a minimum distance of two feet from the pipe in all directions.
- Three seepage collars were specified along the length of the pipe. The middle cut off collar was to be placed at the mid point of the clay core of the dam. The remaining two collars were to be placed 30 feet on either side of the middle collar.

- The seepage collars were to be constructed of reinforced concrete. The collars were to be excavated around and beneath the pipe and poured flush against the compacted soil.

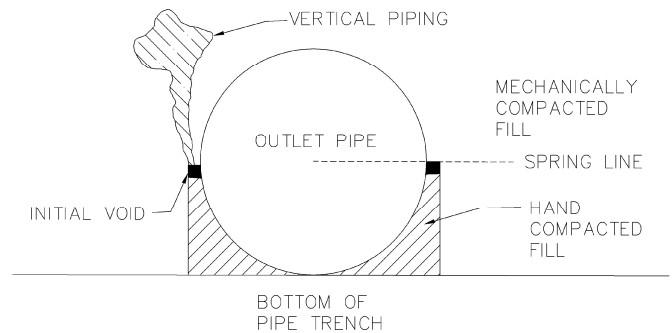
*Figure 4 – Progression of Voids*

The mechanism of failure in RCP5 was associated with the normal seepage of water into the soil that comprised the dam. As the soil became saturated, the poorly compacted soil under the haunches of the pipe began to settle and pull away from the mechanically compacted soil above creating a void at this location.

Water began to flow along the pipe alignment following the resulting void and piping corrugations until it exited the piping void as seepage on the downstream end of the pipe. As the seepage increased, direct water pressure on the pipe joints also increased and the flow of water around these joints also increased resulting in even higher pressure on the coupler gaskets. The couplers used in this application were not designed for external pressures and therefore began to blow

into the pipe joints providing yet another pathway for water to drain from the dam.

As the flow of water began to increase, pore water in the sandier soils in the core also began to drain into this void. As pore water from the dam core drained into the void it dragged soil particles with it down into the void. This progressive erosion of the internal soil resulted in the voids encountered in the interior of the dam (Figure 4).

The primary cause of the failure in RCP5 was found to be improper construction methods.
