Pit Slope Failure Problems in Goan Iron Ore Mines, Goa, India

A. Santha Ram

Indian Bureau of Mines, Nagpur, Maharashtra, India

PIT SLOPE FAILURE PROBLEMS IN GOAN IRON ORE MINES, GOA, INDIA

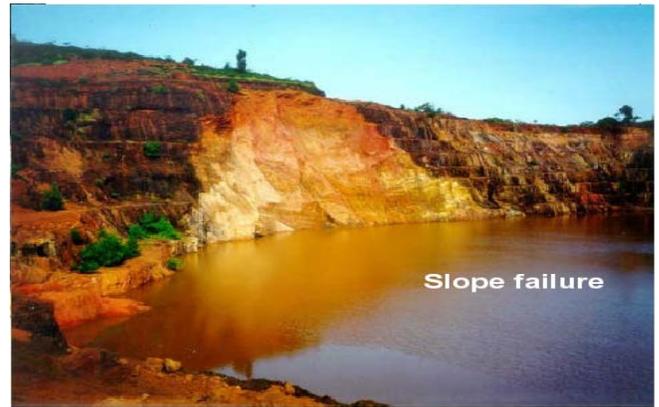
The pit slope which is 90 m in height is maintained by bench height of 5-6 m and 6-7 m bench width, maintaining an overall slope angle of 30°. Near the surface, 15-20 m comprise of hard laterite followed by 20 m of transitional zone of limonite/ferruginous clays followed by 25-30 m thick blackish brown plastic shale material which is located in the immediate footwall portion. The clays are of porous in nature and after getting highly saturated, there will be increase in pore water pressure and consequent loss of internal friction reduces the load bearing capacity and material behaves like a mud like material resulting in plastic flow/mud flow type failure. This, in turn causes crumpling of benches in hard laterite in the surface.

Pit Slope failure: Gross instability of benches

Pit slope above the seasonal springs is usually unstable. The benches on this part of the pit slope slide down and break off into large boulders along the fault and fissure filling planes. The lower benches in soft clays below laterite formation get deformed and slide down the pit slope, horizontally and vertically and present an appearance of subsidence of the strata.

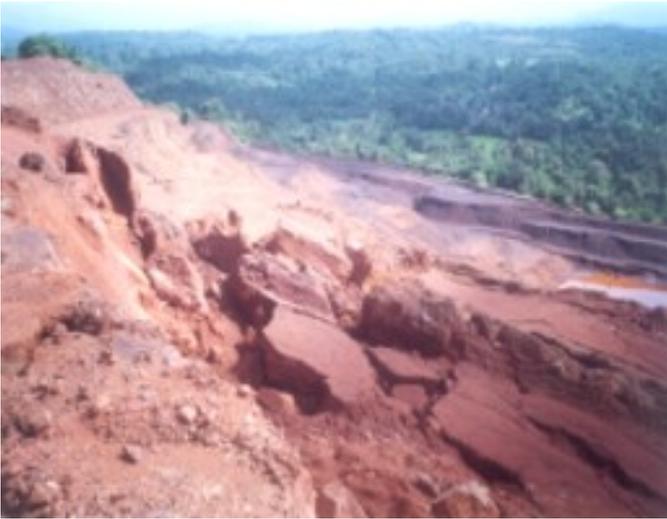
Geo-technical investigations at Saniem mine comprise of Geo-technical mapping of the tension cracks, their attitude of propagation with the help of EDM total station (1 Sec least count) by indirect triangulation method. The procedure involves setting up the instrument at a fixed base station having fixed location with reference to local mine grid. Target points are fixed along the benches at different section at 60 m and 30 m intervals covering the entire length and width of the cracks along its direction of propagation. From the observation of the EDM surveys the areas affected due to crack propagation is 200 m in length and 140 m in width from 187 RL to 140 RL (47 m). The general direction of crack propagation is S 30° E.

Pit Wall Collapse: Saniem Iron Ore Mine
