Rapid Recovery of Demolished Young-Dong Highway 205.4km Due to Heavy Rain

KyungSoo Jeon
Korea Expressway Corporation, Whasung, South Korea

RAPID RECOVERY OF DEMOLISHED YOUNG-DONG HIGHWAY 205.4KM DUE TO HEAVY RAIN

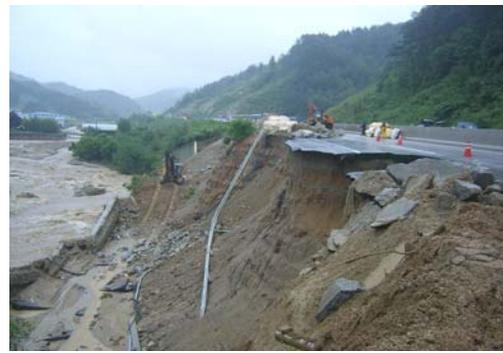
Walljeong stream has a small water volume except the rainy season, but heavy rainfall in the rainy season scoured the ground below concrete retaining walls, and retaining walls were overturned. A lot of water smeared into the embankment, and the two westbound lanes at 205.4km from west end of Yong-Dong highway contact on the stream were demolished. A sharpened S-shape flow line was detrimental to stability of the embankment. Length and maximum height of overturned concrete retaining walls were 114m long and 8m high, respectively. The lost soil amount of the embankment was about 19,000m³, and length of broken asphalt concrete pavement was 72m. Pic.1 shows the overturned concrete retaining walls, the broken asphalt concrete pavement, and guardrails. Pic.2 shows S-shape line of water, which flows turbulently and some equipment try to recover the destroyed highway just after the accident.

Pic.1 Destroyed embankment

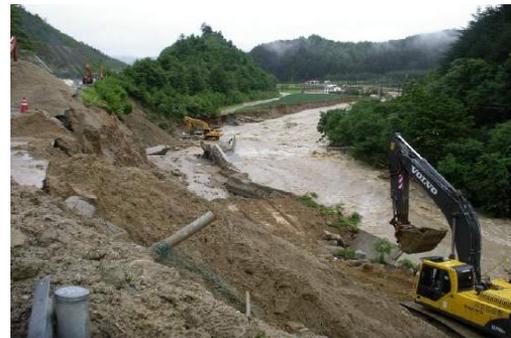
Pic.2 S-shape flow line

In Korea about a half of rainfall a year comes for the rainy season. KEC has an obligation to recover the highway rapidly to provide a convenient travel to South Korean people. To get rid of possibility for fast flowing water to scour the embankment, we changed the flow line by removing the deposit area of the other side, and dropped big rocks whose diameters are over 1m to compensate the lost

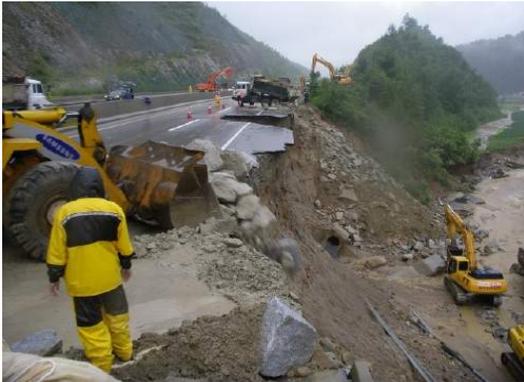
Pic.3. Dropping rocks

embankment without compaction. Pic.3 shows the scene dropping rock.

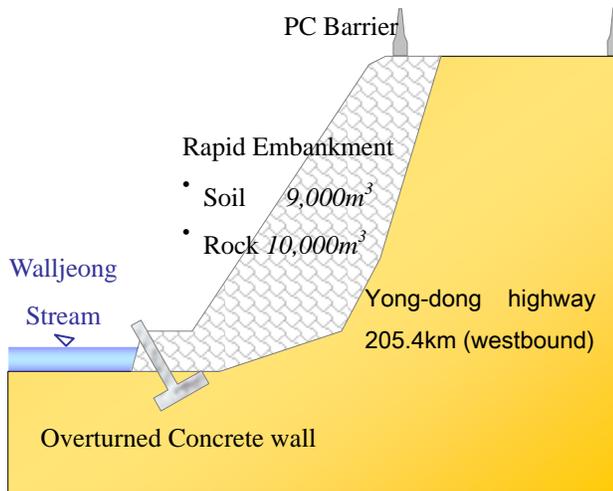
Fig.5 Schematic drawing of rapidly constructed embankment

To prevent the further overturning of the concrete retaining walls a lot of rocks were deposited in front of them. Fig.5 shows a schematic drawing of the rapid recovery. Some soil was put below a subbase of an asphalt concrete pavement.

We checked stability of the rapidly constructed embankment with Modified Bishop Method by SLOP/W 3.0. Table 1 shows values of unit weight, friction angle and cohesion to check stability of the embankment. A minimum safety factor was 1.4, and it satisfies a minimum value, 1.3, of South Korea slope design specification (KISTEC, 2006)

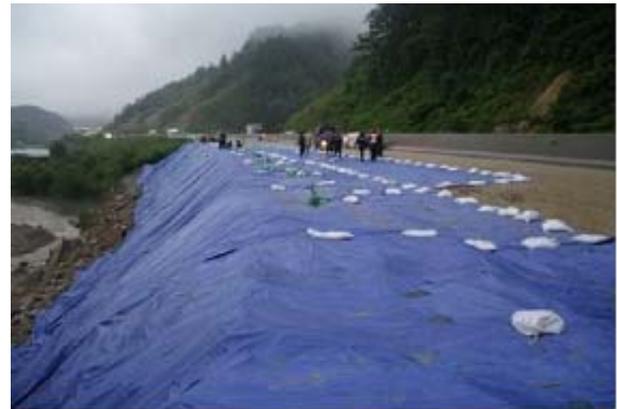
Pic.4 Vinyl mat was covered on the embankment

We also could check the stability of the rapidly constructed embankment by driving heavy vehicles on it. After making the embankment, a big vinyl mat was covered on it to prevent the embankment from washing out as Pic.4. Asphalt concrete pavement was made on the recovered area just after rain stopped. It took only two days to recover the demolished embankment and additional two days to pave the damaged highway with asphalt concrete.

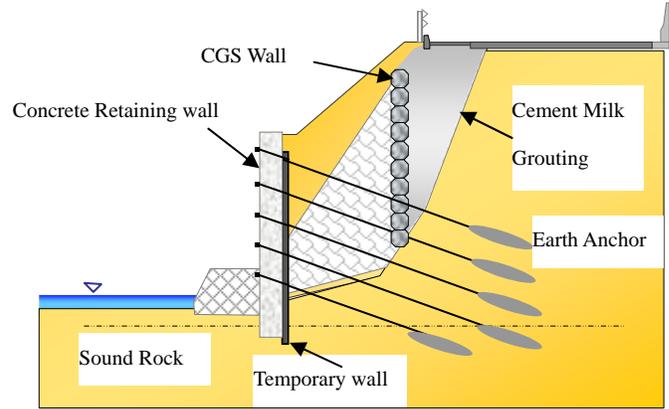
The rapidly constructed embankment that was consisted of big rocks had a lot of voids, and it could make upper soil fall down through them. The subbase below asphalt concrete pavement had resistance because of arching effects in a short period, but in the long run it could not resist the pavement and traffic load. To prevent pavement from losing subbase material through a lot of voids, we decided to make a wall with compaction grouting system (CGS), which has a role to prevent cement grout milk from leaking out though the voids and is grouting method with cement paste, and then grout the whole area recovered by rocks. The grouting was done at many points with low pressure to escape the disturbance from the high pressure. The foundation of the concrete wall was installed from 1m below sound rock to get rid of any possibility to be scoured considering 100-year flood. In South Korea L-type concrete retaining wall is common, but concrete wall and earth anchor were chosen in this case. The reason is that if the base of L-type retaining wall is constructed, a large excavation will be made and it will hurt the embankment. To escape the disturbance of the highway and deformation of the pavement, temporary retaining wall and earth anchors were installed before constructing the concrete retaining wall. A size of H-pile for the temporary wall is 250x250x9x14 mm, and it was driven at every two

Fig.6 Schematic drawing of permanent recovery works

meters. Every earth anchor is installed at 20 degrees from horizontal line in one to six layers and length of anchors is from 12m to 24m including 6m bonded length. Design tensile forces of anchors are 5.1 ~ 24.0 ton. They are calculated in every cross section by EXCAV/W, which is for a temporary retaining wall design and back analysis program. During constructing the temporary wall some tilting gages were installed on H-piles, and the deformation of H-piles was monitored. We could check stability of the temporary retaining wall during construction through reviewing the measured data from them. Pic.5 shows the temporary retaining wall under construction. Pic.6 shows the concrete wall whose thickness is 1m was made in the front of the temporary wall and the anchor was extended. Fig.6 shows a schematic drawing of permanent recovery works. It took about four months, from August 14th, 2006 through December 16th, 2006, to complete permanent recovery works. Several cracks were found in the pavement of westbound and eastbound lanes due to deformation of the rapidly repaired embankment before grouting it with cement milk. Cracks of the eastbound lanes mean that deformation of rapidly recovered embankment was transmitted. The depths of cracks were very deep, and it indicated the cause of cracks was deformation of the embankment. Pic.7 shows cracks in the westbound pavement, and Pic.8 Shows cracks in the eastbound pavement. Table 2 shows the recovery work schedule.

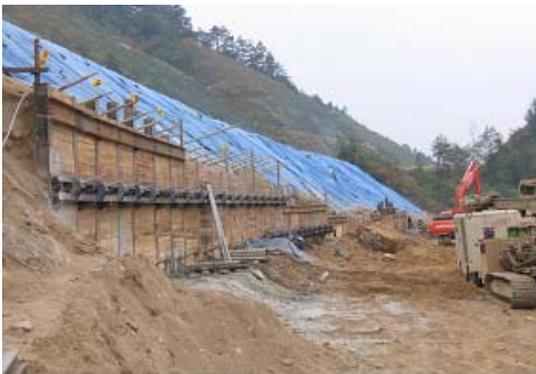
Pic.5 Temporary retaining wall

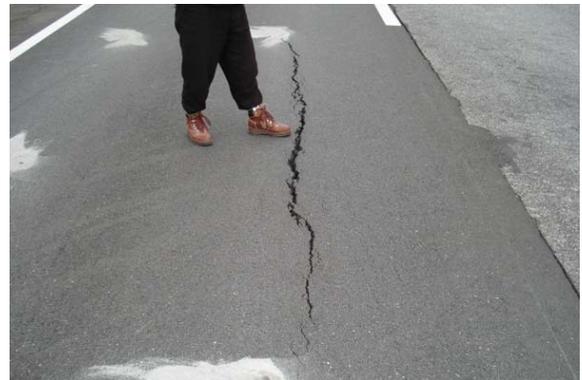
Pic.7 Cracks of the westbound lane pavement

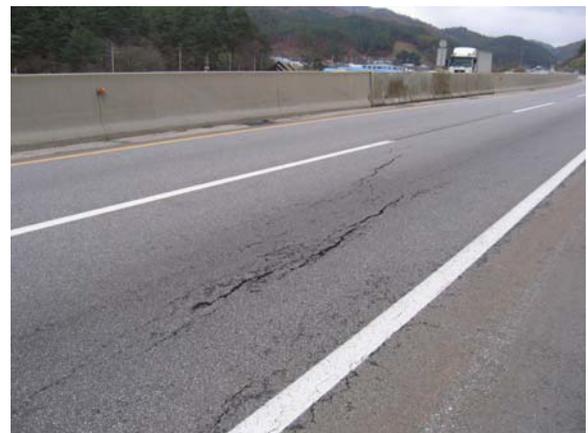
Pic.8 Cracks of the eastbound lane pavement
