Rehabilitation of Sliding Motorway Slopes on Deep Failure in Bulgaria

Chavdar Vassilev Kolev
"Perikal 2003" Ltd., Sofia, Bulgaria

REHABILITATION OF SLIDING MOTORWAY SLOPES ON DEEP FAILURE IN BULGARIA

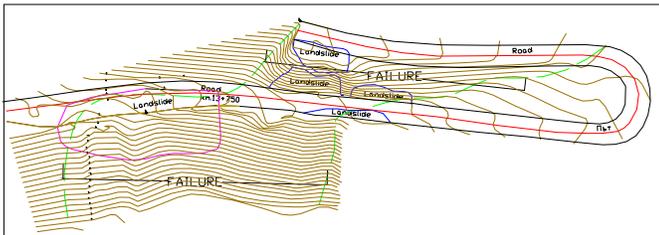
Fig.1: Situation at km.13+750

The sliding is part of an ancient landslide circus, which reaches the erosion base of the river at the foot of the slope (*Fig.1*). The uncovered layers along the steep inner slope consist of uneven alternations of decayed marls and cracked sandpits. The layers are tilted towards the slope. Once the

maps were prepared, and drainages and geophysics profiles were made, we found out that the broken culvert is located within a zone of tectonic movement with amplitude up to 0.5-1.0 m. An erosion gully was formed along it, which was filled with rubble and talus cover. The zone is wide 18 m. On the side of the fault the road is on the natural steep profile of the slope. The thickness of the talus layer starts at zero at the inner slope and reaches 5.5 m at the outer road lay-by. Under the diluvia is located the decaying zone of the rock padding, which has a variable thickness. In the drainage we have made along the axis of the gully, the zone is represented by cracked and decayed rock and marl materials with maximum thickness of 2.0-2.5 m. To the left and right of the axis of sliding the decaying zone gradually becomes shallower.

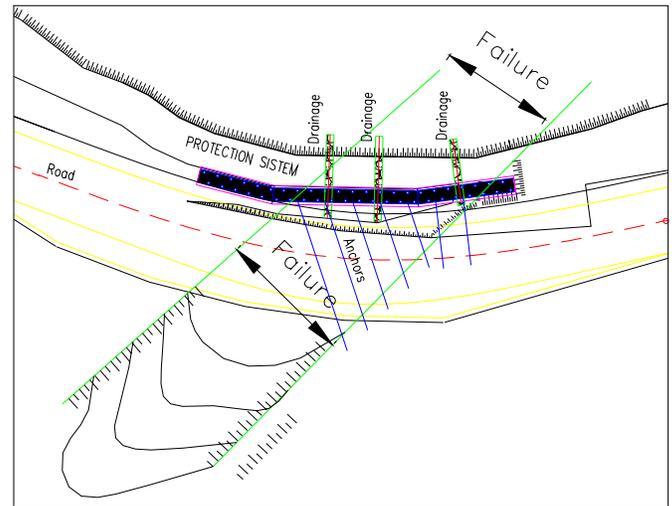
Fig.3. Situation of the protection at km.89+383

We have found out that the reason for the sliding lies in the increased hydrodynamic pressure and the erosion of the slope waters. Prerequisites for the loss of firmness are also created by the fault, which is situated slantwise the road, and which concentrates the waters and contains crushed rock materials. As a result of former tectonic movements, the main rock – alternation of sands and marls – is very largely folded and slanted downwards along the slope. The talus layer, which constructs the sliding body, is rather thick (6 to 9 m). The slope under the sliding tong is steep, densely afforested and practically inaccessible.

The geological cross-section of the slope is represented by dust clay with fragments of marl, decayed marl with layers of clay, and a base of alternating at each 20-30 cm sandstones, marls and alevrolits. The sliding has developed in the clays. The main sliding surface is along the contact with the rock padding. A considerable part of the road embankment has slid. The road lane has sunk about 2.50 m and has moved horizontally nearly the same distance. The depth of the main sliding surface in the zone of the road is from 6 m to 9 m (Fig.3).

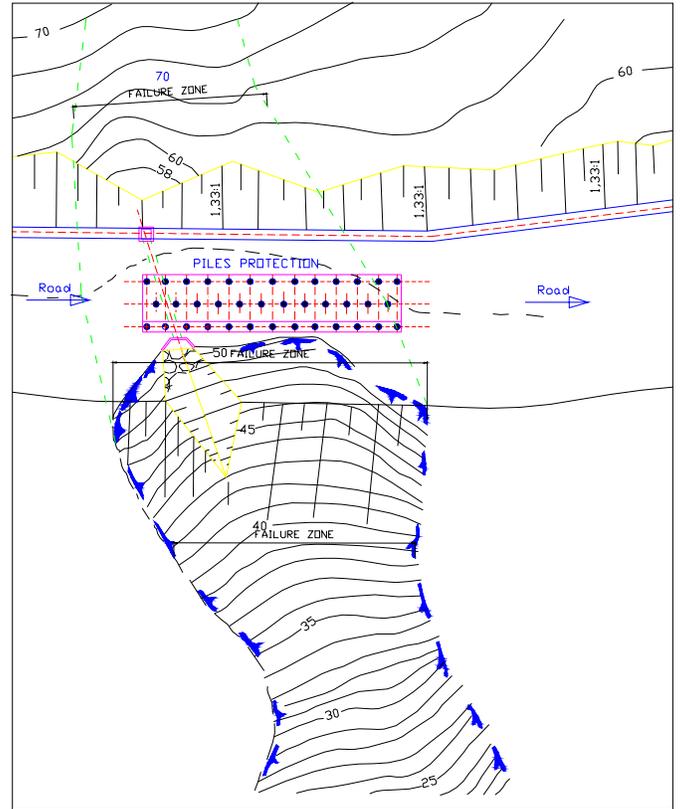
Fig.6. Situation of the protection near Bosna village

The road is situated in a steep Northern slope (Fig.6). It is parallel to a small river, which is located at the heel of the slope, more than 30 m below the elevation of the road. At this

place the route crosses a shallow gully, which is filled in its lower part by the road embankment. There is a culvert, which, for unknown reasons, is located about 15-20m away from the gully. Most likely the talus accumulations have leveled the furrow of the gully to such an extent that its role of water catchments was underestimated when constructing the road.

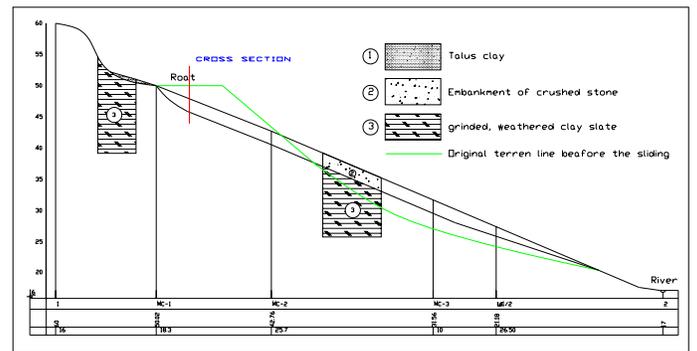
Fig.7. Cross section of the failure near Bosna village

Therefore, the rock base in the fault section is hidden along its whole vertical profile. Water is constantly concentrated there and forms a steep depression curve, joining the river at the heel of the slope (Fig.7). The disconnected fractioned rubble, used to construct the road embankment, slid under the influence of the hydrodynamic pressure, caused by the infiltrated waters from heavy rainfalls during the period of the spring snow melting. When uncovering the rock base in the fault section at a depth of 6 m and more, it turned out that its density is not higher than that of the surface (Fig.8). This fact is an additional proof of the existence of a fault. At the two ends of the damaged section one could clearly notice the transition to monolithic rock along the sides of the fault.
