# Repair of a Failed Slope Using Geogrid Reinforcement

Pichit Jamnongpipatkul

*Bureau of Road Research and Development, Department of Highways, Thailand*

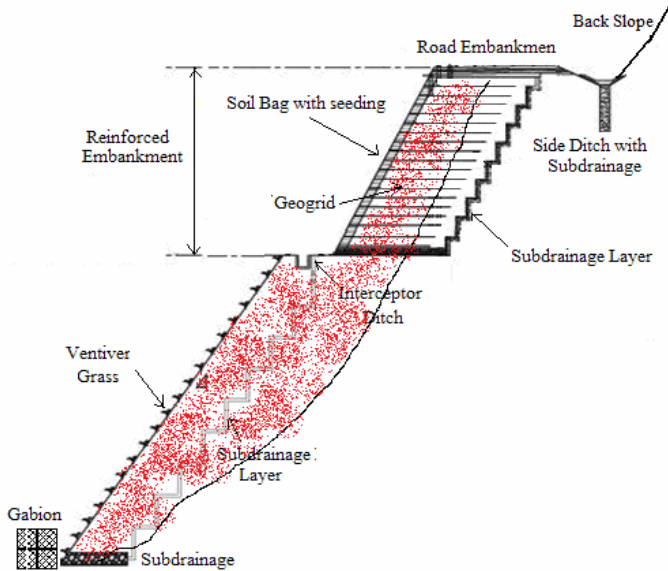
A test site with sloped embankment failure was selected and the failure characteristic is shown in Figure 1 and Figure 2. The failure occurred on December 2005 after the big raining. The failure occurred from the side slope in which the toe slope started to move. Then everything above including the road embankment was collapsed. One traffic lane disappeared causing difficulty and danger to road users. Thailand Department of Highways had the budget for the repair work and the reconstruction had begun.

**Figure 1:** Cross Section of the Sloped Embankment Failure

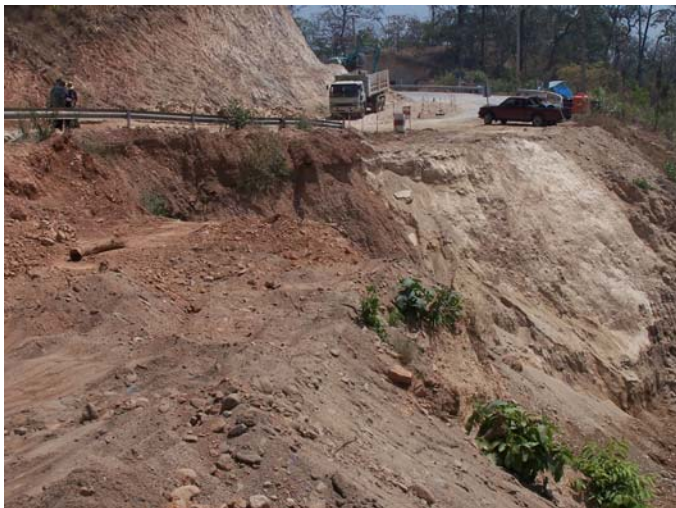
**Figure 2:** Site with Sloped Embankment Failure

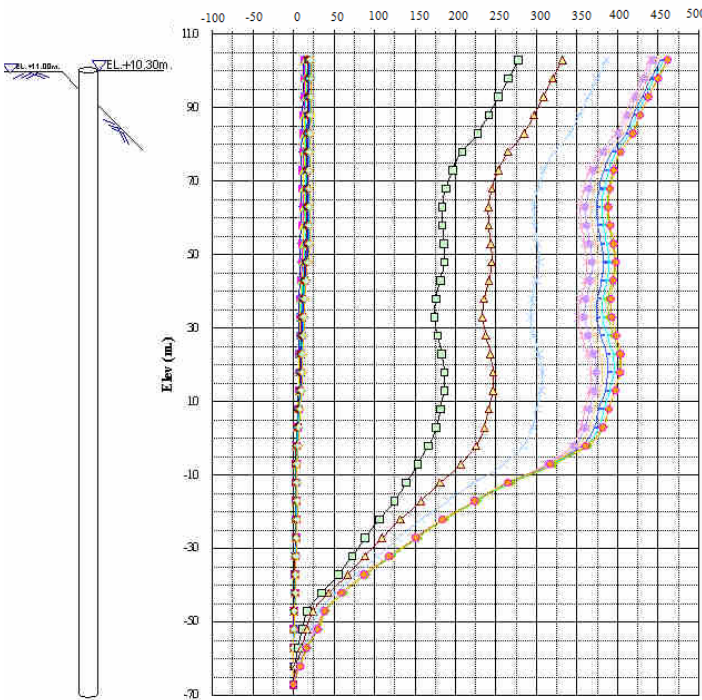
The horizontal displacements from inclinometer INC-02 and INC-03 are shown in Figure 4 and Figure 5.

**Figure 4:** Horizontal Displacement of INC-02 in millimeter

At 9 months after the reconstruction, the maximum horizontal displacement of the top berm was about 470mm, which it was quite similar for the bottom berm. When considering the

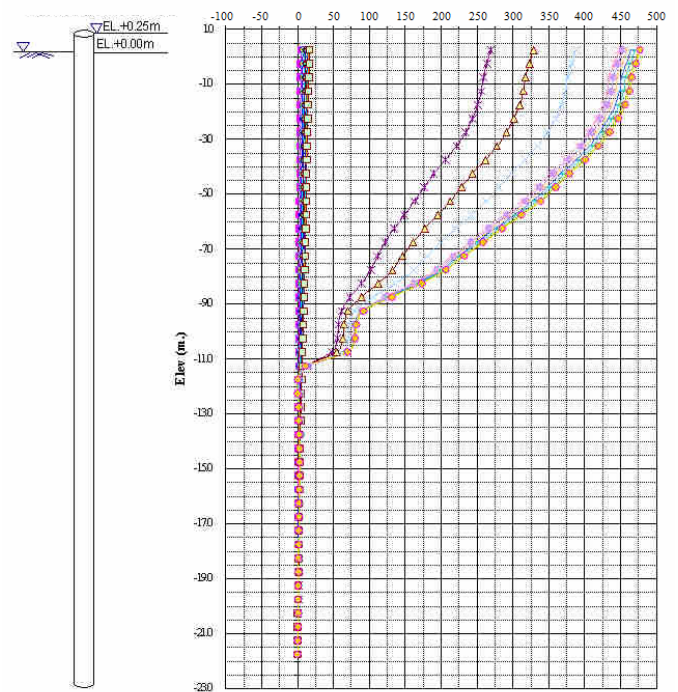
**Figure 5:** Horizontal Displacement of INC-03 in millimeter

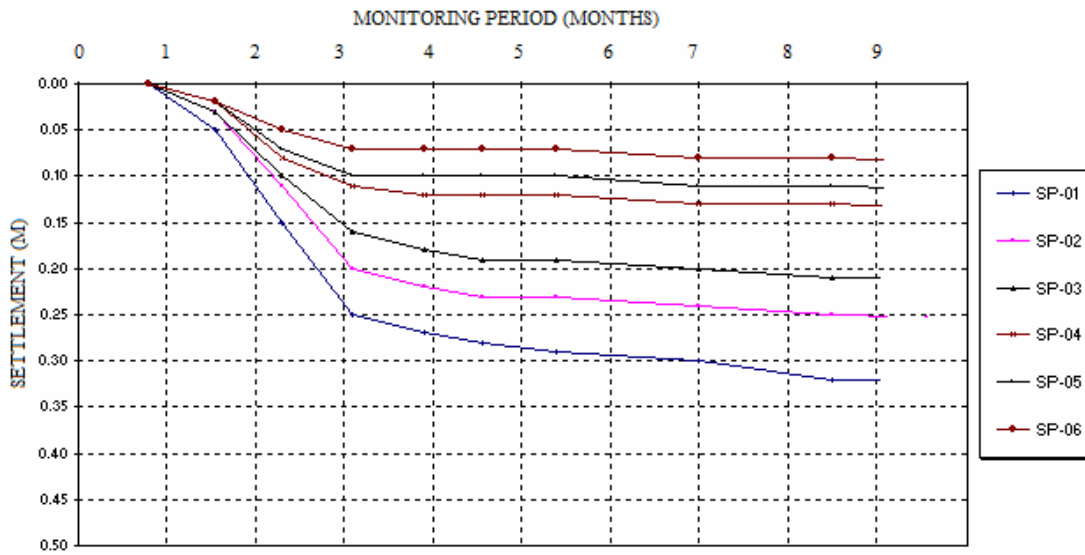
vertical settlement at the top of embankment, the reading from SP1-5 showed the maximum of 32cm settlement as shown in Figure 6.

The large horizontal movement and vertical settlement were expected to be due to the underground water, which lessened the soil strength. This was confirmed by the reading of the

Figure 6: The Settlement at the top of Embankment (SP1-5)

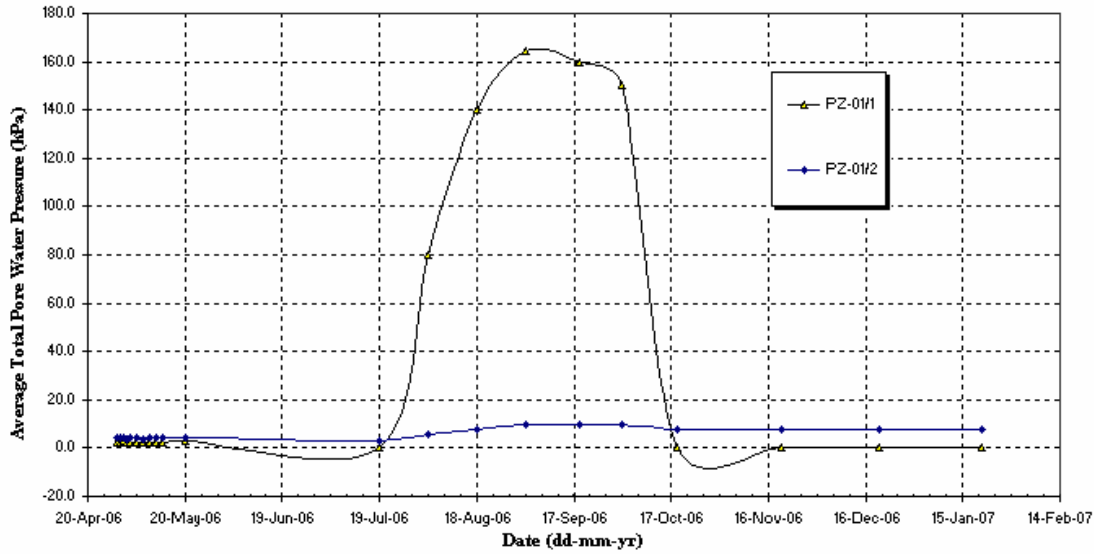
piezometers PZ-01 and PZ-02 as shown in Figure 7 and Figure 8.

Figure 7: The Water Pressure in kPa from PZ-01/1 and PZ-01/2

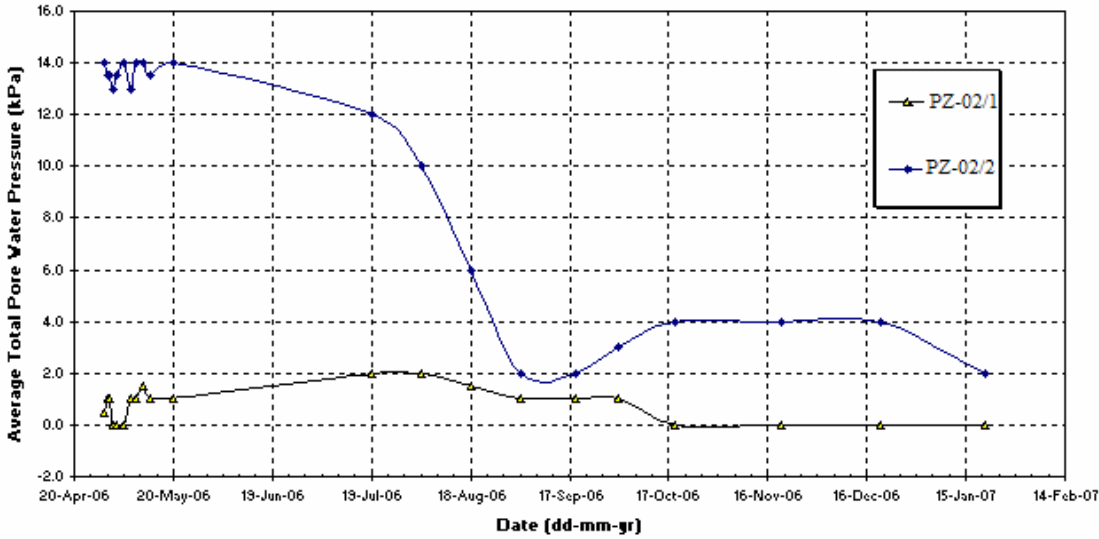
**Figure 8:** The Water Pressure in kPa from PZ-02/1 and PZ-02/2

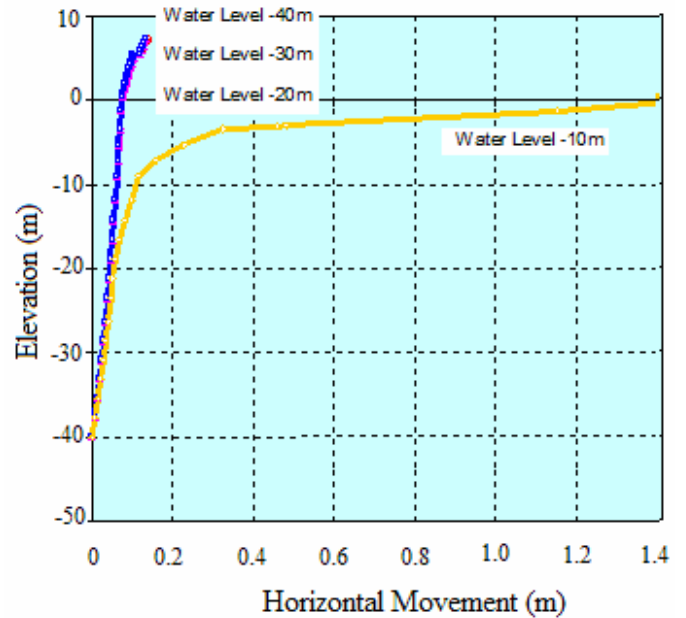
The FEM model was calibrated with the measuring data. In the model, two experiments were conducted. The first one was the changing of ground water table, in order to see the effect of underground water on the horizontal movement of the slope. The FEM analysis showed that the higher the water table level, the higher the horizontal movement, especially when water table was higher than elevation -10.000m as shown in Figure 10 and Figure 11.

**Figure 10:** Horizontal Movement at INC-2 with Various Water Table

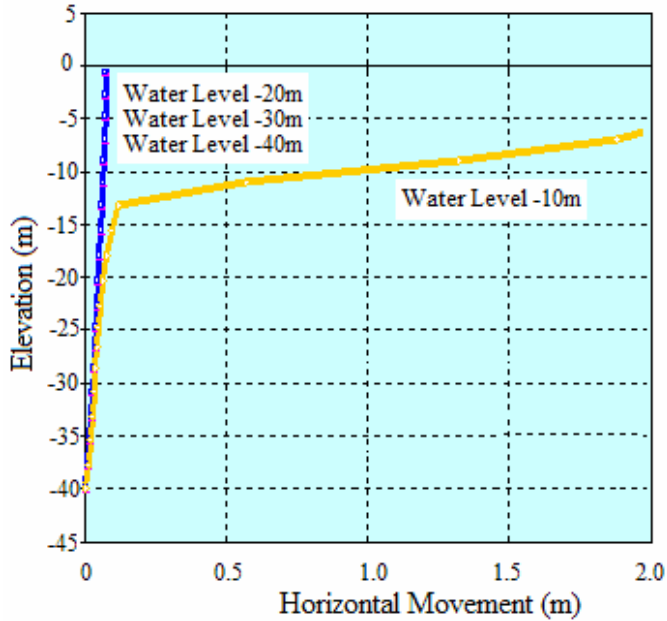
**Figure 11:** Horizontal Movement at INC-3 with Various Water Table

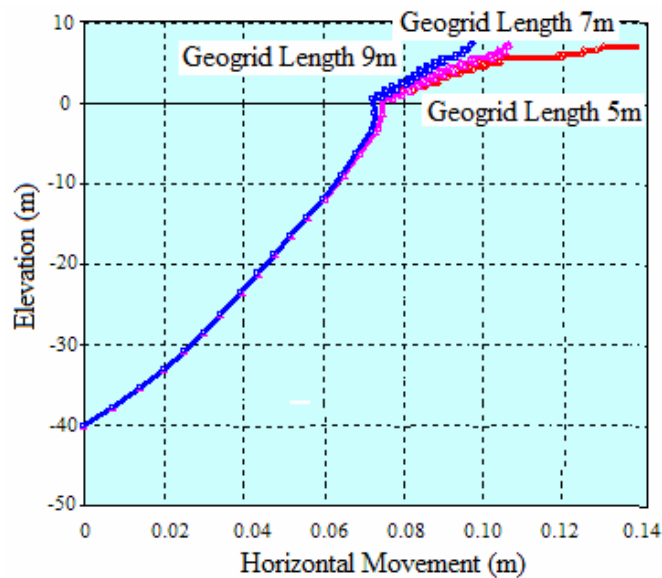
The second experiment was the changing of geogrid length. By increasing length of geogrid, it will increase length of anchorage zone. The FEM analysis showed that the horizontal movement could decrease about 10-30% by increasing the geogrid length from 5.0 – 9.0 m.

**Figure 12:** Horizontal Movement at INC-2 Changing with Geogrid Length

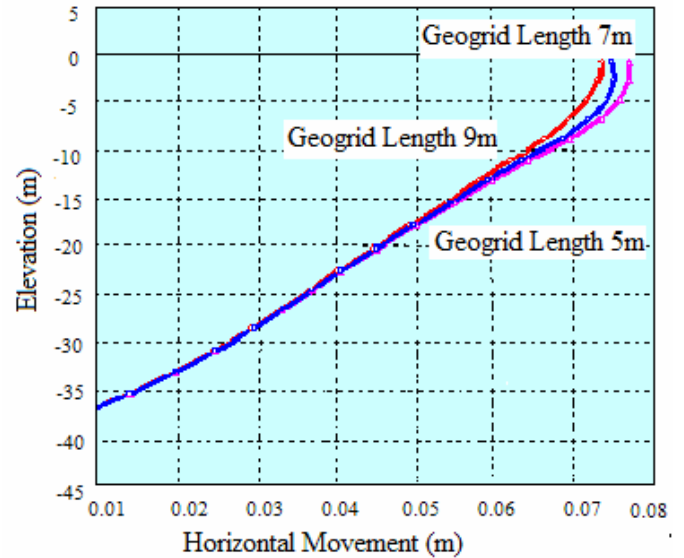
**Figure 13:** Horizontal Movement at INC-3 Changing with Geogrid Length
