REPAIR OF A FAILED SLOPE USING GEOGRID REINFORCEMENT

Pichit Jamnongpipatkul, Ph.D.

Bureau of Road Research and Development
Department of Highways, Thailand

Slope failures often occur in highways located in the mountainous terrain of Northern Thailand. There are several factors which induce those failures. The construction material consists of cohesionless decomposed granite. The highway embankment is steep over 30 m in height. The rainfall is very high during the monsoon season. Due to limitation of right of way, difficulty in the reconstruction and environmental consideration, geogrid reinforced embankment is introduced. The advantages of using the reinforced structure are to use less material because the very steep slope can be maintained and the vegetative cover is feasible. However, the method is expensive, economical design is necessary, i.e., very steep slope, wide spacing of geogrid and the minimum length of geogrid. The research was commenced on a selected failed slope repaired by using geogrid reinforcement. Borings were performed with soil samples taken to our laboratory to determine the engineering properties of the embankment materials as well as the soil profile of

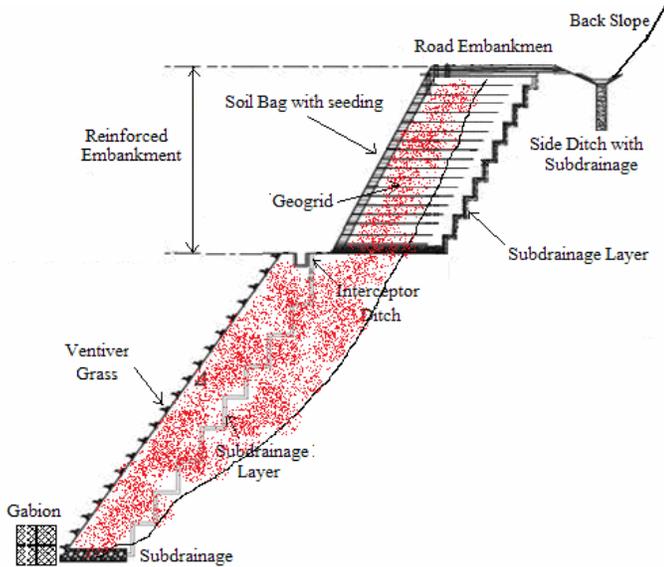
Figure 1: Cross Section of the Sloped Embankment Failure

A test site with sloped embankment failure was selected and the failure characteristic is shown in Figure 1 and Figure 2. The failure occurred on December 2005 after the big raining. The failure occurred from the side slope in which the toe slope started to move. Then everything above including the road embankment was collapsed. One traffic lane disappeared causing difficulty and danger to road users. Thailand Department of Highways had the budget for the repair work and the reconstruction had begun.

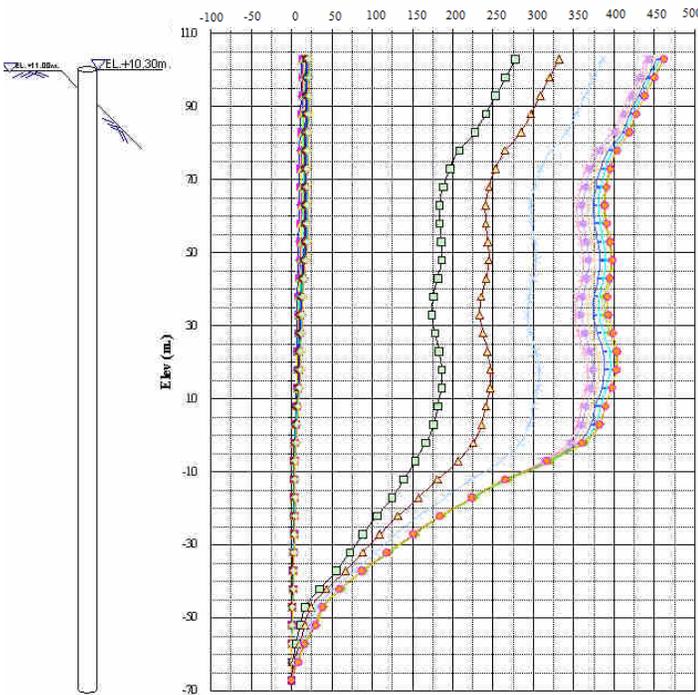
Figure 4: Horizontal Displacement of INC-02 in millimeter

The horizontal displacements from inclinometer INC-02 and INC-03 are shown in Figure 4 and Figure 5.

At 9 months after the reconstruction, the maximum horizontal displacement of the top berm was about 470mm, which it was quite similar for the bottom berm. When considering the

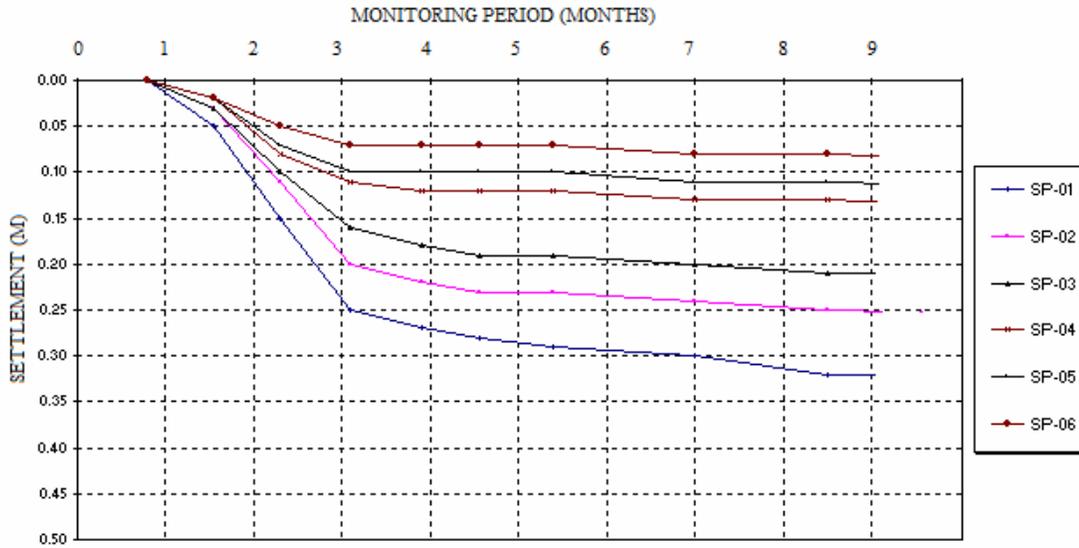
Figure 6: The Settlement at the top of Embankment (SP1-5)

vertical settlement at the top of embankment, the reading from SP1-5 showed the maximum of 32cm settlement as shown in Figure 6.

The large horizontal movement and vertical settlement were expected to be due to the underground water, which lessened the soil strength. This was confirmed by the reading of the

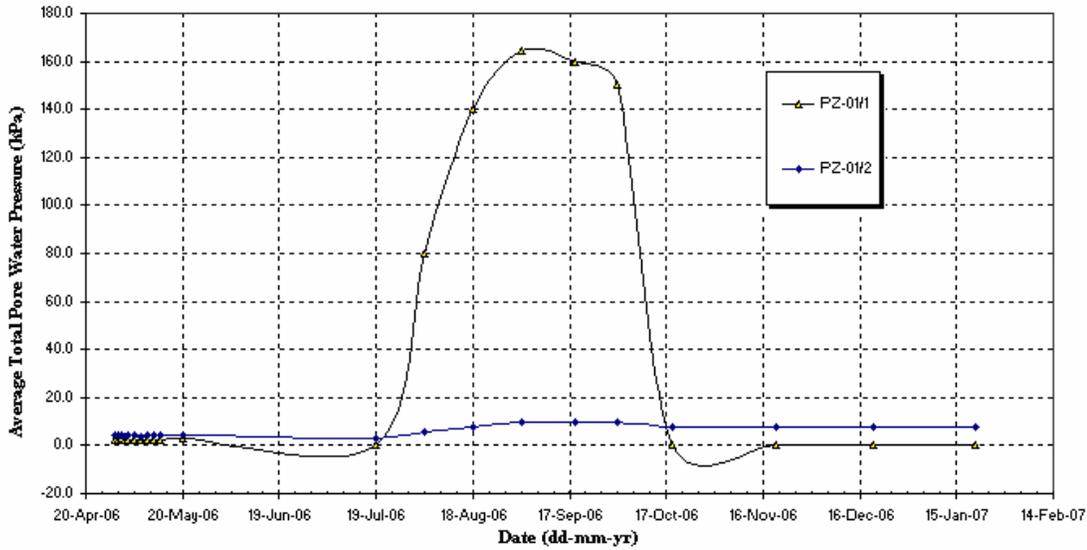
Figure 7: The Water Pressure in kPa from PZ-01/1 and PZ-01/2

piezometers PZ-01 and PZ-02 as shown in Figure 7 and Figure 8.

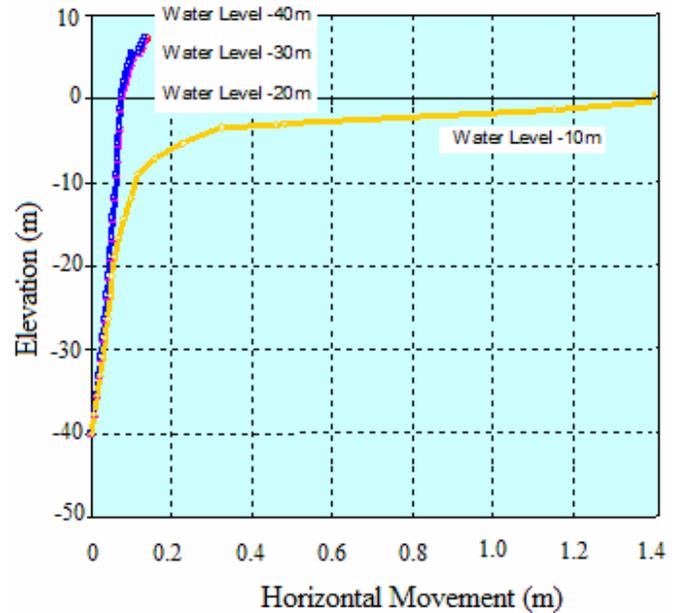
Figure 10: Horizontal Movement at INC-2 with Various Water Table

The FEM model was calibrated with the measuring data. In the model, two experiments were conducted. The first one was the changing of ground water table, in order to see the effect of underground water on the horizontal movement of the slope. The FEM analysis showed that the higher the water table level, the higher the horizontal movement, especially when water table was higher than elevation -10.000m as shown in Figure 10 and Figure 11.

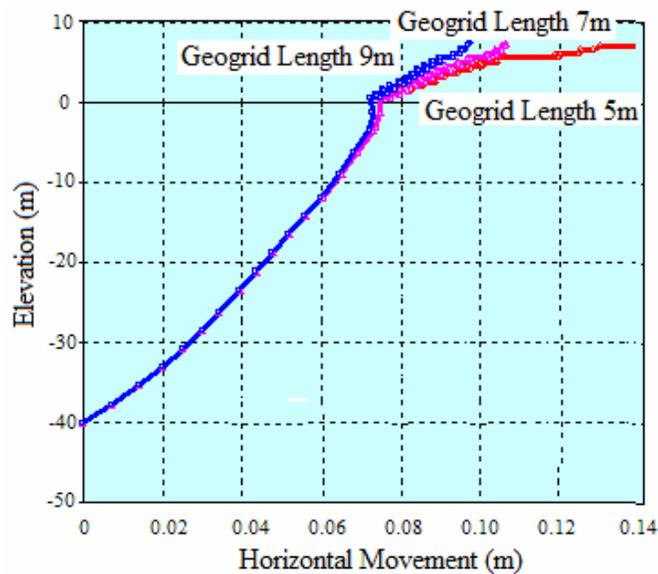
Figure 12: Horizontal Movement at INC-2 Changing with Geogrid Length

The second experiment was the changing of geogrid length. By increasing length of geogrid, it will increase length of anchorage zone. The FEM analysis showed that the horizontal movement could decrease about 10-30% by increasing the geogrid length from 5.0 – 9.0 m.

Due to many failures of sloped embankment in Thailand, Thailand Department of Highways decided to conduct a study by installing geotechnical instruments at a reconstruction site. The geotechnical instruments were inclinometers, piezometers, observation wells, surface settlement plates and total pressure cell. The monitoring data indicated large horizontal movement and large vertical settlement. The expecting cause of large displacements was due to ground water between soil particles, which lessened the soil strength. This was confirmed from high water pressure monitored from piezometers and from the FEM analysis. From this study, the researchers suggested to install the horizontal drained pipes into the compacted embankment. They would help draining the underground water and reduce the excessive pore water pressure. In addition, the FEM analysis suggests putting longer geogrid. This will increase the anchorage length, which increasing the resistance force at the fixed end.
