## **CASE HISTORIES OF WIDESPREAD LIQUEFACTION AND LATERAL SPREAD INDUCED BY THE 2007 PISCO, PERU EARTHQUAKE**

### ABSTRACT

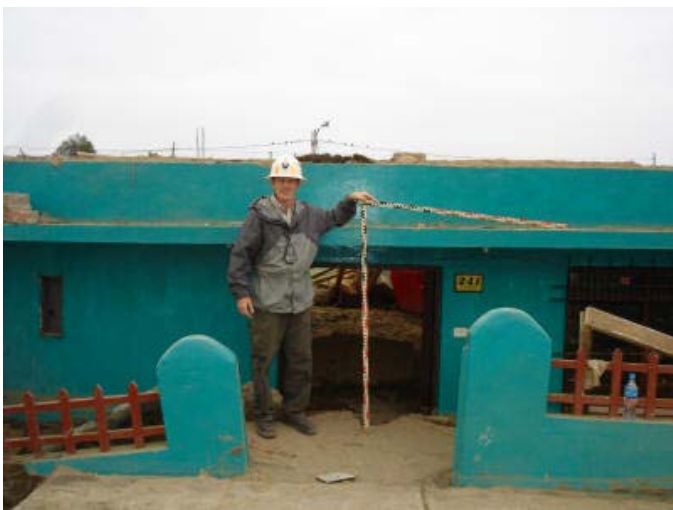
Liquefaction-induced foundation failures were documented in the northwest portion of Tambo de Mora approximately 0.5 km from the coastline and 38 km from the rupture plane. Tambo de Mora is located on Holocene alluvial and eolian deposits and has a shallow ground water table. While widespread evidence of soil liquefaction (minor settlement and sand ejecta) was present throughout much of the northwest portion of the city, particularly heavy damage (excessive settlement) was observed in one- to two-story buildings along a 300 m stretch of Alfonso Ugarte Street. Along this stretch of road, nearly every building settled substantially (0.3 m plus), with multiple buildings settling between 0.7 and 0.9 m (Figure 6).

*Fig. 6. Approximately 0.9 m of liquefaction-induced settlement at a one-story house in Tambo de Mora.*

Large quantities of ejecta was observed in cracks that had developed in the road and inside of buildings whose unreinforced slab-on-grade floors had been broken apart and heaved-up into their interiors. In most cases, ejecta was gray, non-plastic, poorly

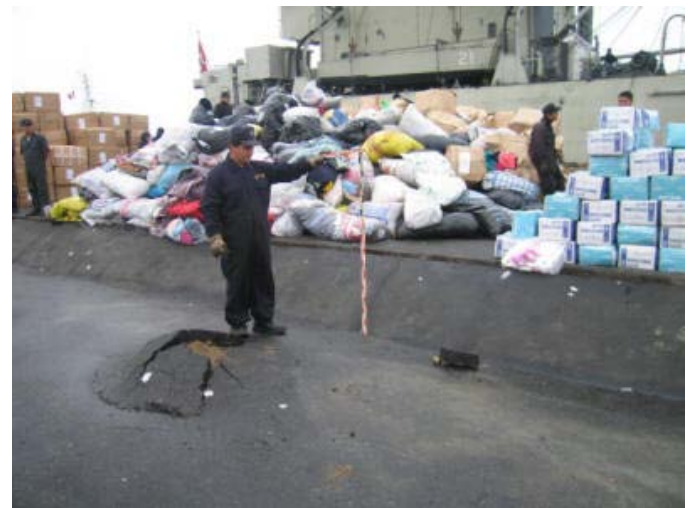
The General San Martin Port was inaugurated in 1970 and operates with ships as heavy as 25,000 tons of dead weight. It is located in Punta Pejerrey, Pisco Beach, approximately 30 km from the fault. The port is surrounded by granite porfids (intrusive rocks), which are part of the San Nicolas Batholite. The granite porfids have a fine to coarse matrix with colors ranging from pink to dark brownish red. Port facilities were constructed on reclaimed land. The wharf has a reinforced concrete deck that is supported by 780 circular steel pipe piles. The reclaimed land area of the port settled over the years resulting in differential movement between the pile-supported buildings and the surrounding soil. The typical solution to this problem was to place more fill to level the surrounding reclaimed ground surface. The earthquake induced liquefaction in the reclaimed land, as evidenced by sand boils and lateral spreading with significant cracks as wide as 0.25 m and vertical offsets as large as 0.8 m (Figure 7).

*Fig. 7. Vertical displacements as large as 0.8 m were observed between the pile-supported wharf and the reclaimed*

*backfill. The bulge appears to be a pile that was buried in the fill. Although the port was heavily damaged, it had enough functionality to receive relief for earthquake victims*

The pile-supported deck appeared slightly inclined seaward, and horizontal offsets in the deck joints were as large as 0.50 m. Ground cracking developed parallel to the deck on the reclaimed land area and was most severe near the waterfront. A pipeline that ran across the port inside of a concrete box was not damaged in the earthquake despite the fact that the surrounding ground settled substantially. It is presumed that the concrete box was supported on piles. No cracks were observed in native ground around the pier.

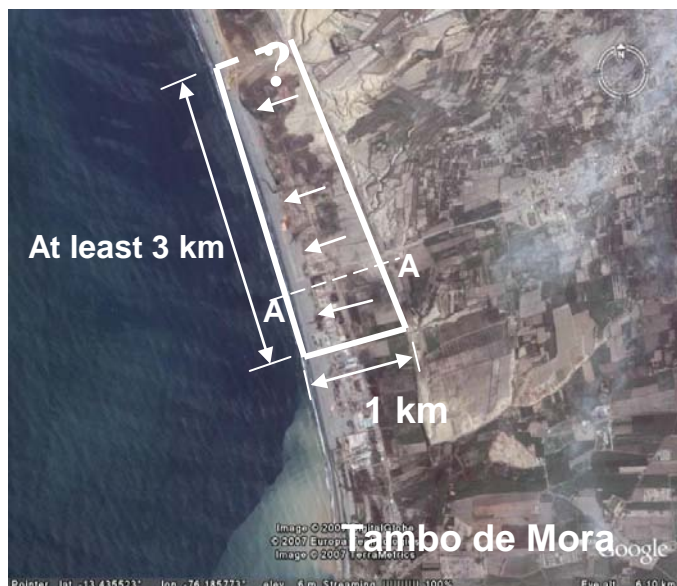
A massive liquefaction-induced seaward displacement of a marine terrace occurred in Canchamaná, 2.5 km north of Tambo de Mora. The approximate displaced area was 1 km wide by 3 km long (Figure 8).

*Fig. 8. Approximate extent of a massive seaward lateral spread of a marine terrace in Canchamaná. The boundary of the mobilized area on the north is uncertain and could possibly extend further (Background image from Google Earth).*

A clear vertical offset (scarp) of variable magnitude was observed along much of the geological interface between the marine terrace and the Cañete Formation. A maximum vertical displacement of approximately 3 m was measured where a local dirt road links Canchamaná with La Victoria town. In addition to the main scarp at the interface, numerous extensional ground cracks developed across the marine terrace parallel to the coastline. In general, the cracks were largest (both in terms of horizontal and vertical displacement) near the scarp and became smaller towards the coastline. Some crack widths were as large as 1 m and sand ejecta was found inside many of them. In some areas the cracks also ran perpendicular to the beach or in a circular pattern, indicating the effect of topography.
