Failure of a Hybrid Flexible Shoring System for a 30m Excavation: Exploration of Causes and Remedial Measures

FAILURE OF A HYBRID FLEXIBLE SHORING SYSTEM FOR A 30M EXCAVATION: EXPLORATION OF CAUSES AND REMEDIAL MEASURES

Salah Sadek, Ph.D.

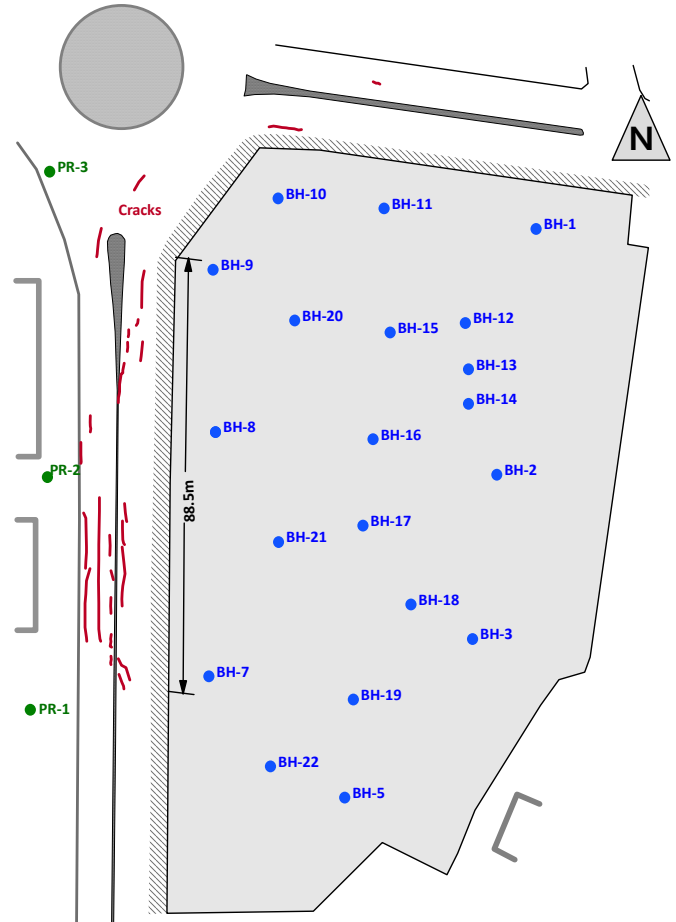
The distress and deformations in the shoring system itself were accompanied by the development of longitudinal cracks in the major road at the western boundary, at distances of ~8m, ~13m and ~ 17m away from the edge of the excavation, with a perceptible differential downward movement across some them.

volumes of soil/rock. A schematic plan of the site which shows the mapped cracks (in red) is provided in Fig. 1.

Fig. 1. Plan view of the site showing the cracking in the roads

At this point, emergency remedial measures were put into effect. These included the closure of the main road to traffic and the initiation of round the clock backfilling operations along the affected side of the excavation. The backfilling operations proceeded to eventually reach a height of about 20m from the base of the excavation. The cracks along the road were “sealed” to prevent the infiltration of rain waters which could further destabilize the failing mass. The system was stabilized and no further significant movements were observed, either along the portion of the facing which remained exposed (top 8m) nor in the cracks along the road to the west.

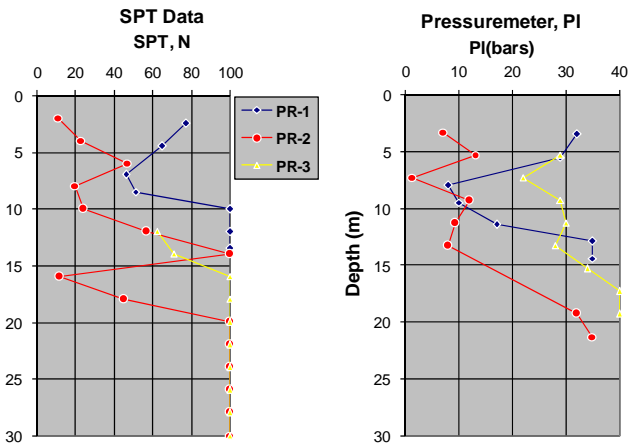
Fig. 2. Field test results from the second investigation effort

A number of significant differences can be identified between the earlier geotechnical investigation and the one carried out in the days following the shoring system distress. The new subsurface model (Profile 2) consists of three “layers” or strata assigned the following engineering characteristics:

- ❑ Clayey Sand: $\gamma=19\text{kN/m}^3$; $c=25\text{ kPa}$; $\phi=25^\circ$.
- ❑ Silty Marl/Marl: $\gamma=20\text{kN/m}^3$; $c=50\text{ kPa}$; $\phi=25^\circ$.
- ❑ Marly Limestone/Marl: $\gamma=22\text{kN/m}^3$; $c=75\text{ kPa}$; $\phi=25^\circ$.

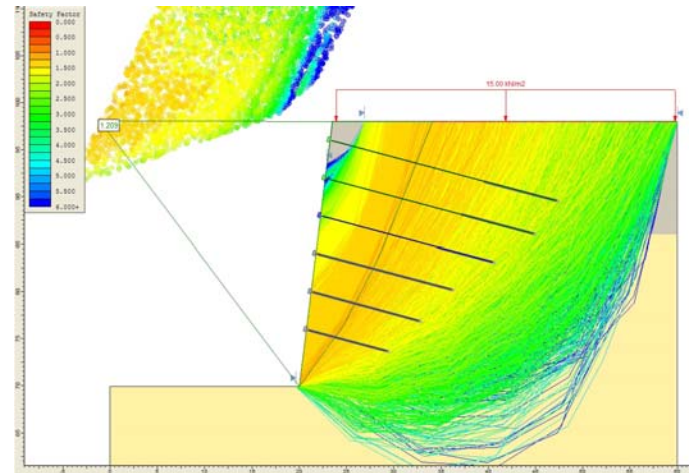
The executed shoring system design was evaluated at a first stage by using limit equilibrium analyses. The behavior of the system was explored in reference to a target global safety factor using un-factored soil and material parameters. We considered that an appropriate target global factor of safety for conditions such as the ones relevant in the project under consideration would be $FS \sim 1.5$. The analysis tool used was the specialized software SLIDE by roscience. The results of the runs and limit equilibrium analyses conducted using both Profile 1 (original subsurface parameters) and Profile 2 (strata characteristics and parameters as established in the later site investigation effort) are presented in Figs. 3 and 4. The minimum global safety factors obtained for profiles 1 and 2 using non-circular failure surfaces, were 1.209 and 0.921 respectively. These numbers indicate that the original design was not satisfactory even with the subsurface model and associated characteristics used and that the second profile with its relevant the strength parameters indicates failure conditions ($FS < 1$) as observed. It is interesting to note that the mobilized mass indicated by these analyses appear to correlate well with the observed crack patterns and distress.

Fig. 3. LE analyses Profile 1. With all surfaces. $FS_{min} \sim 1.21$.

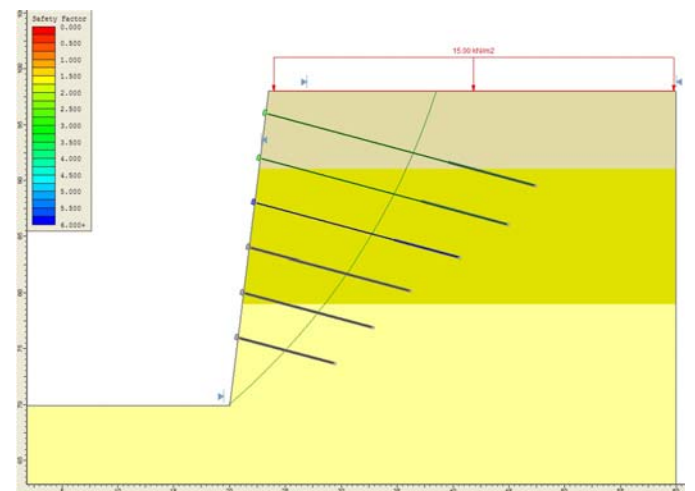
Fig. 4. LE analyses Profile 2. Critical surface $FS_{min} \sim 1.21$.

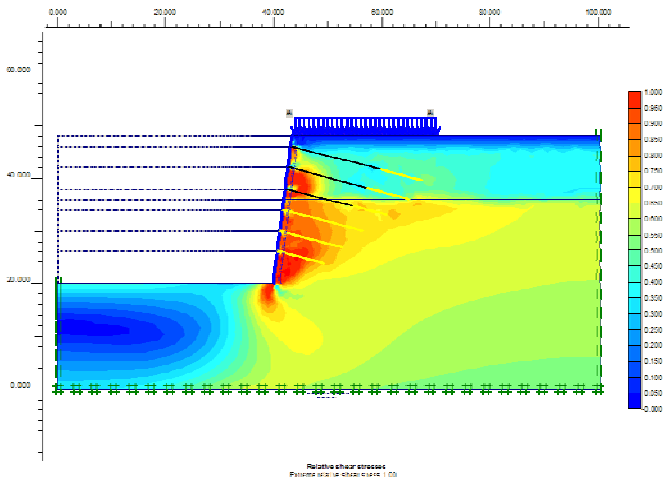
- As the final excavation step is reached, a large concentration of plastic points develops at the toe of the slope and extends upward and outwards, without developing full “failure conditions” in case Profile 1 model characteristics are used, whereas clear failure patterns are evident for Profile 2. Interestingly, tension points are noted at or near the ground surface, starting at a distance of ~12-15m behind the face of the excavation, which correlates well with the observed cracking and distress patterns shown in Fig. 1.

Fig. 6. FEM Profile 1. Relative shear stresses $\tau/\tau_{max(m-c)}$.

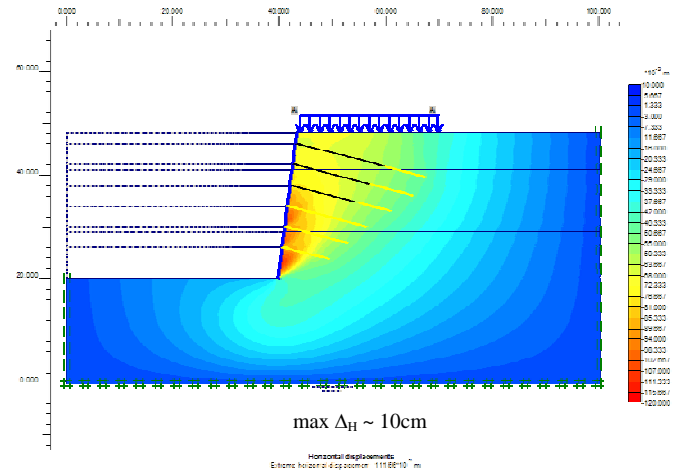
- Finally, for the case of Profile 2, the outwards horizontal deformation patterns at the facing match (in form) and even to some extent the general magnitudes (on the order of ten cms as a maximum) the patterns observed in the survey monitoring data, a typical sample of which is shown in Fig. 7.

Fig. 7. FEM Profile 2. Horizontal displacement contours.

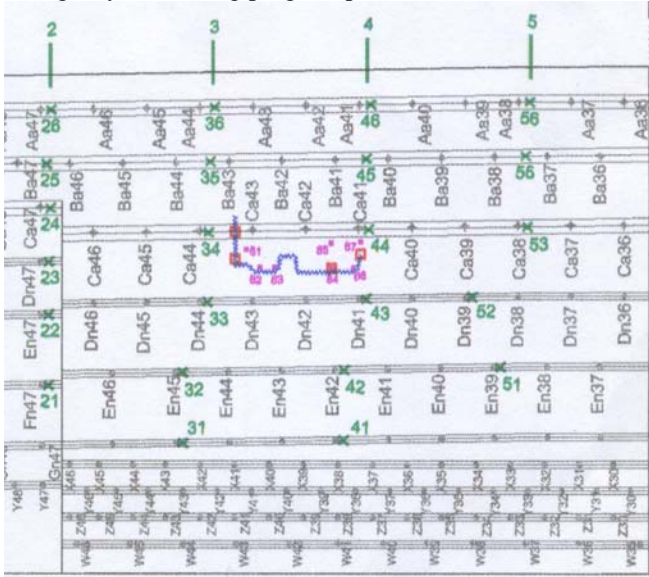
Fixed references were placed at some anchors heads locations and other points along the shored face. These references points were regularly monitored for displacements in the three directions. The relevant reference points along the section which is the subject of this paper are shown on Fig.8. On that same figure blue lines mark the locations which showed significant distress in the shotcrete facing as the works proceeded to the final grades. All the survey data made available to us for the relevant section were analyzed and plotted along various vertical alignments through the section. Typical horizontal (Y direction) deformation measurements along alignment 3 are presented in

Fig. 8. Partial view of the monitoring points along the section (surveyed points in shown in green)

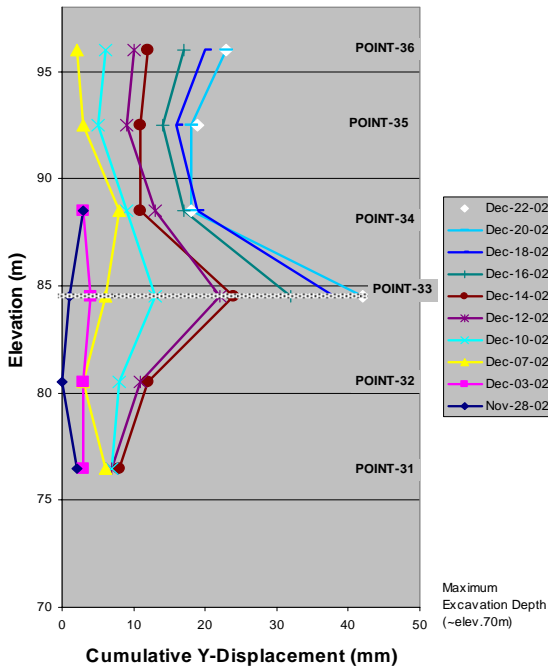
Fig. 9. Horizontal movement along alignment 3. The grey line marks the backfilling elevation obstructing further readings.

It is clear from these figures that the movements started to increase at an alarming rate from approximately December 10

and stabilized significantly after the remedial backfilling was implemented.

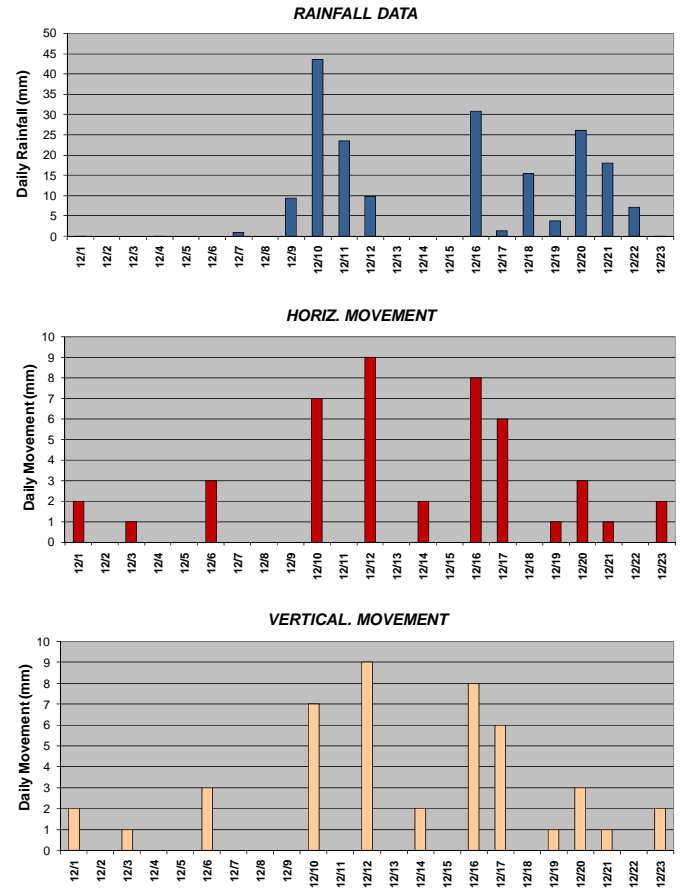
In order to investigate the effect if any of the rainfall which fell over the area on the observed patterns of movement, the results for the period spanning from Nov 28 to Dec. 22nd for the point of maximum deformation along alignment 3 (point 33) were plotted and they are presented in Fig. 10 along with the corresponding average rainfall data obtained from the Beirut International Airport weather station.

Fig. 10. Incremental horizontal and vertical movements at Point 33 with average rainfall data for same period.

- ❑ Water reaching the soil/rock strata along the distressed side was clearly a contributing factor to the observed failure, as the displacements are well correlated with increased precipitation and more importantly, resulted in measured very low strength in the post-failure exploration boreholes (particularly PR-2)
