International Conference on Case Histories in Geotechnical Engineering (2008) - Sixth International Conference on Case Histories in Geotechnical Engineering

## Lessons Learned from Two Investigation Cases of Ground Distresses Due to Deep Excavation in Filled Ground

Liew Shaw-Shong  
*G&P Geotechnics Sdn Bhd, Kuala Lumpur, Malaysia*

Khoo Chee-Min  
*G&P Geotechnics Sdn Bhd, Kuala Lumpur, Malaysia*

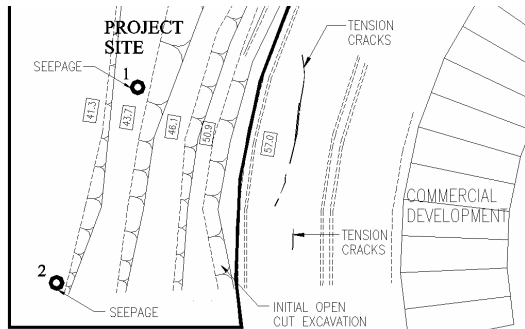
A site inspection was carried out by the project team shortly after observing the tension cracks on the road pavement. The semi-circular crack pattern was generally observed on the top of the excavated slope as shown in Fig. 3. Water seepage at two locations were also observed, indicating high groundwater levels within the filled slope (see Fig. 4). At the time of investigation, the excavation at the southern portion of the site was in a more advanced stage. It was not surprising that more ground movements were occurring behind the excavation where the tension cracks were firstly observed.

Fig. 3. Tension cracks at earlier stage.

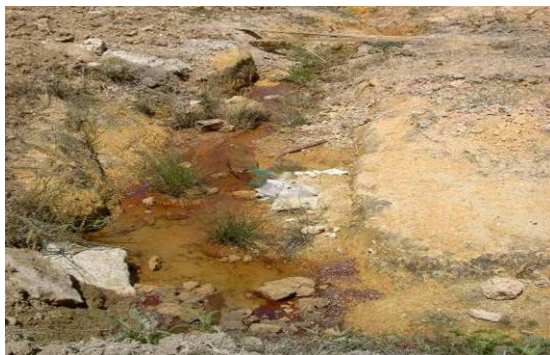
Fig. 4. Seepage (Location 1).

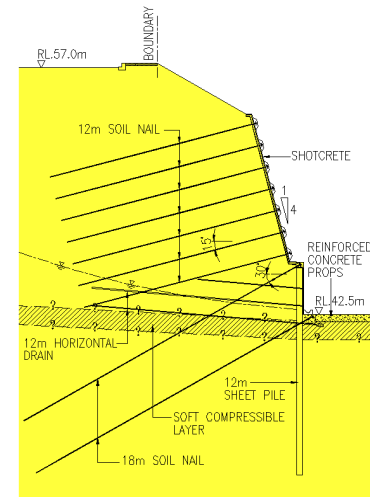
Fig. 8. Cross-section of stabilisation work in the valley area.

At the valley area where excessive creep movement was observed, 12m long FSP IIIA sheet pile walls with two rows of 18m long soil nail anchorages and permanent reinforced concrete props against the basement structure were used to supplement the passive resistance of the excavation in addition to the soil nailed slope on top. The cross-section of stabilisation work at the valley area is shown in Fig. 8. Strength reduction method in finite element (FE) analysis was used to assess the original safety factor and the improvement after the proposed stabilisation work at this critical section.

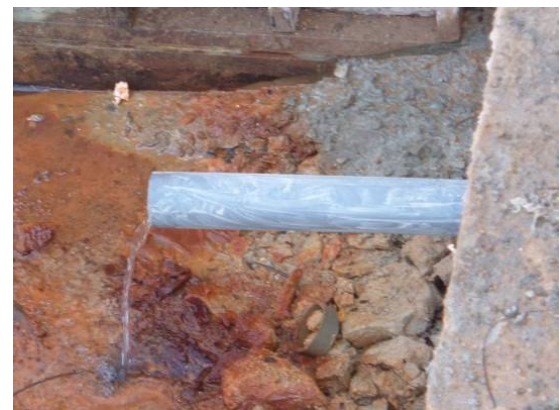
In one location, groundwater was observed continuously flowing out immediately after excavation. This particular location was believed to be the natural water path of the stream as revealed in the pre-development ground contour. Sufficient horizontal drains were installed at this location to release the perched groundwater. Figure 9 shows the water continuously discharging from horizontal drain after installation.

Fig. 9. Continuous seepage flow.

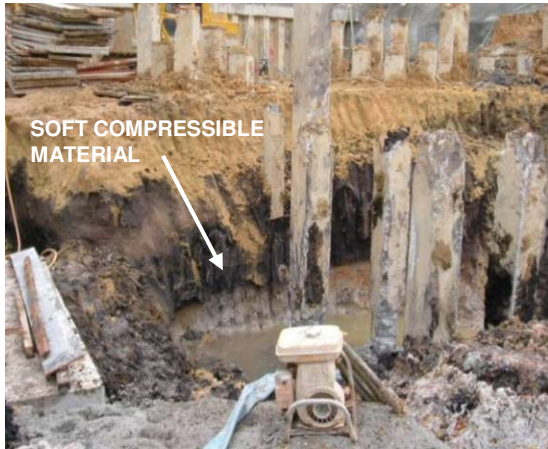
When excavation nearly reached the final excavation level, additional field testing such as Mackintosh probing and in-situ penetrating vane shear tests were conducted at the expected soft compressible layer to verify the soil parameters adopted in the remedial design. The localized excavation for pile cap construction further confirmed the existence of this soft deposited material as shown in Fig. 10.

Fig. 10. Soft compressible material detected at localized pile cap excavation.

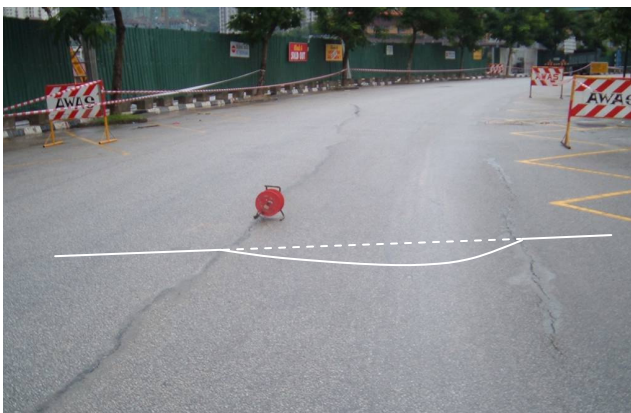
Subsidence troughs developed on the retained ground surface has been observed from the FE back-analysis results (see Fig. 14). The results show that surface subsidence is generally expected at a distance of 8m from the excavated face, which tallies extremely well with the site conditions as demonstrated in Fig. 15. The location of the trough is just immediately behind the end of the soil nail where a relatively large shear strain is developed along the potential slip surface behind the reinforced soil mass. This is fairly close to the formation of an active wedge in the retaining wall design. Two major tension cracks signify the extent of the developed active wedge behind the reinforced slope mass.

Fig. 15. Subsidence trough developed on the retained ground.

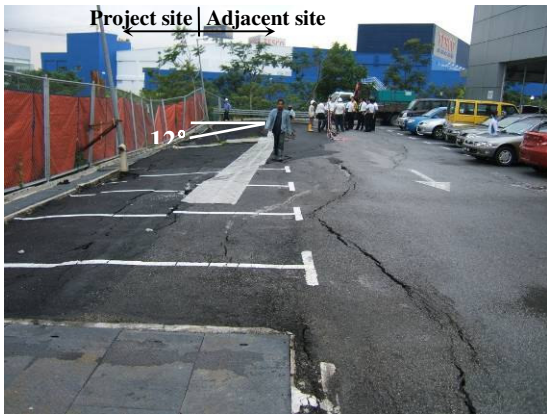
It was observed that continuous tension cracks appeared at varying distance away along the sheet pile wall of approximately 73m long. The tension cracks were more distant from the sheet pile wall at the southern end and become closer to the sheet pile walls toward northern end. At the time of inspection, more extensive excavation was carried out at the southern portion than the northern portion. The backyard car park platform of the adjacent lot had shown signs of subsidence and tension cracks as shown in Fig. 21 and 22.

Fig. 21. Site conditions of adjacent lot after the incidence of wall and ground distresses (Southern view).

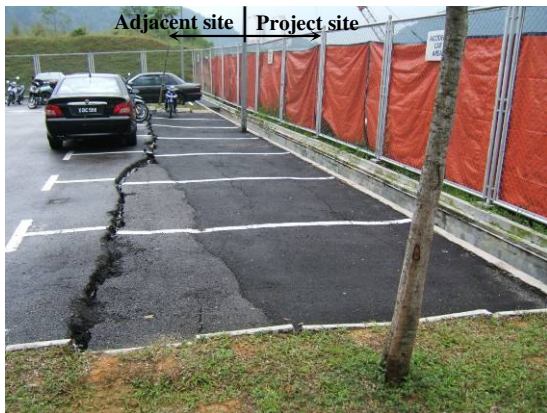
Fig. 22. Site conditions of adjacent lot after the incidence of wall and ground distresses (Northern view).

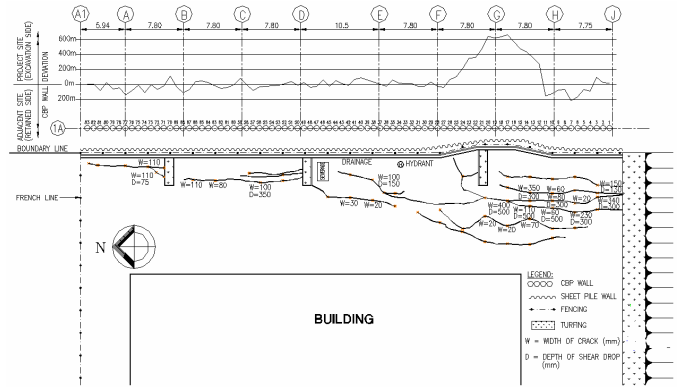
Site mapping had been carried out on the observed tension cracks and tilted sheet pile wall. Much more tension cracks were observed at the southern region. In this particular location, the sheet pile wall was seriously deviated outward relatively to the designed wall alignment. Efforts were made to map the crack lines by using measuring tape and slope meter. Figure 23 shows the details of mapped tension cracks.

Generally, the tension cracks were measured up to 400mm wide with shear drops between the two dislodged earth blocks. At the critical location (Gridline G), the major crack line was measured at approximately 6.2m from the original fence line. While, the furthest crack line was measured at approximately 12m from the original fence line. In addition, the overall tilt angle of subsided platform at this area was crudely measured to be about 12° as shown in Fig. 21. Sheet pile wall had also moved outward about maximum 1.2m from the designed wall alignment (at Gridline G). On the other hand, the measured pile top deviation of contiguous bored pile wall is also shown in Fig. 23.

Fig. 23. Crack mapping layout.

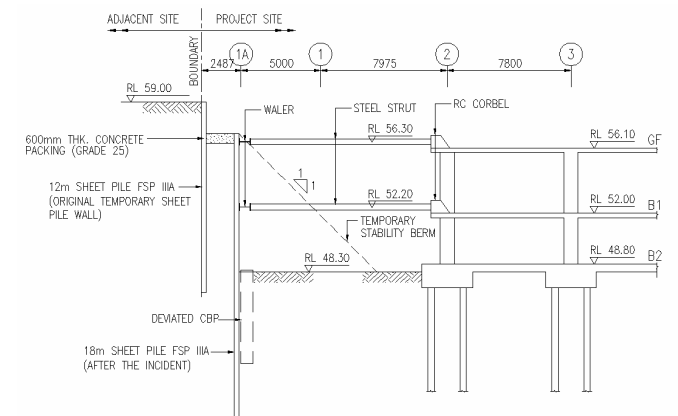
Fig. 27. Cross-section of remedial works.

The remedial works carried out included installation of additional row of 18m long sheet piles behind the deviated CBP area to stabilise the retained ground. Temporary strutted coffer-dam was constructed to facilitate the localized excavation of lift core. Two layers of temporary horizontal strut were installed propping the sheet pile wall against the permanent basement structures at distant before casting of remaining basement slab as shown in Fig. 27. Excavation was only allowed to be carried out in stages after the struts were put in place. Once the final excavation level (B2) was reached, the CBP wall was cut off at that level and verified with integrity testing (both low and high strain dynamic pile tests) to confirm structural integrity. Fortunately, most of the damages of the deviated CBP wall were well above the B2 level. Cast in-situ reinforced concrete wall was constructed over the starter bars from the intact CBP wall. The finished permanent basement structure is shown in Fig. 28.
