AN “UNEXPECTED” ROCK FAILURE IN A LIMESTONE OPEN PIT MINE

On 28th October 2004 a rock failure occurred in a limestone open pit quarry in Tuscany (Italy). The phenomenon evolved slowly with the collapse of about 1000 cubic meters. The complex failure mechanism mainly involved plane sliding along stratifications with rotation and block toppling. The phenomenon continued to evolve slowly and on 3rd November failure extended to the neighbouring portion of rock with a total collapse of about 5000 cubic meters of rock. Failure analysis took advantage of an accurate characterization of geology, geometry and mechanical properties of the collapsed rock mass. Such analysis led to the conclusion that the failure has been caused by the concurrence of various factors, namely:

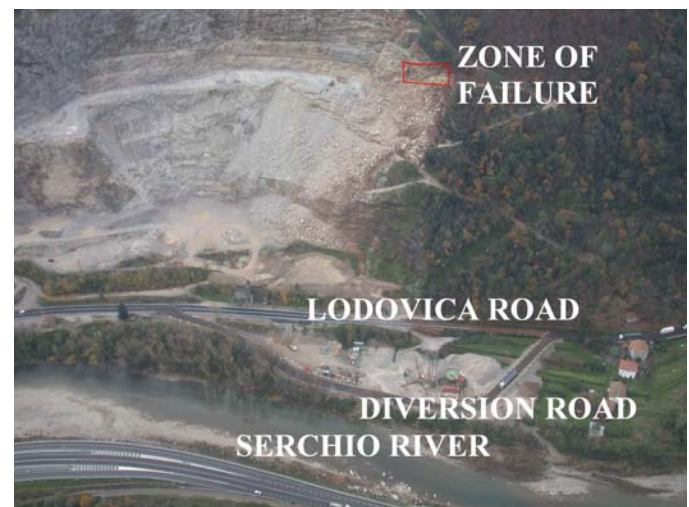
Fig. 1 View of the quarry site

The rock slope failure had two main consequences: 1) mining exploitation was definitively stopped; and 2) a diversion road (Fig. 1) was constructed and kept in use until the west portion of the quarry was put under safe conditions by means of appropriate works not described in this paper which mainly

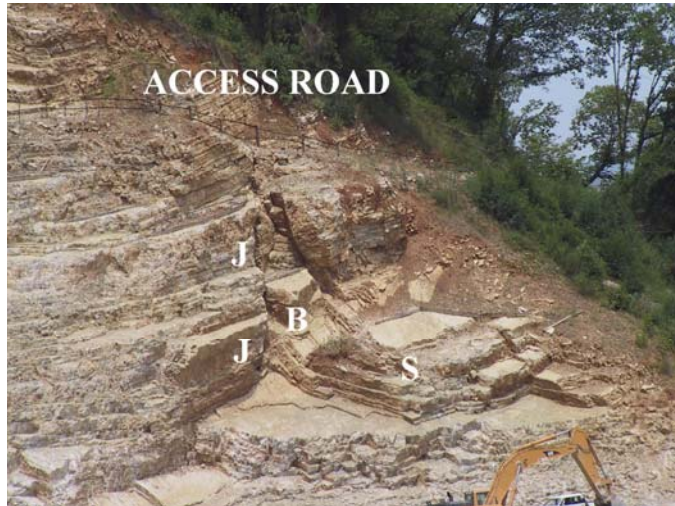
Fig. 2 Picture taken on 25th June 2003 of the collapsed rock mass before the failure: JJ sub-vertical joint, B Block, S 20° dipping stratification)

In conclusion, the Newmark - analysis results suggest that, more than one single blast, the accumulated effect of repeated blasts should be considered as one possible triggering factor. The rock mass which collapsed in autumn 2004 was apparently stable in June 2003 (Fig. 2). It is also worthwhile to remark that the first signs of rock instability (tension cracks in

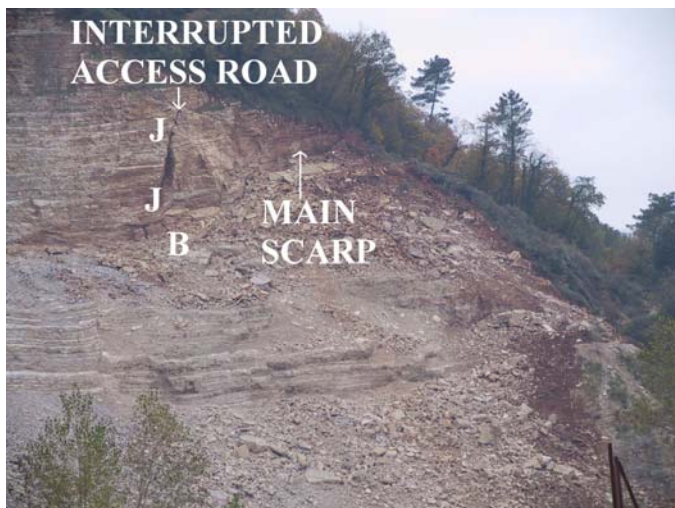
pictures: the same sub - vertical joint indicated as JJ in both pictures, the same block indicated as B and the access road which in Fig. 3 is interrupted.

Fig. 3 Picture taken on 22nd November 2004 of the collapsed zone after the failure: JJ sub-vertical joint, B Block

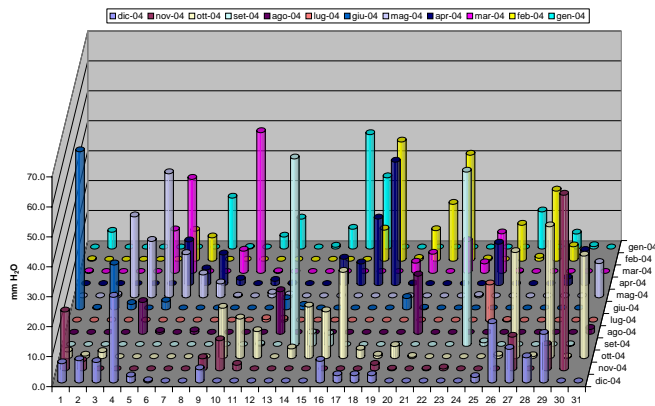
Fig. 4: Rainfall recorded at the Piaggione pluviometer, located near the quarry site (year 2004)

the access road) appeared in the afternoon of 27th October (the day before the first failure) in concomitance with intense rainfall (see Fig. 4).

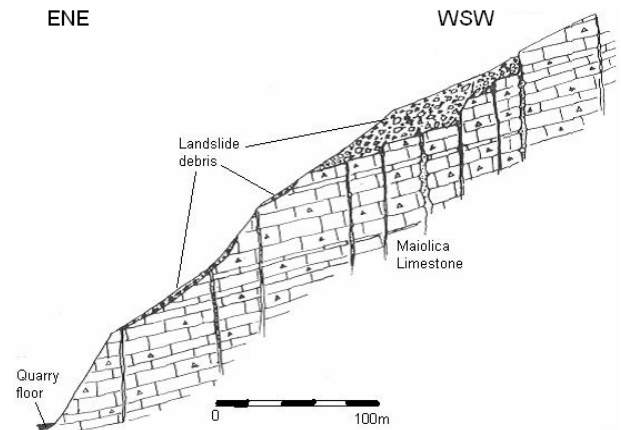
A geological section in sector 3, is shown in Fig. 5. The local rock mass structure is characterized by the bedding joints S_t ($107^\circ/19^\circ$) and three principal joint systems: K_1 ($348^\circ/83^\circ$), K_2 ($45^\circ/82^\circ$), K_3 ($74^\circ/86^\circ$). Bedding joints(those joints developed on bedding surfaces) are highly persistent and represent the lowest angle set while the other three joint sets represent high angle or subvertical joints. All the joints subdivide the rock mass in almost straight dihedra prevalingly formed by the intersection of the K_2 , and K_3 sets as the set S_t which makes up their base. The S_t surfaces appear smooth, slightly weathered and usually tight, sometimes showing silty or sandy infillings. According to the local bed thickness, their spacing is usually $<0.5m$, while the spacing of the other joints is generally $\sim 1m$. The surfaces of the K_2 set, which often shows a less than 1m linear size, are slightly rough and have wide separations. Their intersection with S_t makes the edge of the wedges align with the quarry slope. K_1 , and K_3 sets are also non - persistent and show wide separations, however their surfaces appear oxidized and very weathered and karstic features can be seen. All these disjunctive features could have had an important role on the structural control of the rock mass and on shaping the scar of the rock slope failure.

Fig. 5: Geological section in the sector 3, subject to the failure (Puccinelli, 2005)

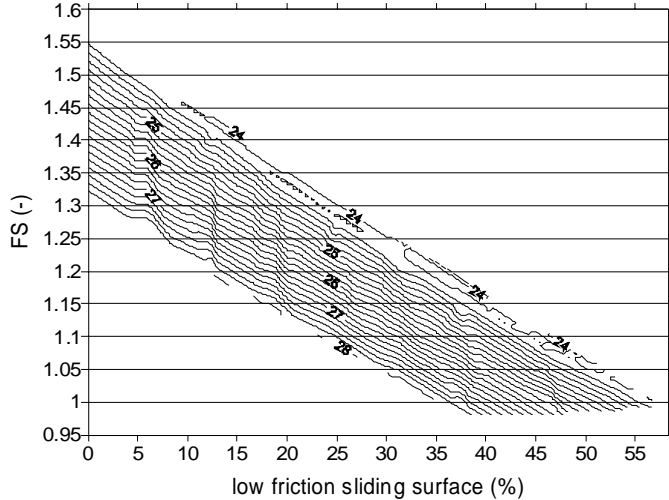
Fig. 6 Trend of FS versus percentage of the sliding surface having low ϕ_i for different α_{ST} .

All the above mentioned types of analyses led to the conclusion that the rock failure becomes justified only assuming a degradation of the joint strength. It is especially instructive to see the safety factor FS obtained from LEM analyses as a function of bedding plane inclination (α_{ST}) and percentage of the bedding plane having low strength (Fig. 6). It is possible to notice that the safety factor becomes less than

1.0 when such a percentage is greater than 40 -55 % for $\alpha_{ST} = 24 - 28^\circ$

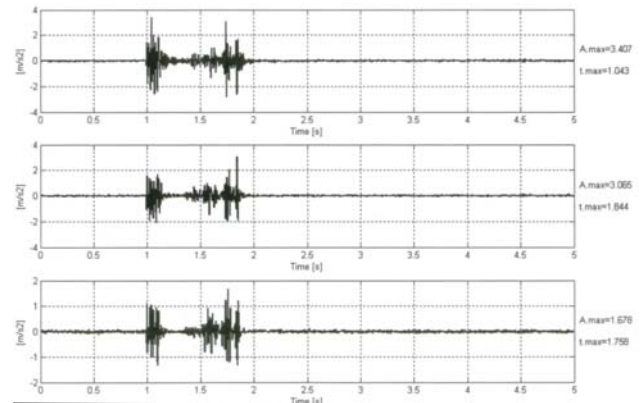
Fig. 7 Time histories (X, Y, Z) recorded by SETAC 1

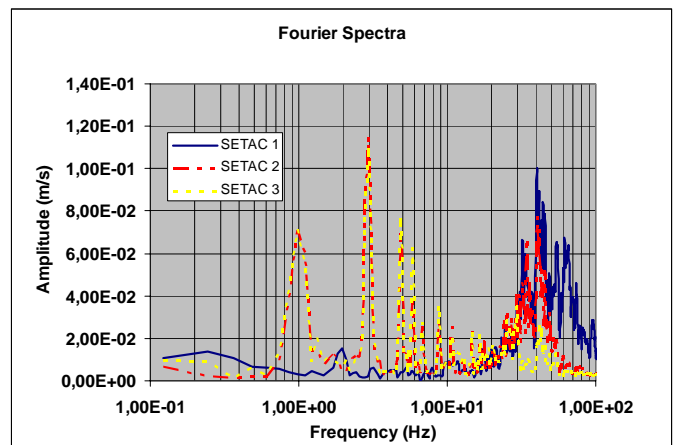
Fig. 8 Fourier Spectra X component of acceleration time histories recorded by SETAC 1, SETAC 2, SETAC 3.

Figure 8 shows the Fourier spectra of the X components, recorded at three different distances. It is possible to notice that for the accelerometer closest to the blast area (SETAC 1) the peak amplitude of Fourier spectrum is observed at around 50 Hz while such a peak moves towards lower frequencies for the other two accelerometers. The same result is obtained if the two wave trains, observed in the acceleration time histories, are analysed separately.
