A Case Study on Rectification of Damaged Structures on Expansive Soil Deposits

A CASE STUDY ON RECTIFICATION OF DAMAGED STRUCTURES ON EXPANSIVE SOIL DEPOSITS

J.M. Kate

Indian Institute of Technology, Delhi
New Delhi – 110016, India.

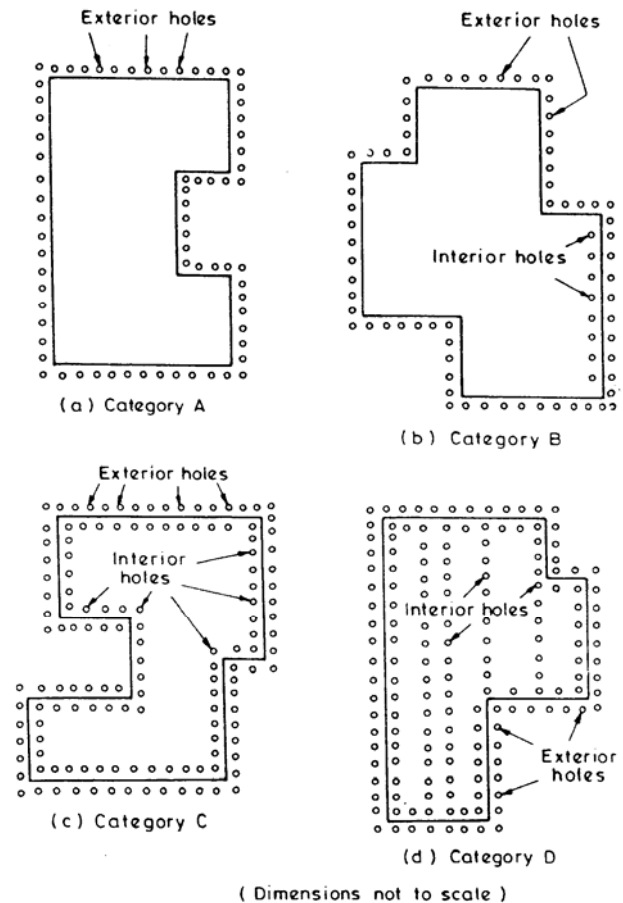
Fig. 3. Schematic arrangement of injection holes for various category of damages.

In order to adopt suitable pattern of injection holes for LSPI application, the damaged buildings depending upon the seriousness of their distress have been broadly categorized as A,B,C and D with the following descriptions.

Category A – Lightly damaged: Minor cracks on the walls extending to short lengths with no visible damage to the floors.

Category B – Moderately damaged: Fairly wide cracks on the walls extending to considerable lengths, with or without visible/minor damage to the floors. One side of the building exhibiting light damage whereas, other side showing moderate to heavy damage.

Category C – Heavily damaged: Very wide cracks in the walls everywhere extending to considerable lengths and heights with visible damages and distortions in the floors.

Category D – Extensively damaged: The distress is widespread throughout the building as evidenced through severe horizontal, vertical and diagonal cracks in the walls extending from floor to ceiling level, heavy crackings in joints of structural members, sinking and considerable distortions in the floors.

Auger holes of 50 mm dia. spaced between 0.5 m to 1.0 m were drilled all around the damaged structures following a pattern based on their shape, size and extent of damages. These holes were drilled to substantial depth ensuring penetration down into constant volume zone or at least to a depth of 1 m below the base of existing footing/under-ream bulb. The preliminary estimate indicated the depth of constant volume zone to be around 1.7 m within yellow soil below its surface. The line of such holes was kept as close to the outer edge of footing/under-ream bulb as practicable. This arrangement of drilling exterior injection holes all around the

structure was common for all the four categories of damages. The schematic arrangement of such injection holes are illustrated in Fig. 3 (a to d) for structures with different degree of distress.

The side(s) of building which exhibit(s) more damage in case of Category B, additional holes were drilled inside the building on damaged side by removing floor slab and the line of such holes kept as close as possible to the inner edge of the footing/under-ream bulb (Fig. 3,b). Similar lines of interior holes were drilled inside the entire building for both the category C and D buildings (Fig. 3, c and d). In addition, for category D, such injection holes were drilled in the central portion encompassing the damaged floor area (Fig. 3,d).
