International Conference on Case Histories in Geotechnical Engineering (2008) - Sixth International Conference on Case Histories in Geotechnical Engineering

Evaluation of Damage to a Road and Sports Complex on Expansive Clays

EVALUATION OF DAMAGE TO A ROAD AND SPORTS COMPLEX ON EXPANSIVE CLAYS

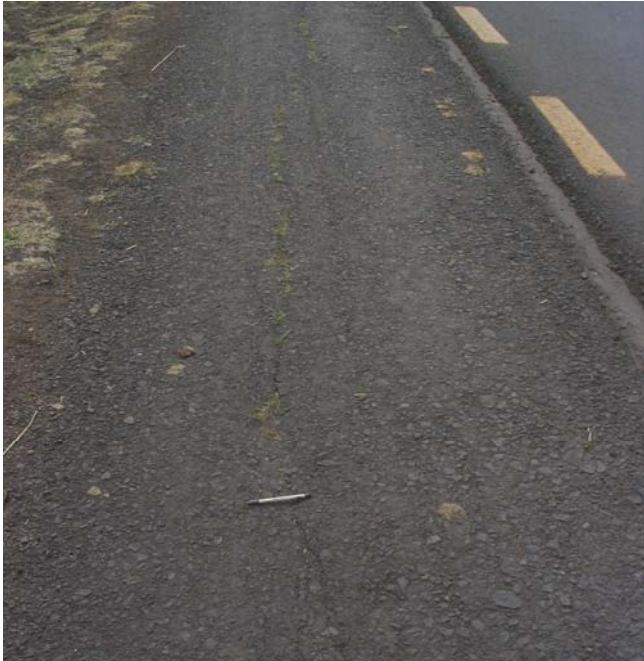
Figure 1 shows an example of the longitudinal cracking in the shoulder. Figure 2 shows a typical longitudinal crack in the asphalt observed along the roadway.

Fig. 1. Longitudinal cracking in the shoulder

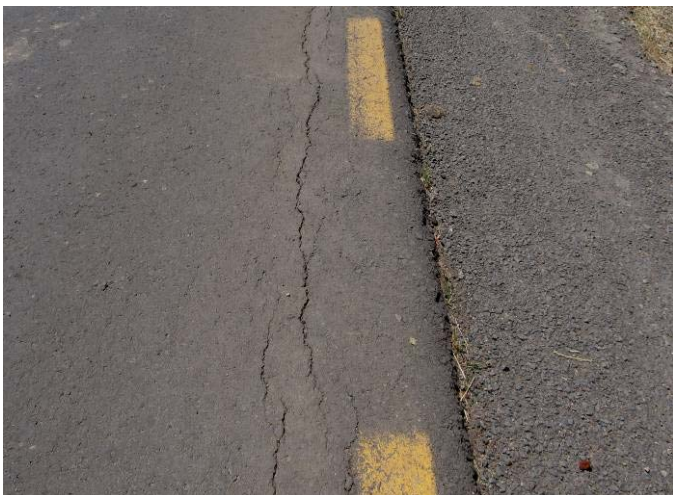
Fig. 2. Illustrative longitudinal crack in asphalt carriageway

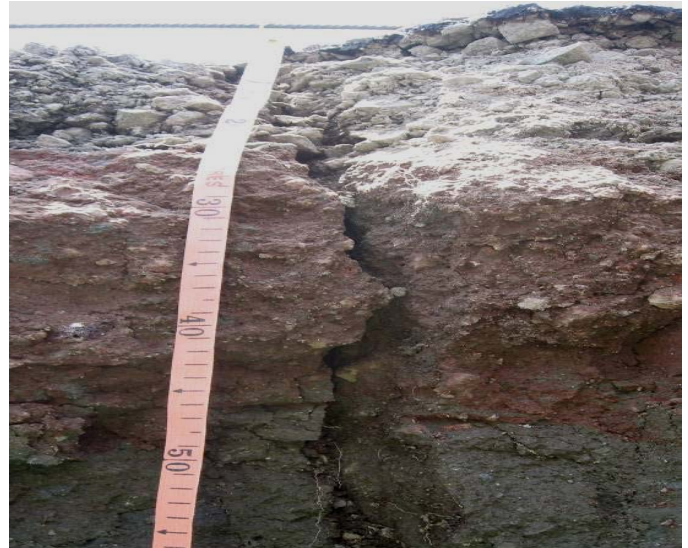
Test pit observations. Figures 3 and 4 show the crack propagation with depth as observed in two of the test pits. Figure 3 shows the crack at a shoulder location while Fig. 4 shows the crack propagation underneath the carriageway near the outer wheel track. The cracks pass through all of the pavement layers. While the cracks could not easily be discerned in the roadbed itself, the highly slickensided structure was indicative of the seasonal movement taking place within the clay.

Fig. 3. Crack propagation in shoulder

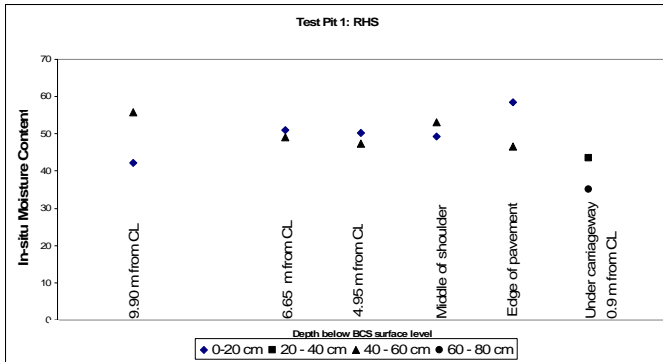
Fig. 5. Lateral moisture content distribution within the BCS roadbed

The results generally showed a variation of the moisture content. Fig. 5 shows that at a depth of about 20 cm below the BCS, the moisture content was higher at the edge of the pavement than in the shoulder.

These values were, however, higher than at the toe of the embankment. At a depth of more than 40 cm, within the BCS, the shoulder was wetter than the side of the embankment as well as the edge of the pavement. Lower moisture content values were obtained from samples collected under the carriageway. The roadbed was also generally wetter under the embankment surface than under the carriageway, suggesting a vertical moisture migration from the embankment surface towards the roadbed.

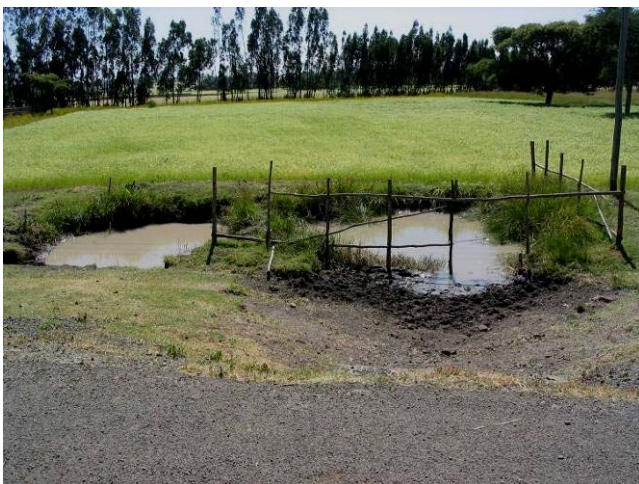
Drainage control. The generally flat topography of the area under investigation required that particular attention be paid to drainage to ensure that the surface rainfall does not accumulate near the roadway. However there were sections along the route where there was water ponding alongside the road (Fig. 6). This photo was taken during the last month of the rainy season and no rain had fallen for a week.

Fig. 6. Ponding of water adjacent to road

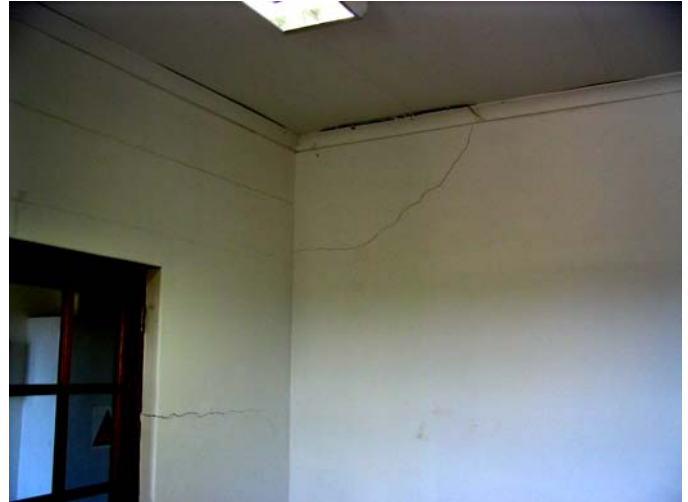
It is evident that the precautionary measures had an impact although the extent of differential movement of the foundations has a significant impact on many of the buildings. The installation of the concrete ring beams reduced the tendency for corner cracking but led to cracking parallel to them (Fig. 7) and between the groundbeam and window-level ringbeams. Corner cracking and movement of the ceilings, however, affected internal walls (Fig. 7), window frames and many of the floors were cracked.

Fig 7. Cracking parallel to ring beam (above window) and on internal wall

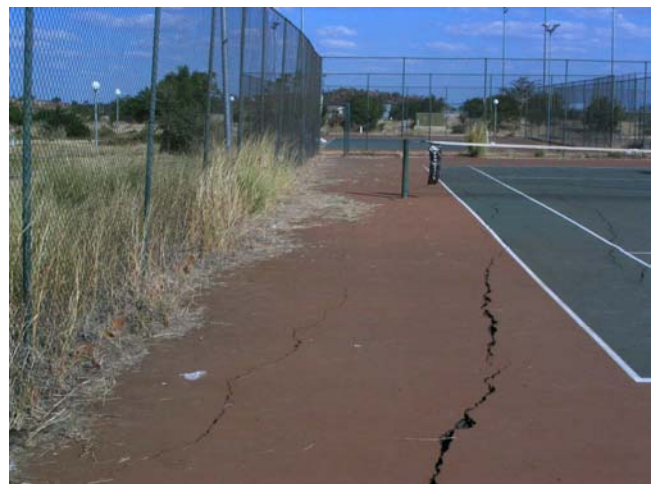
Other facilities such as tennis courts were placed on soil rafts. Despite this, the edges of the courts were subject to movement and cracking (Fig. 9).

Fig 9. Damage to tennis court – note distortion of fencing supports
