## **CASE HISTORY OF THE TEMPORARY SUPPORT OF AN 11-STORY HISTORIC BUILDING IN DOWNTOWN WASHINGTON, DC**

**David Rothenberg, P.E.**  
Clark Foundations, LLC.  
Bethesda, Maryland, USA 20814

### **ABSTRACT**

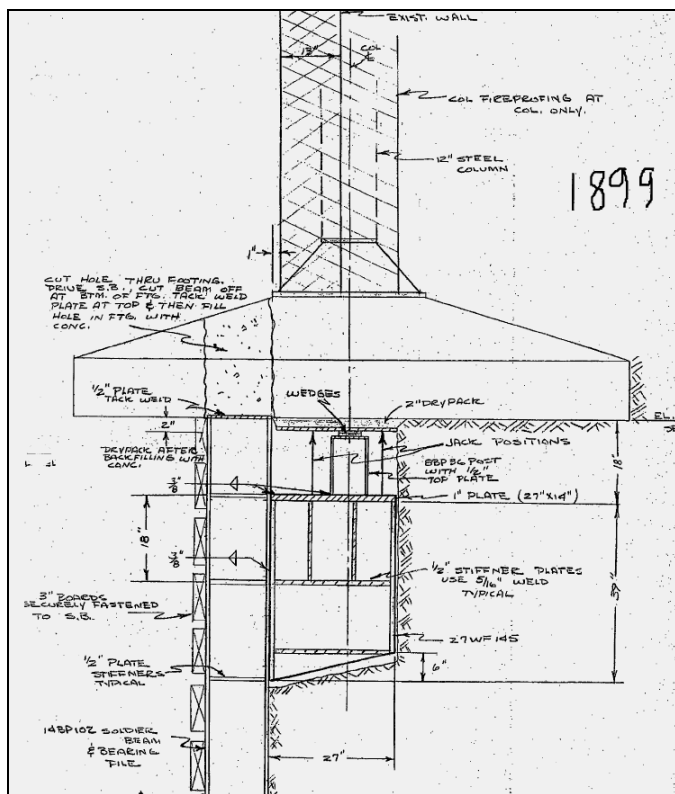
As a result, two additional test pits were excavated through the foundation wall of the 1819 building. This was done in an effort to tunnel under the spread footings of the 1899 building. The test pits, along with partial support of excavation drawings discovered later by the structural engineer, confirmed that the historic 1899 building had a spread footing foundation and that its west wall was underpinned with bracket piles during the construction of the 1819 building in 1960. Figure 3 below shows the existing upper bracket detail installed in 1960 that would be eventually incorporated into our system. This detail clearly shows that a portion of the existing footing was removed prior to installing the driven soldier beam. Once the pile was installed, a half inch thick bearing plate was attached to the top of the soldier pile and the footing concrete and reinforcing was replaced

Figure 3: Upper Bracket Detail Installed 1960

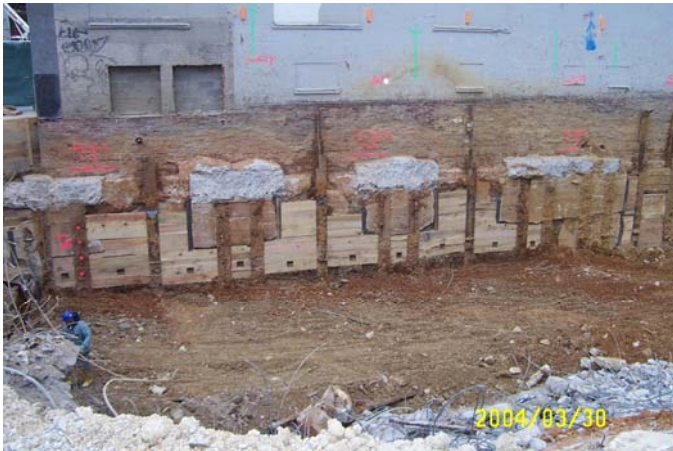
Once soldier beams were installed along the North Alley and H Street to the south, excavation of the site adjacent to building 1899 could proceed in four-foot lifts. It was confirmed through calculations that a portion of the existing 1899 footing could be removed to the face of bracket pile. See figure 6.

As the excavation proceeded, the foundation wall was removed and the 40-year-old bracket piles were exposed. Each pile was inspected for corrosion. Some minor repairs were made-mostly in the form of cover plating the outside flange and web as required. In addition, a portion of the concrete encasement around each of the 28 brackets was removed in an effort to visually inspect the 40-year-old bracket connection. The brackets had very little, if any, corrosion and needed no repair. Finally the wood lagging was automatically replaced.

Figure 6: Existing Bracket Piles Supporting 1899

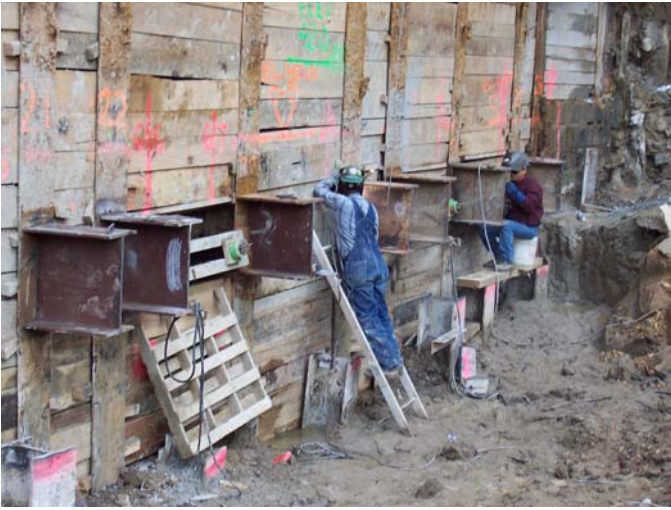
Once the 25 new bracket piles were installed, the transfer girder (W21x83) and lower bracket (W24x104) installation could begin. The brackets were located and installed first. These brackets, were welded directly to the existing piles. Again, special consideration for corrosion was given to the 40-year old pile at the bracket location. The flange and web were cover plated to beef up the section as required. The newly installed soldier beams were cut off to provide enough space to install the W21x83 transfer girder plus two-inch gap for the flat jack. A one-inch thick plate was welded to the top of each pile to provide bearing. This plate connection detail required slight adjustments at each pile based on the final pile and transfer girder as-built locations. The transfer girder was then installed in 40-foot sections and placed as tight to the existing pile as possible to limit the moment induced by the bracket load.

Figure 10: Installing lower brackets

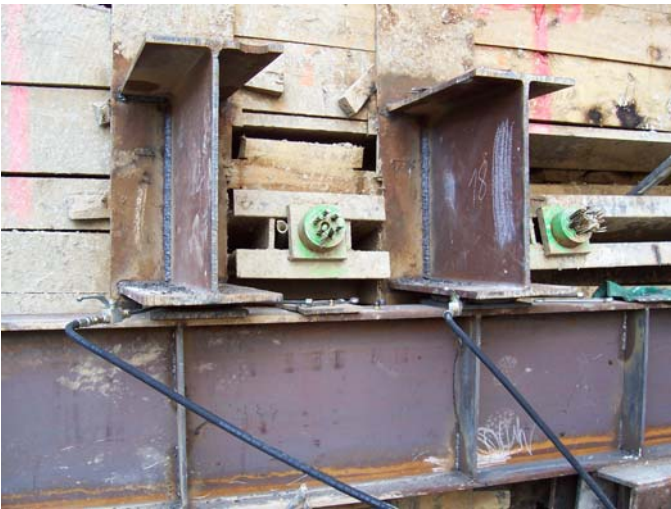
Figure 11: Completed Lower Jacking System

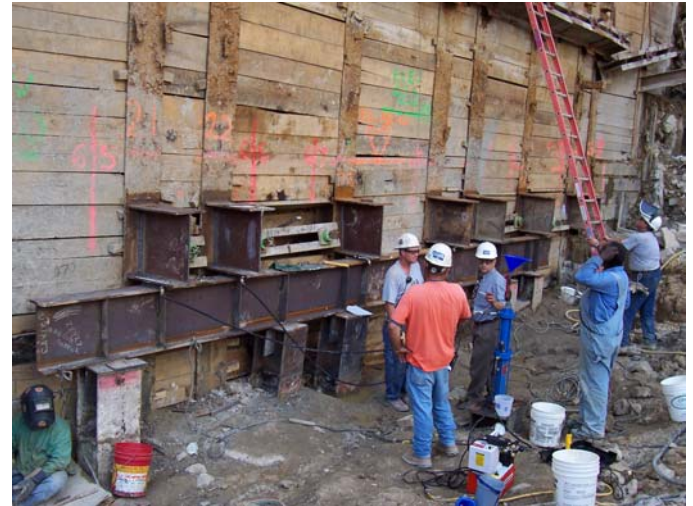
newly installed bracket piles for settlement. The intent was to limit the possible of over jacking the footing which could in turn induce stress cracks. Throughout the jacking process, no cracking or appreciable movement was observed, maximum deflections of 0.01 to 0.02 inches were noted.

The pre-stressing load was applied in three stages of 33, 67, 100 percent of the pre-stressing force. Each stage was held only long enough to take readings on adjacent piles. Additionally, at each stage, visual observations, of the footing being jack were made to insure that we were not overstressing the footing.

Figure 12: Three Brackets Pre-stressed Simultaneously
