## **FAILURE OF TWO HIGH EMBANKMENTS AT SOFT SOIL SITES**

Two highway bridge approaches, about 10 and 12 m in height, near Calcutta, India constructed with mechanically stabilized earth failed recently. These embankments were founded on soft and compressible, fine-grained soils of the intertidal flats and backswamps of the Ganges delta. One of these embankments, which failed in the final stages of its construction, was constructed after foundation soils were strengthened with preloading and prefabricated vertical drain installation and the other second embankment that failed within a month of its opening for traffic was constructed on unimproved ground. Fortunately, direct collateral damage from these incidents was small. Available geotechnical data indicated that design inadequacy was the main cause of these failures. Using pre- and post- consolidation shear strengths the embankments were redesigned. Reconstruction involved PVD installation at the second site and construction of stabilizing berms at both locations. The facilities are now operational and appear to be performing satisfactorily. Details of the failures, post failure investigations and monitoring, and redesign are pr

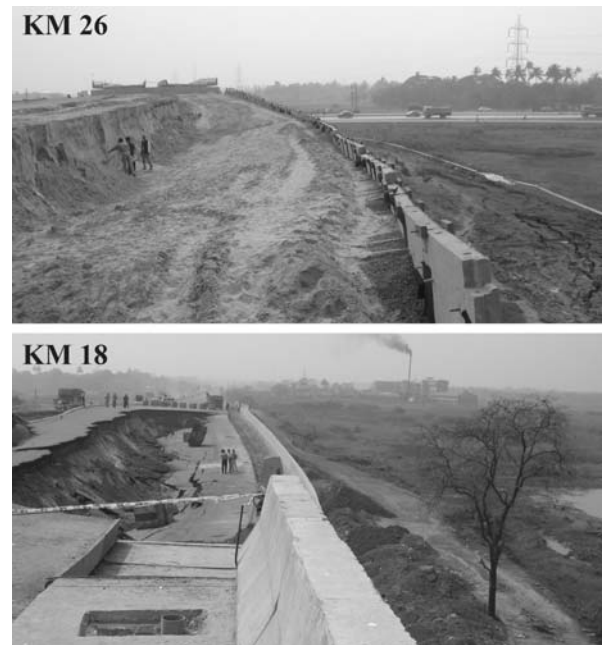
*Fig.1. Failures at KM 26 and KM 18site.*

The first event affected a highway interchange structure, under construction since July 15, 2003. The structure is retained by a Mechanically Stabilized Earth wall along the outer shoulder and with the fill slope of 2 (H):1(V) along the inner shoulder. The nearly-complete MSE wall underwent a deep seated failure in the early hours of rains received and an additional 0.4 mm of rainfall on the following day. The height of the affected embankment was between 8.9 and 9.8 m at the time of the incident. The cross section of the failed MSE wall is shown on Fig. 3. Post failure inspection indicated that the MSE wall failed due to external instability without significant internal distress.

The second incident involved an MSE wall that runs along the western edge of the northbound lanes of a highway approaching a railway overpass. A 30-year old, 9-m high earth embankment with 3H to 1V side-slope along the eastern edge of the approach carries the southbound traffic. The failure occurred immediately after midnight on February 9, 2006 about a month after the highway was opened for vehicular traffic. During the failure, a section of the newly constructed 2-lane approach vertically settled by about 3 m and laterally translated outward by about 1 m. The cross section of the failed MSE wall is shown on Fig. 4. As at KM 26 site, the MSE wall at KM 18 site appeared to have failed due to external instability without significant internal distress.

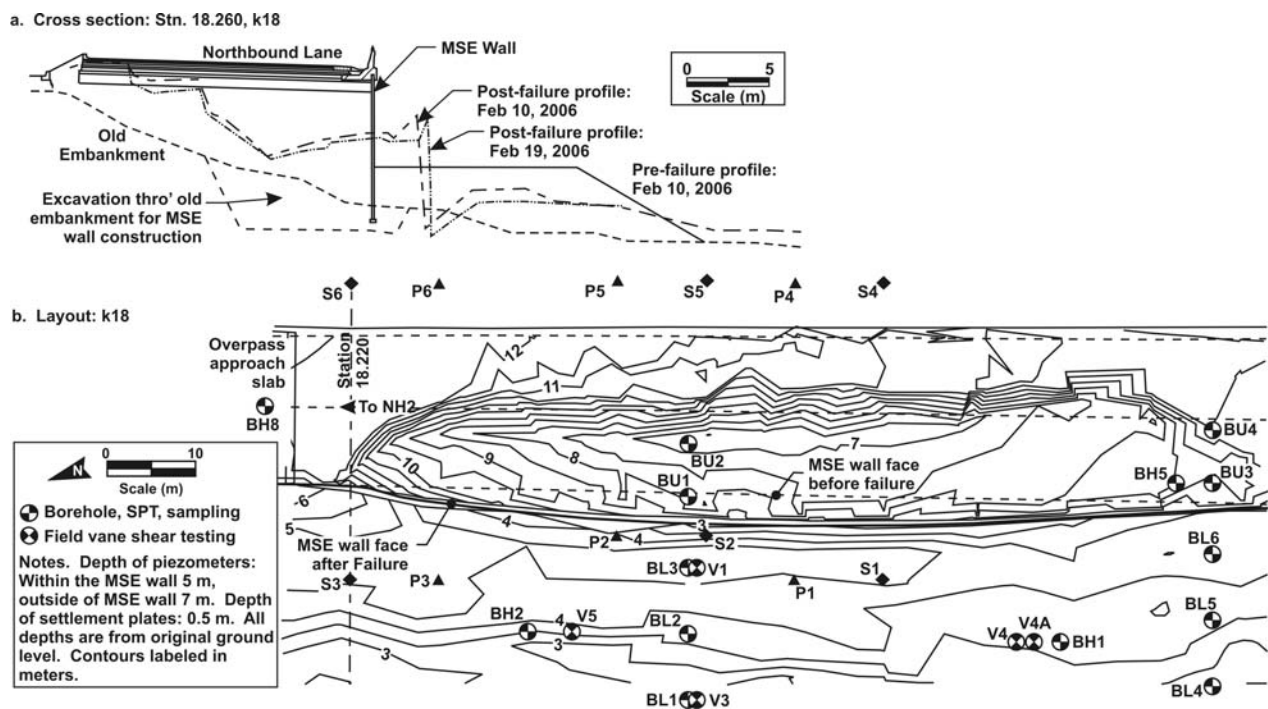
Fig. 4. Cross section of the KM 18 MSE wall.

The failed MSE wall was constructed for four laning of a pre-existing two-lane, undivided highway that runs on the 30-year old embankment with 3(H):1(V) side slopes. The construction of the old embankment also triggered several slope failures. One such failure occurred in 1966, when the embankment reached its full height 10.7 m. The instability was assessed to be due to a deep-seated circular slip that day lighted just beyond the toe. During this failure, the maximum embankment height within the stable stretch was 6.7 m. As remedial measures, the failed embankment was removed, the highway elevation was lowered and the embankment was reconstructed along with a 2.1-m high stabilizing berm along the edges of the embankment. Another slope failure occurred later immediately to the south of the railway tracks. Since poor subsurface conditions did not allow construction of an embankment of required height at the location of this failure, the earth embankment at the location of this failure was replaced by structural spans added to the bridge structure for carrying the overpass. Details on the original geotechnical investigation and design of the highway in this area can be found in Gangopadhyay and Das (1969).

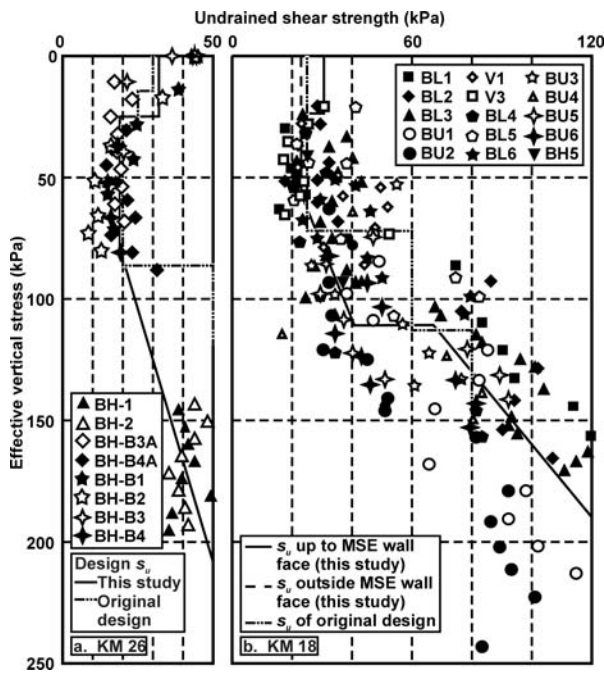
Fig. 5. Undrained shear strengths.

Measurements from KM 26 site indicate that the undrained shear strength at this location can be expressed as a function of effective vertical stress shown with a solid line in Fig. 5a. Since, the undrained shear strength is a function of effective stress under which the deposit was in equilibrium, for estimating the shear strength at the time of failure the state of consolidation at that time needs to be assessed.

Data from KM 18 site indicate that (a) the undrained shear strengths at this location decreases westward and (b) the undrained shear strengths can be expressed as functions of effective vertical stress as shown with a solid and a dashed line on Fig. 5b.

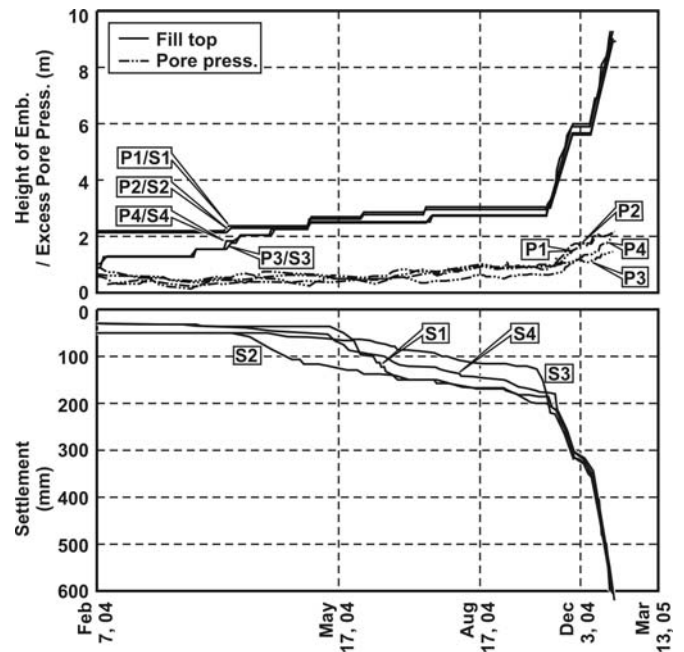
Fig. 6. KM 26 site monitoring data.

The embankment and the MSE wall at KM 26 site were constructed after installing PVDs to depths between 11.5 and 15.5 m in square grids with 1.5 m spacing. The PVD treated zone covered the entire embankment footprint and extended to 4 m outside of the MSE wall face. To monitor the settlements and pore water pressure development during fill placement, four settlement plates S1, S2, S3 and S4 and four stand pipe piezometers P1, P2, P3 and P4 were installed near Station 800 (Fig. 3). These monitoring data indicate that the rapid construction rate after October 31, 2004 lead to a rapid pore water pressure development and accelerated settlement rate (Fig. 6).

It is evident from available instrumentation records that the embankment at KM 26 site was undergoing rapid settlements over approximately 2.5 months prior to failure. The construction rate was not controlled to allow settlement rates to decelerate. As deformations increased the strain within the foundation soils beyond those at which the peak undrained shear strengths are mobilized. This eventually led to failure.

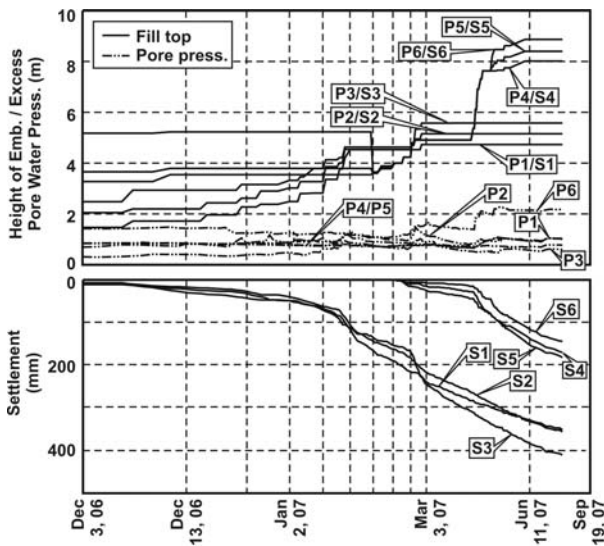
Fig. 7. KM 18 site monitoring data.

Data from the instruments installed after failure for monitoring the reconstruction activities, presented in Figure 7, indicate that the settlements were continuing to develop and pore water pressures were still dissipating after about 4.5 months of preload placement (completed in the first week of January 2007) and PVD installation (completed in the third week of October 2006).

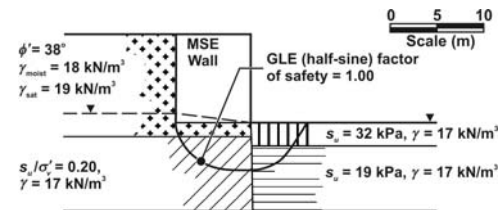
Fig. 8. Undrained stability of KM 26 embankment at failure.

For the profile of peak undrained shear strength indicated with the solid line on Fig. 5a, the results of limit equilibrium stability computations for the MSE wall configuration at failure indicate that the structure was marginally stable at the time of failure according to the Generalized Limit Equilibrium (GLE) procedure (Chugh 1986) (Fig. 8). Software package XSTABL Version 5.1 (Interactive Software Designs, Inc. 1994) was used in all stability analysis of this study.

In comparison, the minimum factor of safety against circular slip in the original design was under static loads was 1.15 in the slope stability analysis. However, in the original design the maximum considered embankment height including pavement structure was 9 m against the actual maximum height of 9.8 m and a total unit weight of  $15 \text{ kN/m}^3$  (in stead of  $18$  to  $19 \text{ kN/m}^3$  representative of the compacted river sand used to construct the embankment) was assumed for the

embankment body because of the initial plan of constructing the embankment partly with fly ash. Most importantly, the strength parameters used in the original design, shown on Fig. 5a for comparison, were based on the assumption that when the embankment construction reached a height of 9 m, the average degree of consolidation for the soil layers underneath would be 90 % under the surcharge imposed by an embankment of 7.1 m height resulting in an undrained shear strength of 50 kPa minimum. Such a degree of consolidation was not achieved because of rapid construction rate. Moreover, even if 90% consolidation was to be achieved, available test data from the site indicate that the undrained shear strength would only have increased to about 30 kPa, an estimate smaller than the value assumed in the original design. Thus the bases of the original design were, in general, unconservative. Even with these inputs, the overall stability requirement of IRC (1979) of a limit equilibrium factor of safety of 1.25 was not fulfilled.

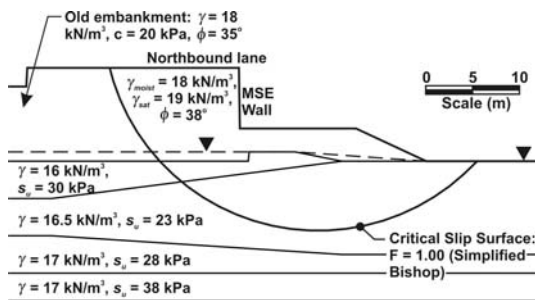
Fig. 9. Undrained stability of KM 18 embankment at failure.

External undrained stability of the configuration of the MSE wall assessed using the simplified Bishop method (Bishop 1955). The input parameters used in the analysis were based on the assumptions that (a) the soil layers underneath the MSE wall were fully consolidated under the vertical stress imposed by the old embankment, (b) that the degree of consolidation due to the MSE wall and the newly constructed embankment was 50 %, and (c) the undrained shear strength profiles can be approximated with the solid and dashed lines of Fig. 5b. The strength parameters for the old embankment were back figured from stability analysis to match the observed instance of deep seated rotational failure during the construction of the embankment in the sixties described earlier. In the stability assessment of the old embankment, strength parameters for foundation soil were assumed in accordance with the dashed line of Fig. 5b. The results of external stability assessment for the MSE wall at failure indicate that the MSE wall and the embankment behind it were indeed marginally stable at the time of failure (Fig. 9).

In comparison, the minimum factor of safety against circular slip in the original design was under static loading was 1.42 in the slope stability assessment. However, in the original design the maximum considered embankment height including pavement structure was 8.4 m against the actual maximum height of 10.5 m and a total unit weight of  $15 \text{ kN/m}^3$  was assumed for the embankment body because of the initial plan of constructing the embankment partly with fly ash. Most importantly, the undrained shear strengths used in the original design, shown on Figure 5b for comparison, were over a large portion of the depth range of interest greater than those inferred from laboratory and in-situ test data. Thus the bases of the original design were, in general, unconservative.
