Forensic on Construction Induced Failure of Pipe Pile Foundations

Xiong Bill Yu

Yuewen Huang

FORENSIC ON CONSTRUCTION INDUCED FAILURE OF PIPE PILE FOUNDATIONS

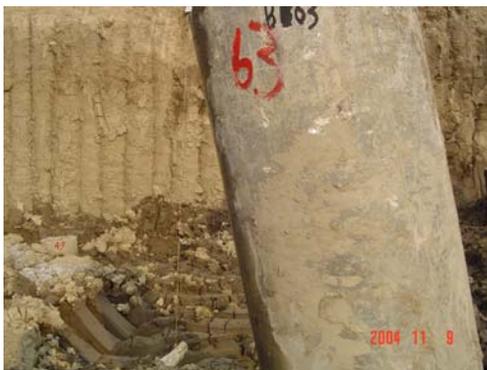
(a)

Upon the accomplishment of foundation installation, construction activities proceeded which included excavation for ground grading with backhoes (Fig. 2a). Severe inclination of pipe piles, however, were observed at a number of locations during the excavation process. The construction activities were halted after observing these excessive inclinations. The inclination of pipe piles continue

Fig. 2 Severe inclination observed during excavation a) photo during construction; b) illustration of pipe pile inclination

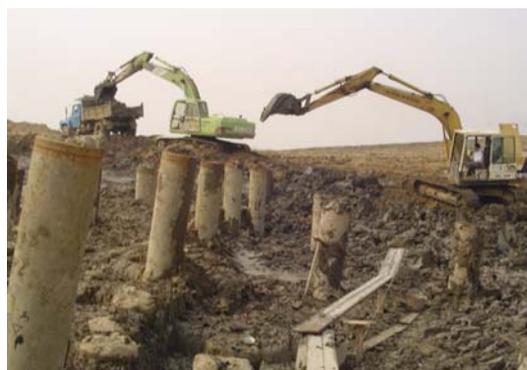
(b)

to increase slightly until it reaches a stable condition. Figure 2b gives an example photo showing the inclination of individual pipe pile. Result of post-accidental survey indicated that the maximal lateral displacement at the top of pile reached as large as 2.6m. A statistics of the magnitude of pipe pile inclinations is listed in Table 1.

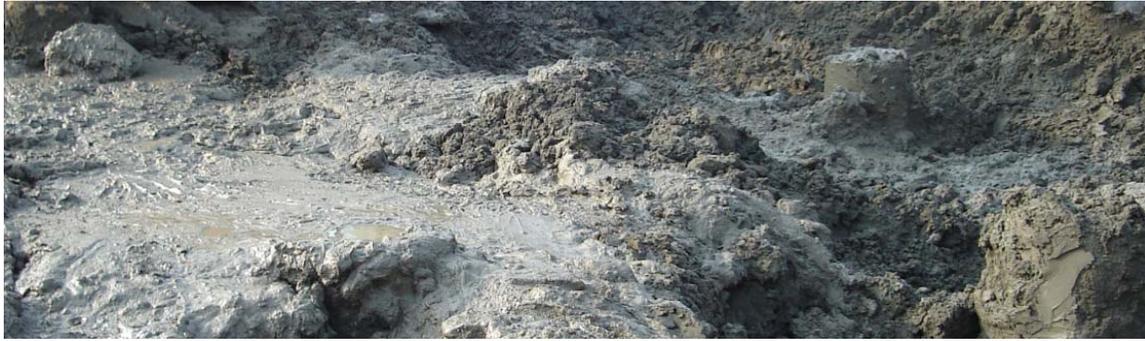
Fig. 3 Effects of construction vibration on sludge

Ground vibration due to motion of construction equipment caused the sludge layer into a semi-liquified condition. Figure 3 shows a photo of the status of sludge to indicate effects of construction

vibration on the sludge behaviors. As can be seen from the left hand side of this photo, the construction vibration caused the sludge to behave like a liquid.

In conjunction with this effect, the differences in elevation due to excavation caused sludge to flow gradually under gravity. These subsequently applied a significant amount of unbalanced lateral force on pipe piles. As the consequent, the soil layer offered insignificant amount of lateral resistance. This unbalanced lateral force together with the lack of lateral support caused large bending moment action on the pipe piles, which was sufficiently large to cause the failure of splices in many cases. Among the factors led to the accident, the internal factor is the thick soft sludge layer with high

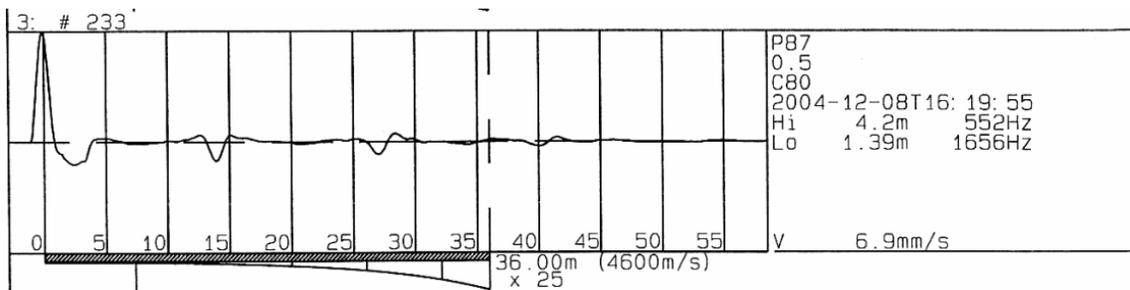
Fig. 4 Example of PIT and inclination measurement on pipe pile

As part of the forensic study, both Pile Integrity Tests (PIT) and inclination measurement were performed on the failed pipe piles. 164 such tests were conducted altogether. Example of measured results is shown in Fig. 4. Both the PIT signal and inclination data imply that the pipe pile fails at around 11m, which is close to the location of the last splicing. Similar failure pattern was observed on other pipe piles.

Based on assessment of the load bearing conditions of the failed pipe piles, it was determined that most of the failed pipe piles could not be utilized for foundation support. Foundation at the location of failure was redesigned with new large diameter piles to ensure the bearing capacity and settlement criteria. The economic loss caused by the foundation failure was estimated to be around 20M Yuan.

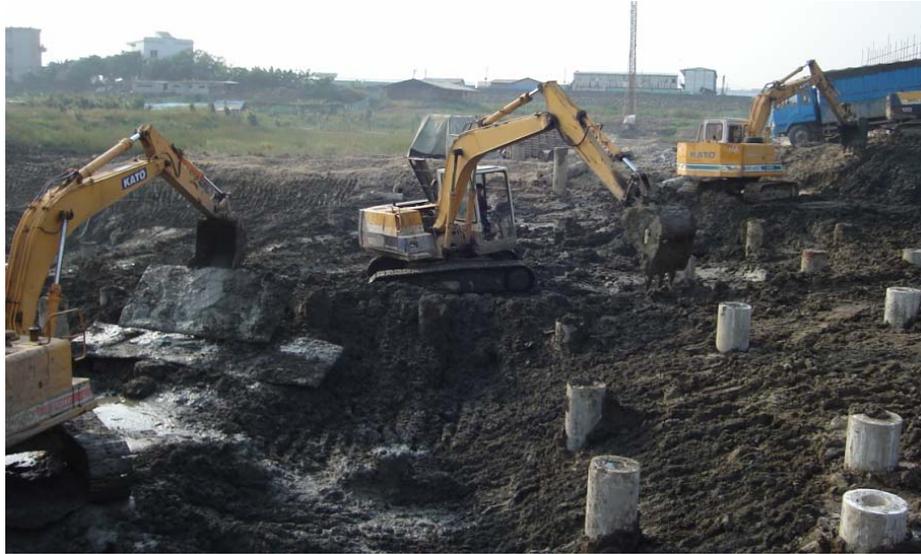
Fig. 5 Photo of construction activities following the recommendations

recommendations were followed during the rehabilitation construction as well as during other similar projects. No failure was observed during these projects. An example of field photo taken during the construction at a similar site is shown in Fig. 5. The field monitoring data indicate the amount of inclination of these pipe piles are all controlled within the allowable limits. The successful experience validated the results and recommendations of the forensic study.

Based on the forensic study, the following recommendations were made to prevent construction vibration and excavation induced pipe pile failure at similar sites, i.e., 1) to reduce the difference in excavation elevations. Properly deploy the construction equipment to avoid the formation of steep slope during excavation; 2) to reduce the effects of construction vibration on soils by placing pad under the construction equipment; 3) to apply field monitoring program to provide warning on potential triggering factors. These
