International Conference on Case Histories in Geotechnical Engineering (2008) - Sixth International Conference on Case Histories in Geotechnical Engineering

Need for Prior Geotechnical Engineering Studies for Foundation Design: Cases of Collapsed Buildings in Port Harcourt and Environs, Nigeria

NEED FOR PRIOR GEOTECHNICAL ENGINEERING STUDIES FOR FOUNDATION DESIGN: CASES OF COLLAPSED BUILDINGS IN PORT HARCOURT AND ENVIRONS, NIGERIA

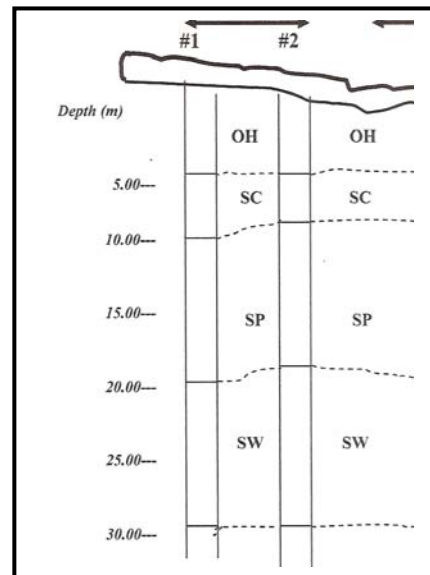
Water Table. The Water Table at the site was observed to be variable due to the ebb and flow of the tides and found to be between -0.40 meters below ground level during low tide and $+0.45$ meters above ground surface during the full tide.

Fig. 5. Soil profile near the building site at Opobo.

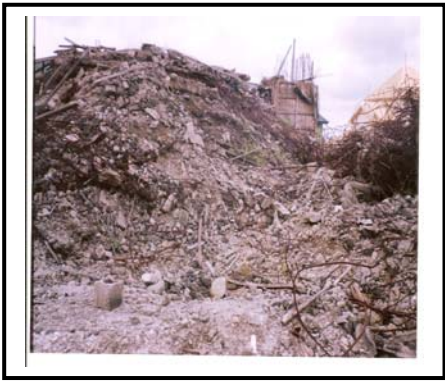
From investigations carried out by a team from the writer’s consulting firm, it is apparent that this building was constructed across a river channel that had sand and gravels as major subsurface materials beneath the building site. Soon after the failure, a soil investigation carried out by the same team showed that the subsurface profile consisted of an upper layer of silty clays (lateritic layer); this was underlain by silty sands and further underlain by sandy gravels and gravels down to depths of over 20 meters. The construction of this building acted as a Dam across the old river channel and thereby accumulated large volumes of water upstream of the building. Meanwhile the water from the upper reaches of this old river / stream continued to flow and constituted a mini-lake upstream of this building whose foundations had constituted the “core” of the dam, as it were. The impact of this dammed water was to significantly reduce the shear strength (especially the friction angle (ϕ)) of the cohesionless soils beneath the building. This scenario can be expressed mathematically as follows:

This is a clear case of Punching Failure.

Fig. 6a: The collapsed building along the New Tombia Extension Road GRA III, Port Harcourt.

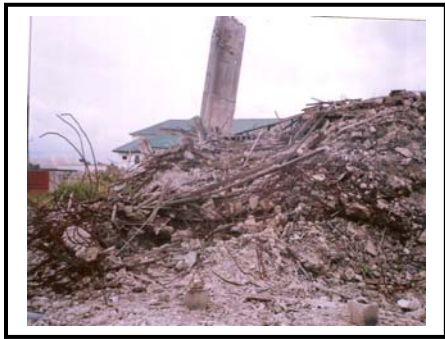
Fig. 6b: Remains of the collapsed building along the New Tombia Extension Road GRA III, Port Harcourt.

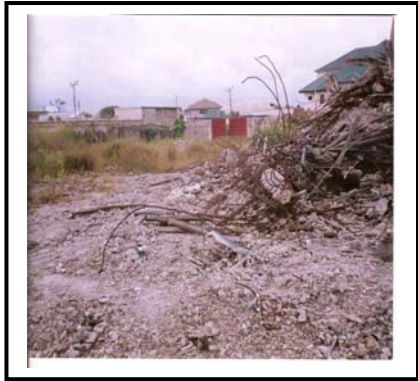
Fig. 6c: Remains of the collapsed building along the New Tombia Extension Road GRA III Port Harcourt.

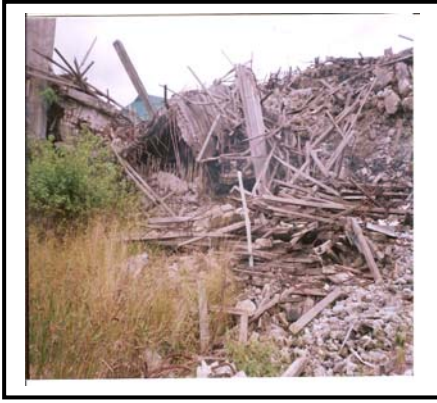
Fig. 6e: Remains of the collapsed building along the New Tombia Extension Road GRA III, Port Harcourt..

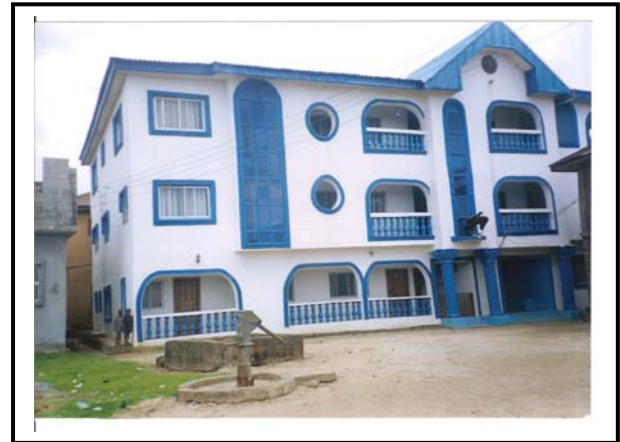
A land developer built for himself a two-storey building in the riverine town of Opobo within the “Transition” zone of the Niger Delta. This was a good example of bearing capacity failure where the building settled differentially similar to that of the legendary “Tower of Pisa” in Italy. Examples of this failure are shown in Figs.7a,b,c and d respectively.

Fig. 7a. Frontal view of the two-storey building leaning backwards.

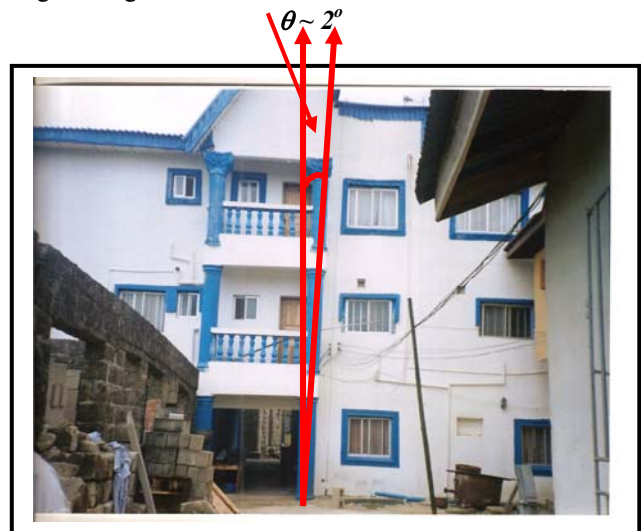
Fig. 7b. Another view of the same building leaning to the right at angle θ

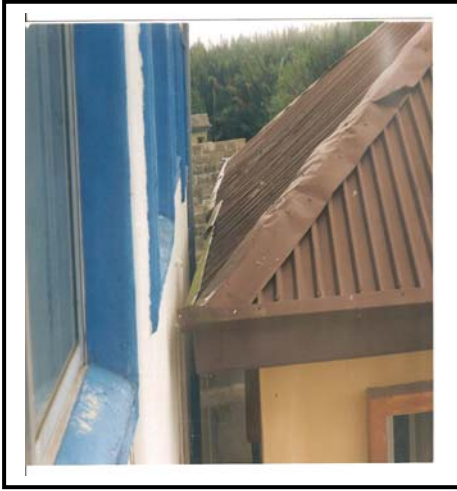
Fig. 7c. A view of the house leaning on an adjacent building
