International Conference on Case Histories in Geotechnical Engineering (2008) - Sixth International Conference on Case Histories in Geotechnical Engineering

UNEXPECTED CAISSON PROBLEMS, SOIL STRUCTURE INTERACTION PREDICTIONS AND REQUIRED GROUND MODIFICATION

ABSTRACT

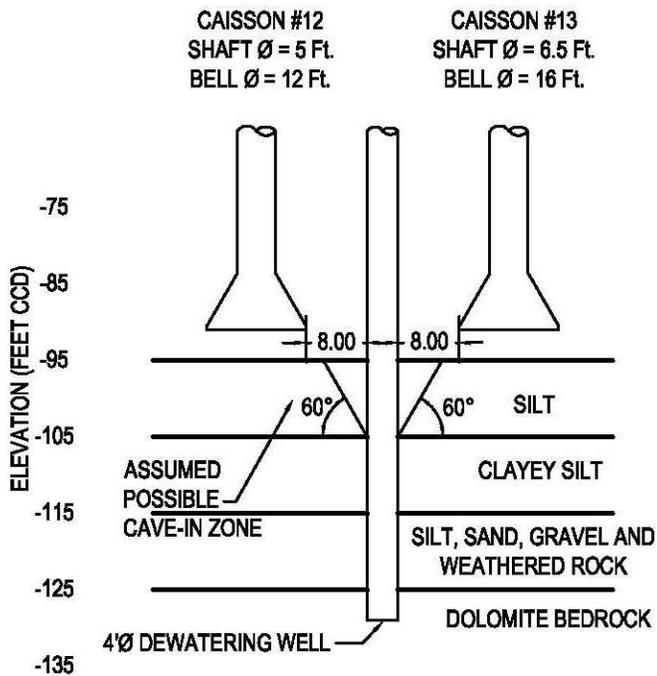
Fig. 2. Dewatering Well No. 3 Cross-Section

Construction of caissons with bells upon the hardpan at 36 ksf was completed before dewatering well installation since lowering of the water table was not considered necessary. Unfortunately, construction problems developed during the installation of the first dewatering well (Well No. 3). The 4-

foot diameter excavated hole was allowed to remain open all the way to bedrock over the weekend prior to installation of the well casing and filter backfill. During that time the borehole was stabilized only by polymer slurry. Some time over the weekend, the dense silt caved-in to a level 23 feet above the bottom of the shaft.

Subsequent soil borings and pressuremeter testing indicated a significant loss of density in the silt around Well No. 3. Since it was felt that this loss of density could affect the adjacent caissons, a compaction grouting program was undertaken to re-densify the silt. Approximately 18 cubic yards of grout was pumped into the zone from the bedrock surface to approximately -90 feet CCD to more than equal the volume of the silt cave-in. Figure 2 shows a sketch of the planned well, the level of adjacent caissons, and the likely cave-in zone. Borings and pressuremeter testing were performed to evaluate the soil conditions following construction of Well No. 3 and the effectiveness of the compaction grouting. The test data is summarized on Fig. 3.

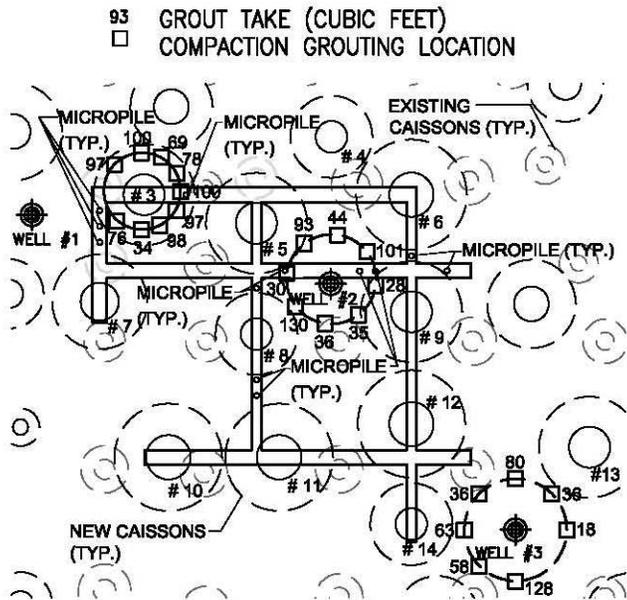
Fig. 5. Compaction Grout Point Locations

The locations of the caissons, wells and soil borings are shown on Fig. 4. The compaction grout injection points and grout take summary are shown on Fig. 5. The grout take volumes indicate that the cave-in was not necessarily uniform around the shaft.

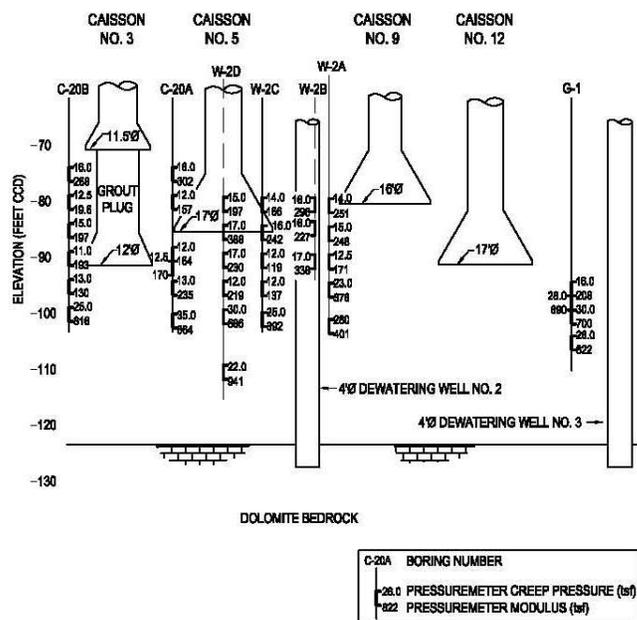
Fig. 6. Partial Cross-Section through the Core

Caisson 3 encountered water inflow and caving conditions when attempting to bell at the design elevation of -92 feet CCD. The water came in too fast for bailing so the partially excavated bell was plugged with grout extending up to the surface of the hardpan at which level another attempt to bell was made after allowing the grout to set because of the presence of existing old caissons and continued water seepage. It was not possible to adequately oversize the bell for the 36 ksf design bearing level. The as-constructed caisson consisted of an 11.5 foot bell at -71 feet CCD combined with the original 12 foot diameter bell plug at elevation -92 feet CCD as shown in Fig. 6.

Pressuremeter testing was performed around Well No. 2, Caisson 3 and Caisson 15 (which was actually replaced by Caissons 1 and 2). Because of the water problems encountered, there was some concern for loosening of the supporting silt. A check boring and pressuremeter testing indicated the marginal conditions at Caissons 1 and 2. Four compaction grout holes were recommended and installed to provide some insurance. The pressuremeter testing results near Caisson 3 and Well No. 2 are shown on Fig. 6.

In order to get the maximum capacity out of the as-built geometry, compaction grouting was undertaken beneath and adjacent to Caisson 3. The total volume of grout (38 cu.yd.) injected from near the bedrock to an elevation of approximately -90 feet CCD exceeded the estimated volume of loosened material that came into the excavation during the belling operation at elevation -92 feet CCD.
