## CASE HISTORIES IN GEOTECHNICAL ENGINEERING EDUCATION

### James Mahar, PhD

## COLONIAL HALL CASE HISTORY

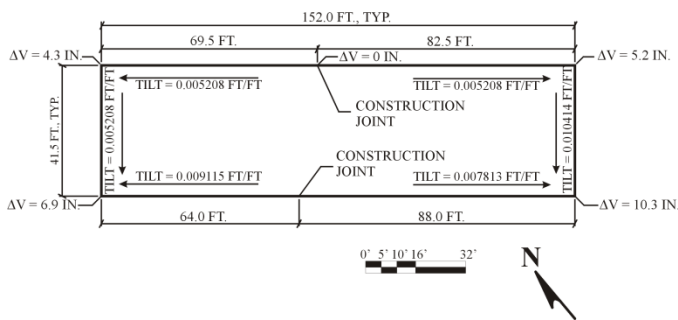
Fig. 2 Colonial Hall Dimensions, Settlement and Tilt Vectors on Campus of Idaho State University.

The structural damage in Colonial Hall is concentrated near the center of the building primarily along the east-west construction joints and intervening slab/joist panels (see Fig. 2). The vertical crack at base of the west side, crawl space foundation wall is 1/2-in. wide with an east-west offset of 3/8-in. (north side east). Further, the north side of the crack is 1/8-in. higher than the south side. The crack becomes progressively wider with increasing elevation in the stub wall above the foundation (1-1/2 in. at 6.1 ft above the base of the footing). The moment crack progresses up through the building and is open 5-1/4 in. in the concrete roof deck above the second floor rooms some 40 ft above the base of the foundation.

The north half of the building is tilted 0.0052 to 0.0091ft/ft north and the south side slopes 0.0052 to 0.0078 ft/ft south (Fig 2). Based on the level line surveys, the south end of the building has settled 5.2 in. (east side) to 10.3 in. (west side) and the north end has settled 4.3 in. (east side) to 6.9 in. (west side) with respect to the construction joints. In addition, the structure has an overall tilt of 0.0052 to 0.0104 ft/ft west. The total magnitude of settlement in Colonial Hall is not known and could not be determined because no reference point elevations were established at or shortly after the time of construction in 1924-1925. Other than the tilt and the interior cracks between the construction joints, the two halves of the building show essentially no angular distortion. Moreover, the two halves of the building have undergone rigid body rotation

to the north and to the south away from the construction joints. The students concluded that the damage in Colonial Hall was caused by differential settlement of the foundation walls with tilt away from the center of the building some unknown time in the past 87 years.

The 2.6 to 5.1 in. of differential settlement along the west side of the building is consistent with ponding of water along the west wall and the greater thickness of the loess west of the structure.
