GEOTECHNICAL FAILURES CAUSED BY HUMAN ERRORS

Marek Tarnawski

West Pomeranian Technical University
Szczecin, POLAND 70-311

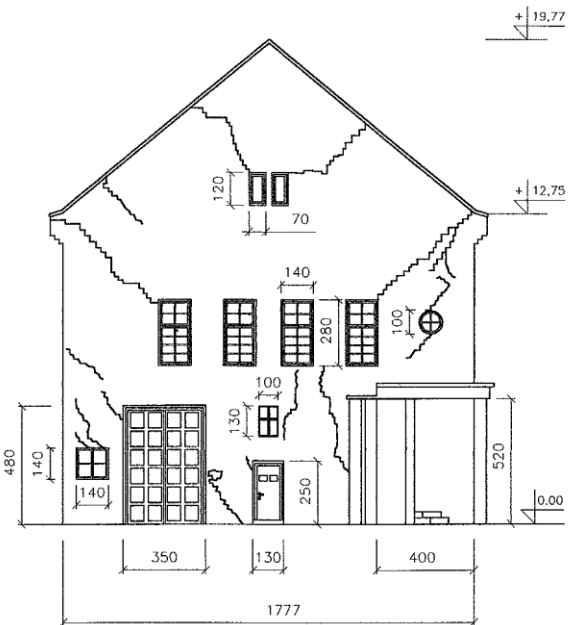
- the structure is founded on loose fill (Bartnik, Bukowski 2007) sometimes underlain by organic soils (Kujawiński 2001; Fig. 3) or straight on such soils (Wojtasik, Troć 2001), or at too shallow depth (Mikołajczak et al. 1979, Pająk et al. 1994),

Fig. 3. Cracks seen in a gable wall of industrial building founded on a weak substratum (Kujawiński 2001).

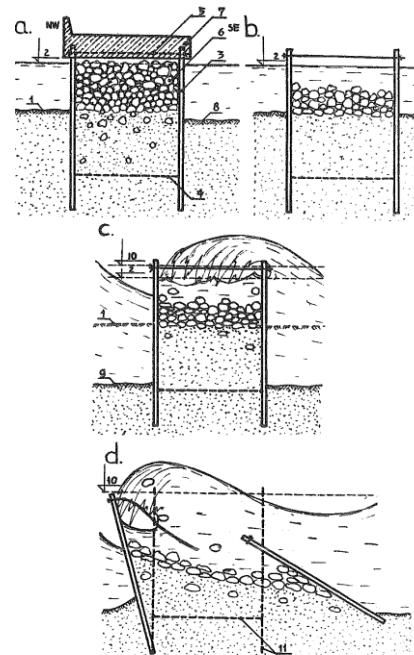
Fig. 4. A breakwater of retaining wall type: a finished structure (a), structure under construction described in the text (b) and the mechanism of the failure (c, d) (Haurykiewicz 1980).

Breakwater is an alien in marine environment. Taking this into consideration means, among others, assessment of possible depth to which the sea bottom (1) can be washed away by breakwater's walls and rational evaluation of the possible working periods (without a storm). As storms are random phenomena one should take into account their possible effects not only when the structure is ready but also when it is under construction. This example shows a connection of unfavorable weather conditions and too optimistic design assumptions. The result is a disaster of one section under construction (Fig. 4b). Storm waves washed out soil 2 m deeper than it was assumed (9) and much deeper than the designed bottom of harbor dock (8). Soil resistance diminished then and the waves, filling easily the section (as sea condition rose from the average "2" to the stormy "10", in Beaufort terms), increased water pressure from inside. Together with stone layer pressure it overcame the diminished resistance (Fig. 4c). The waves attacking upper parts of walls caused a bilateral level effect. Both walls leaned coastward. The tie tore off and the breakwater section had been destroyed (Fig. 4d). A sudden water accumulation in a limited area and the failure of sheet wall piling under construction is also described in another paper (Mazurkiewicz 1999). Flood tides or changes in current arrangement may wash the bases of bridge pillars and their tilt or catastrophe (Łączkowski, Podhorecki 1988). There are known (Mazurkiewicz 1996) destructive results of currents produced by driving devices (propellers) of modern ships or ferries, specially the ones designed for quick mooring and leaving a quay and a harbor without tugboat assistance. They cause erosion of the bottom and destroy normal protection (mattresses, concrete slabs etc.). Structures situated on the beach are exposed to damages or destruction by storm waves (Ostapiuk, Wichtowski 1989). A common denominator for all of the described cases is a maladjustment of structure protections to extreme impacts which may happen in sea or river environment.

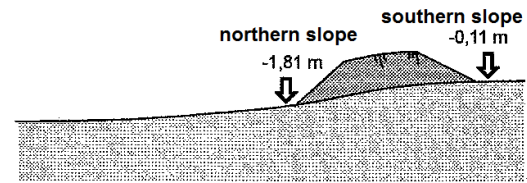
Fig. 5. A sketch showing results of mining exploitation on motorway embankment (Gryczmański, Sternik 2005).

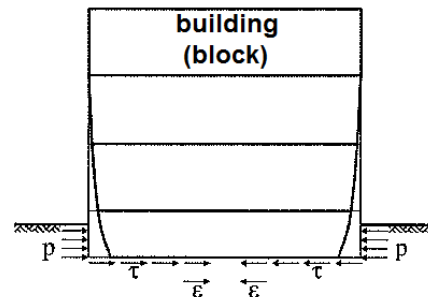
Fig. 7. A scheme of building damages caused by horizontal terrain deformations (Kawulok 2009).

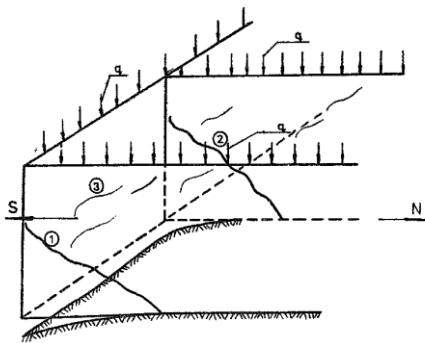
Tertiary clays which occur in many places in Poland are usually bearing soils of stiff or hard consistency. But these expansive soils change their volume under influence of drying up or getting wet. Shrinkage or swelling processes often start as a consequence of human errors. Differentiated settlement may be the result of foundation of the structure on both local peaks of top of clays and in sandy (ie. less compressible) background. When shrinkage is added, the differences grow (Fig. 9).

Fig. 9. A characteristic layout of cracks of suspended wall.
The reason: shrinkage of dried up clays (Klin 1978).
