## Analysis of Piled-Raft Foundation for CAI MEP Container Port, Vietnam

## ANALYSIS OF PILED-RAFT FOUNDATION FOR CAI MEP CONTAINER PORT, VIETNAM

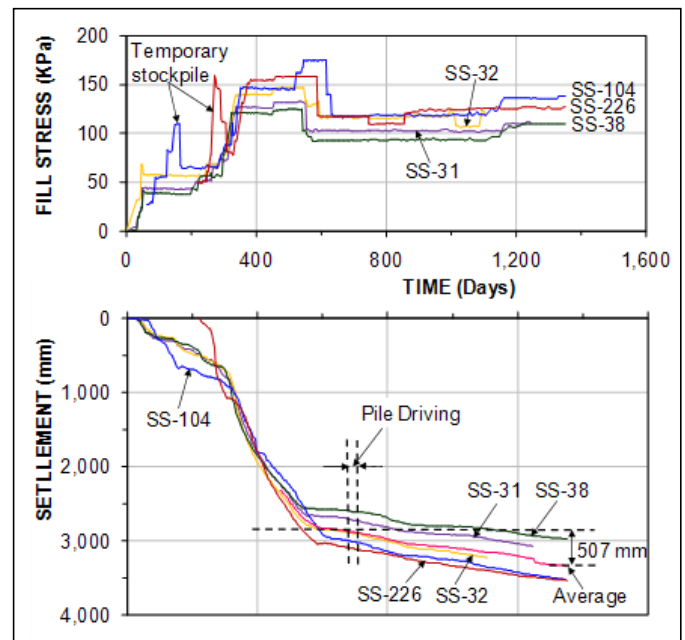
Figure 4 shows the fill stresses and settlements measured at the five plates near the two buildings (benchmarks SS-31, SS-32, SS-38, SS-104, and SS-226) from the start of placing reclamation fill in early January 2009, placing of the surcharge in September through November 2009, removal of surcharge in May-June 2011, and until September 15, 2012; i.e., 0 to  $\approx 300$  days,  $\approx 300$  to  $\approx 600$  days, and 600 to  $\approx 1,300$  days. The total average settlement before removal of the surcharge was about 3,000 mm. The average settlement during about 700 days after completion of the pile driving was about 500 mm.

Fig. 4. Fill stress and settlement vs. days after start

The continued settling of the area was quite a surprise to the project. After the removal of the surcharge, it was expected that the consolidation would have been completed and settlement would have ceased. The reason for the ongoing settlements has been discussed by Fellenius and Nguyen (2013) and shown to be due to the fact that the wick drains used for the project were not stiff enough to resist the large soil stress at depth and did not function below about 20 m depth. That is, below about 20 m depth, the consolidation of the soft compressible soil was incomplete. Indeed, the consolidation continued even after the removal of the surcharge to finished ground elevation, Elev+.5.5 m. Above about 20 m depth, the consolidation was completed. Therefore the measured settlements are those continuing below 20 m depth.

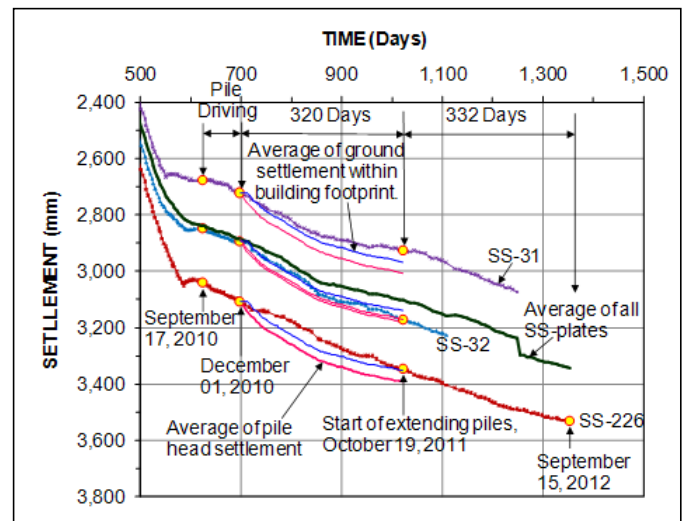
Figures 5 and 6 show the average settlement from Day 500 (≈May 1, 2010) through Day 1,370 (September 15, 2012) of settlement plates SS-31, SS-32, and SS-226 near the Maintenance Shop and SS 38 and SS-104, respectively. Each figure also shows the average settlement of all five plates, and includes the average settlements of the monitored piles within the respective building. The pile head settlement has been connected to each SS-plate curve starting at the SS-plate settlement value measured at the end of the pile driving. At about one year after the end to the pile driving (December 1, 2010 through October 28, 2010), it was decided to extend the piles. (Coincidentally, the settlement of SS-32 on December 1, 2009 was the same as the average of all settlement plates).

The measurements show that the 18 m long piles settled along with the surrounding ground; actually slightly more than the ground outside for the first about three months after the end of driving. The difference is due to the fact that the total weight of the piles added stress to the ground, about 7 KPa for the Maintenance Shop and about 5 KPa for the Substation. It is likely that the ground surface inside the building footprints settled about as much and at about the same initial rate as the piles.

Fig. 5. Settlement of ground and piles at Maintenance Shop

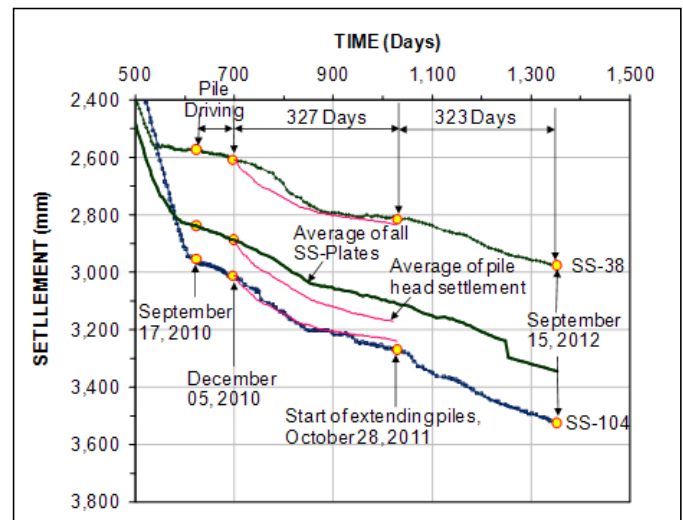
Fig. 6. Settlement of ground and piles at Substation

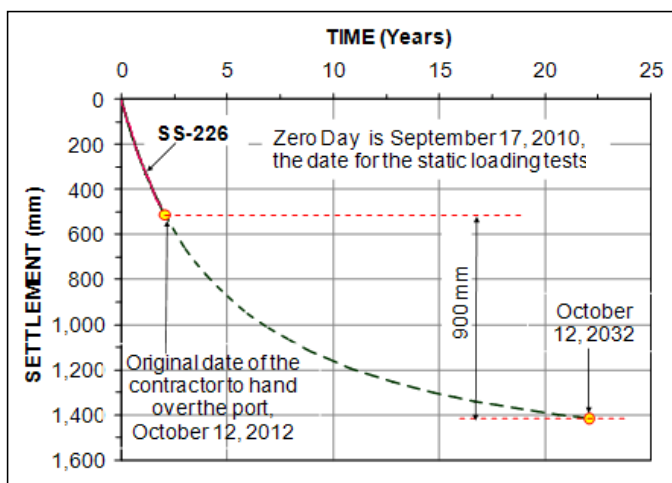
Figure 7 shows a simple hyperbolic extrapolation of the settlement measured after the removal of the surcharge, which suggests that the twenty--year settlement would be more than twice the maximum allowed value of 400 mm. For settlement analysis and discussion of the consolidation at the site, see Fellenius and Nguyen (2013).

Fig. 7. Ground settlement vs. time at SS-226

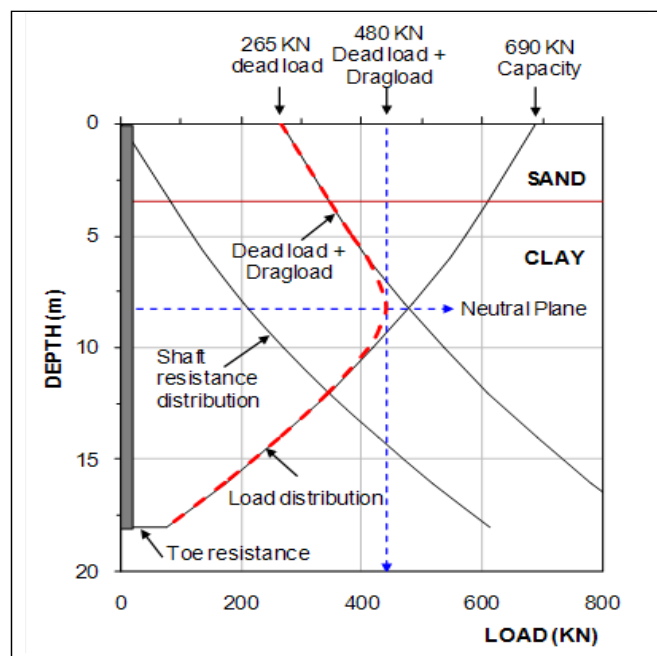
Figure 8 shows the typical capacities, the load and resistance distributions, and the neutral plane location calculated by effective stress analysis using the UniPile program (Goudreault and Fellenius 2012) for the 18 m long piles. The calculations are based on back-calculation of the results of the static loading tests, using effective stress coefficient (beta) of 0.2 and a unit toe resistance of 470 KPa. The neutral plane location calculated for the 265 KN dead load is at about 8 m

depth. The drag load is of no concern for the piles. However, the downdrag (settlement) due to the ongoing settlements for the piles will be significant. Indeed, were the neutral plane even as low as at the pile toe, the downdrag would still be excessive for the foundation.

Fig. 8. Distribution of load and resistance of 18 m pile

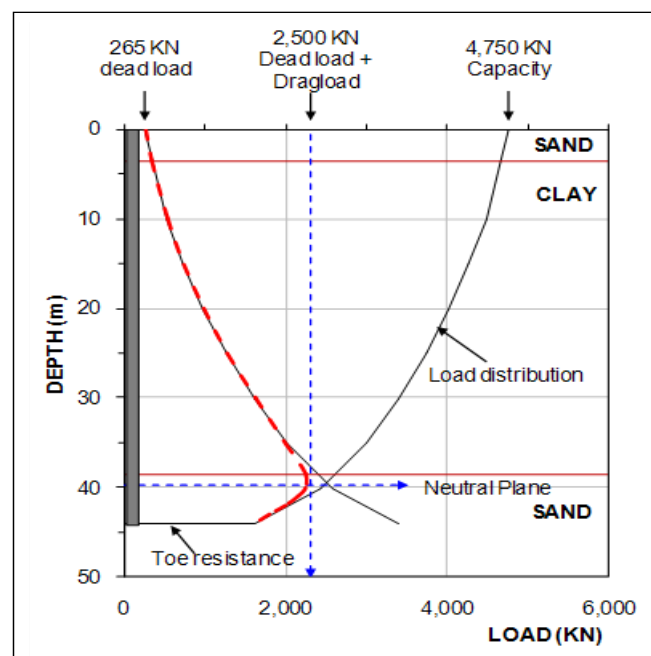
Fig. 9. Distribution of load and resistance of 44 m pile

It was realized that the neutral plane must be brought down into non-settling soil, that is, into or just at the surface of the sand layer found at 35 to 40 m depth. The piles were therefore extended to 44 m total length. Figure 9 shows the typical calculated load and resistance distributions, and the neutral plane location for the new length. The calculations applied the same beta-coefficients for the clay as for the shorter pile. The coefficient in the sand was input as 0.4 and the assumed mobilized unit toe resistance was 10 MPa. The calculation showed the neutral plane to lie at the surface of the sand layer.

A conservative calculation of the total load in the pile (dead load plus drag load) indicated it to be about 2,500 kN, which was considered acceptable for the pile structural strength.

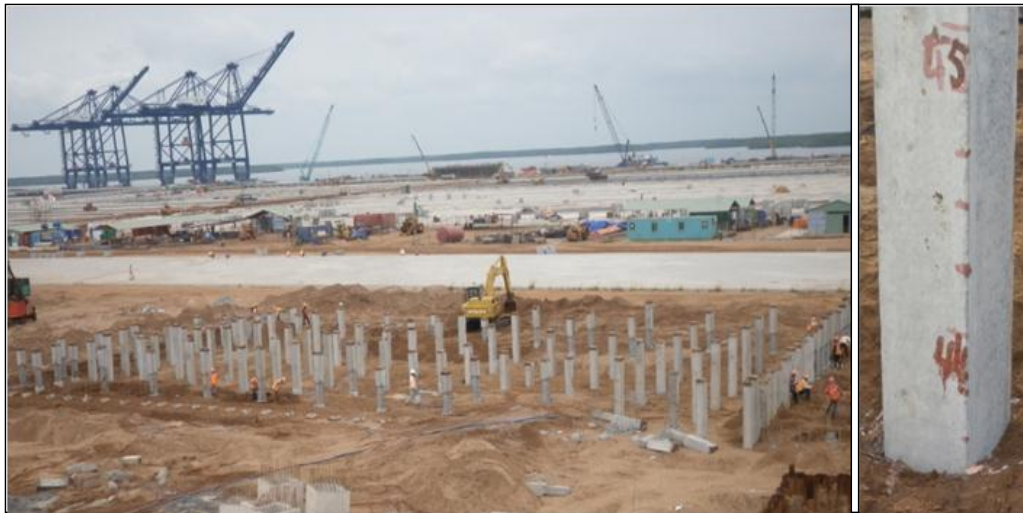
Figure 10 shows a photograph of the Maintenance Shop during ongoing pile lengthening work. The average pile depth is 44 m. The termination of the driving was governed by a dynamic formula which resulted in about one metre variation of the pile depths.

Fig. 10. View on Feb. 10, 2012, of the Maintenance Shop area with about half the piles lengthened (Authors' photo)

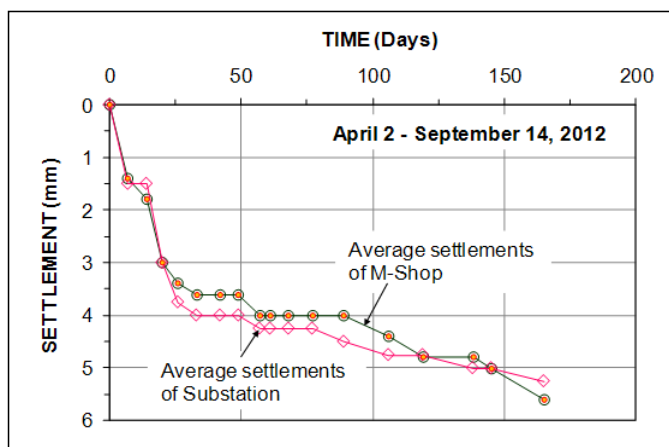
The lengthening of the piles for the two buildings was completed on December 27, 2011. Figure 11 shows the building settlements from end of lengthening through September 14, 2012. The initial settlement is due to the 'elastic' shortening of the pile from the weight of the building being constructed during the first month. Thereafter, the building settlement has been small. However, it still amounts to about 3 mm in 5 months, i.e., 140 mm in 20 years, although the actual settlement would likely be smaller than that suggested by such linear extrapolation.

Fig. 11. Settlement of the two buildings after piles had been lengthened
