Differential Settlement Problem of a Large Apartment Building in Bogotá, Cause and Solution

DIFFERENTIAL SETTLEMENT PROBLEM OF A LARGE APARTMENT BUILDING IN BOGOTÁ, CAUSE AND SOLUTION

Marcela Salcedo Q.
LFO Ingenieros de Suelos
Bogotá, Colombia, South América

ABSTRACT

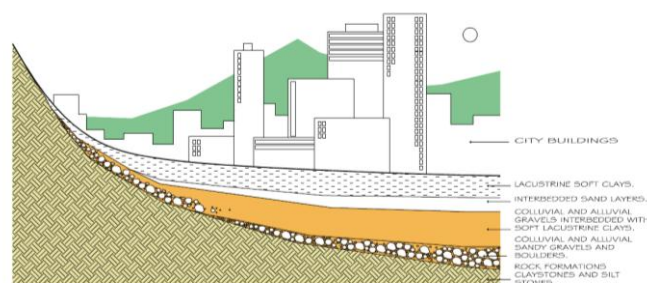
Fig.1. Geological profile at the foothill zone

alluvial origin interbedded with the lake deposits as shown in Fig. 1. The larger buildings in the downtown area, as well as in the north eastern strip, along Carrera Séptima (7th avenue), are mostly founded on the erratic, but sound, gravel and sand layers or sometimes on the clayey and sandy rocks underneath.

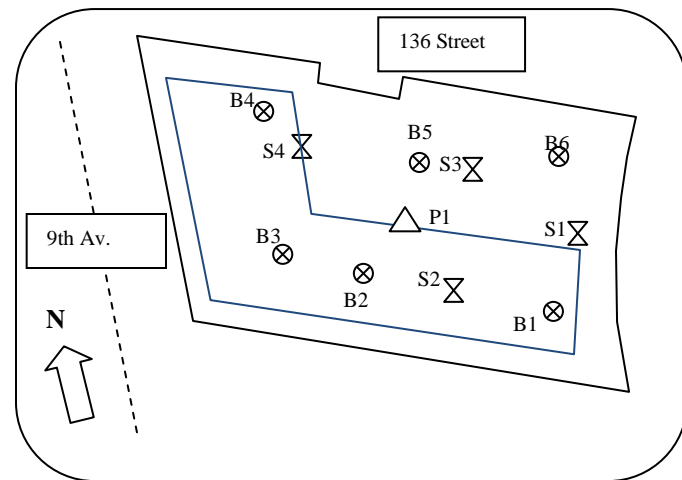
Fig. 6. Boring logs and location, definitive reports

Figure 6 includes the soil profile obtained from the deeper borings and their location. As it may be deduced there is not enough information to design the pile foundation unless geotechnical engineer A had other information from adjacent properties which is not known by the authors at present.

Soils engineer consultant B, made one additional soil boring at the center of the area (Figure 6), for the performance of a down hole seismic refraction test, and the specific site seismic response analysis, and to corroborate the results obtained by geotechnical consultant A.

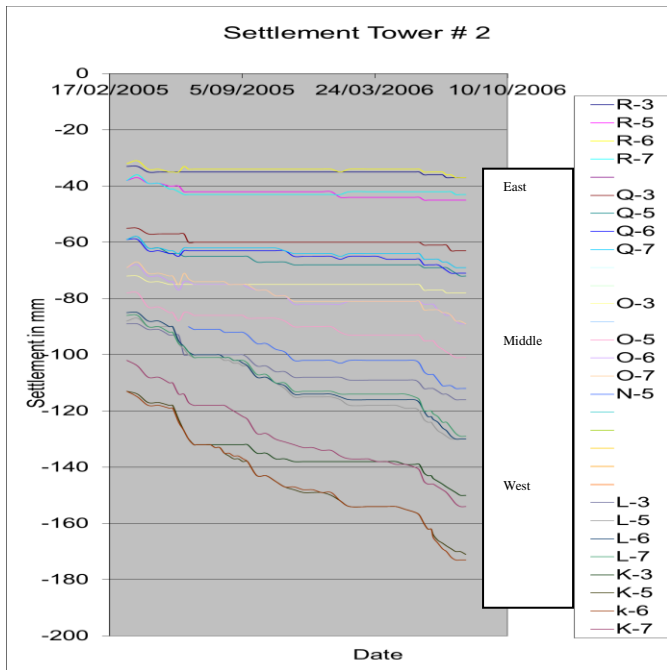
Fig. 8. Settlements Tower # 2

Tower # 1 had settlements values smaller than one inch. Tower # 2 began experiencing a larger settlement towards its western half, noticed from the construction of the structure and during the first one or two years of use (2005 and 2006). Table # 2 and Figure #8 show the values of settlement as a function of time.

But when the differential settlement had reached about 5” (12 cm) between east and west sides of the building, in a 40 m length it was decided that the values were above tolerable, and would get worse. At this point the building had an angular rotation of about 1/333 and there was no internal damage in brick wall divisions, it had settled towards its western end as a rigid block.

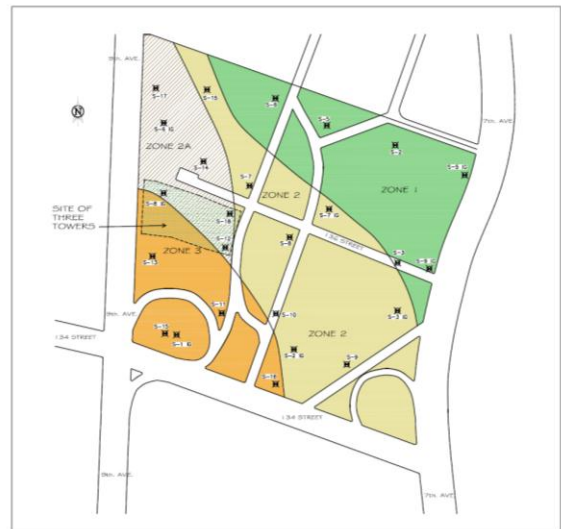
Fig. 9. Geotechnical zoning preliminary report 1996

Figure 9 shows the plan view of the larger site as described in 1990, it has the geotechnical zoning by consultant C, who made the preliminary soil report of 1990. The site had been divided in three different zones. In zone 1 (green) the competent soils gravel and sand layers as well as basal rocks are close to the surface. The good soils dip towards the south west and in zone 3 (orange) these are below 45 or 50 m depth. Zone 2 (yellow) is the transition zone, where the best soil gets deeper as one moves towards the south west.

The larger picture, and thus this variation in depth of the competent soils was not known by the consultants A and B; besides the soft clay layers are interbedded erratically with thin sand and gravel layers which make things more confusing, when soil boring information is scarce and the larger picture is missing.

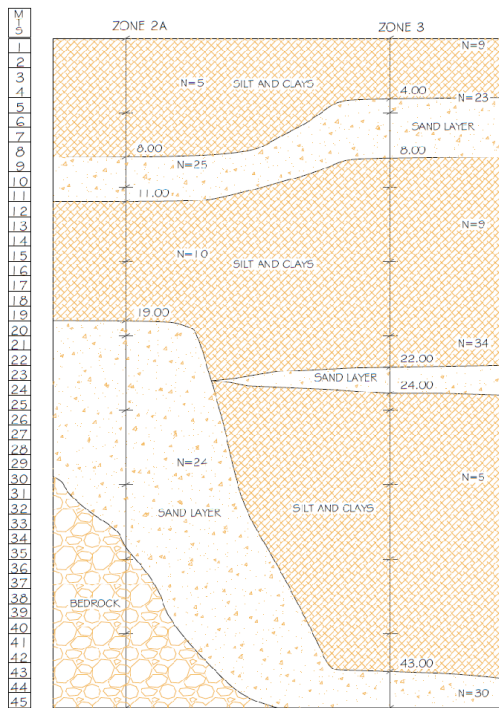
Fig. 10 a. Stratigraphy profiles

gravel layer at a variable depth between 29 m at the east side of tower # 2 and 43 m at the south western side of the same tower.
