GROUND HEAVE DUE TO JET GROUTING NEAR AN EXISTING STRUCTURE

Renovations of the MBTA Copley Station in Boston included construction of a new elevator shaft to improve disabled access to the existing Green Line station. The site is immediately adjacent to the Eastern façade of the historic Old South Church. The construction work required excavation support including a perimeter secant pile wall and a jet-grouted base plug. Significant ground and structural movements were observed during jet grouting, mainly associated with soil displacements during grout injection. A three dimensional numerical model was developed, using the Plaxis 3D Foundation™ program, in order to test the hypothesis that the observed movements of the structure could be associated with the installation of the jet grout piles. The amount of volume expansion associated with installation of jet grout piles is estimated based by calibrating the model to measured ground movements. The finite element model results give a consistent explanation for the observed pattern of movements, including the heave of the church wall and lateral displacements at inclinometers located within the vicinity of the structure, measured at

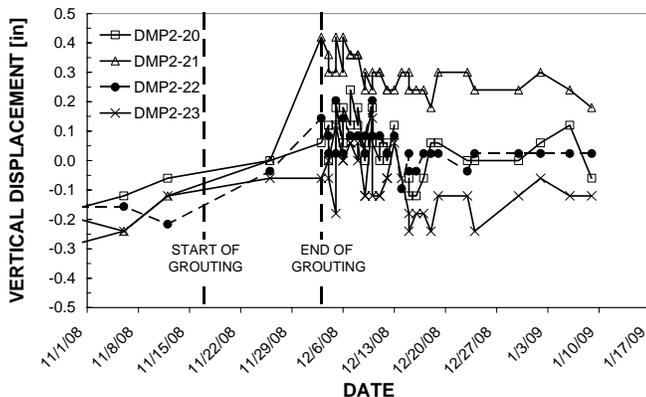
Fig. 2. Observed displacements at East Wall

Work on the project was suspended in December 2008 due to observations of damage to the East façade of the Old South Church including the widening and extension of cracks that extended up from the foundation level, through the stone walls above the main stained glass windows up to the roof level (and height of more than 60ft), causing significant damage to the interior plaster wall. Fig. 2 shows vertical displacements

measured at several displacement measuring points (DMP, Fig. 1). The ground and structural movements were attributed to jet grouting activities for the new elevator shaft that were on-going at the time. Subsequent investigations focused on possible mechanisms causing the movements including detailed inspections of the OSC foundations (involving load testing of several timber piles), an extensive geotechnical site investigation, and implementation of a sophisticated instrumentation program to monitor for any further ground or structural movements. After establishing that movements had stabilized, the below grade works resumed in November 2009 using a revised construction sequence. With careful planning and execution, the elevator shaft was completed in April 2010, with no further movement or damage to the Old South Church. This paper summarizes the development and validation of a 3-D model of the soil-structure interactions that was carried out to test the hypothesis that the observed movements of the OSC could be associated with the installation of the jet grout piles.

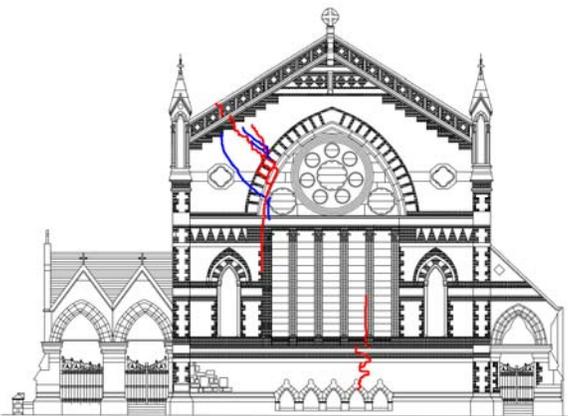
Fig. 4. East Wall – Observed cracks

Figure 4 shows an elevation of the East Wall of the Old South Church, together with the observed cracking pattern. The observed cracks start at the fourth bottom window from the South (left in Fig. 4), coincident with the location of a pre-existing crack, and continue towards the top of the wall, initially following an almost vertical path.

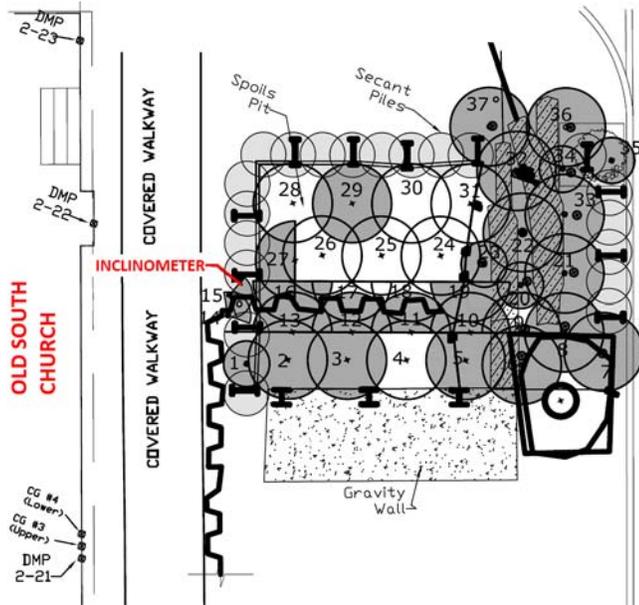
Fig. 8. Partially completed jet grout piles as of Dec. 3, 2008

A single inclinometer (located adjacent to jet grout pile #27, Fig. 8 with toe at El. +64ft in the upper BBC) was used to monitor ground movements during the initial construction phases for the elevator access shaft. Figure 11 compares the predicted and measured ground movements (direction A is orthogonal to the eastern walls of the access shaft and OSC) caused by access shaft construction at the time when damaged was observed (Dec. 3, 2008). The results show a maximum lateral deformation of 1.75 in towards the OSC (at El. +92ft).

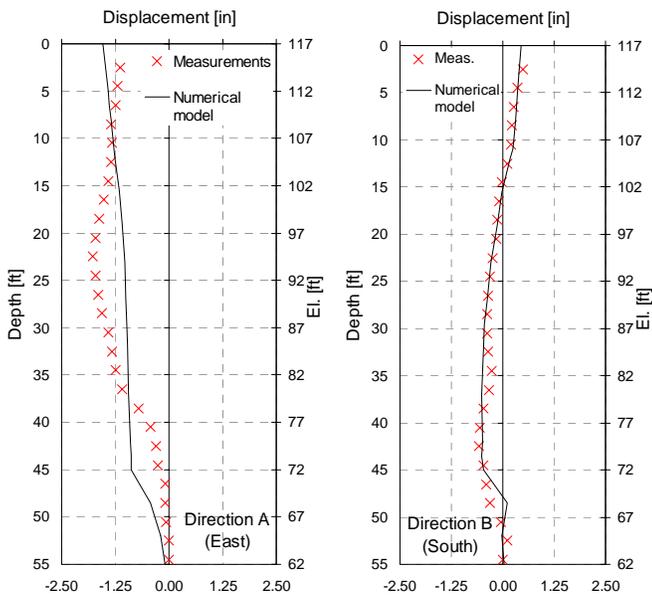
Fig. 11. Comparison of computed and measured lateral ground displacements due to elevator access shaft construction (measurements on 3-Dec-08)

The computed results are in reasonable agreement between with the measured ground deformations in the A axis (and in excellent agreement in the B-axis, parallel to the eastern façade), for a target volumetric strain of 15% in the jet grout piles.

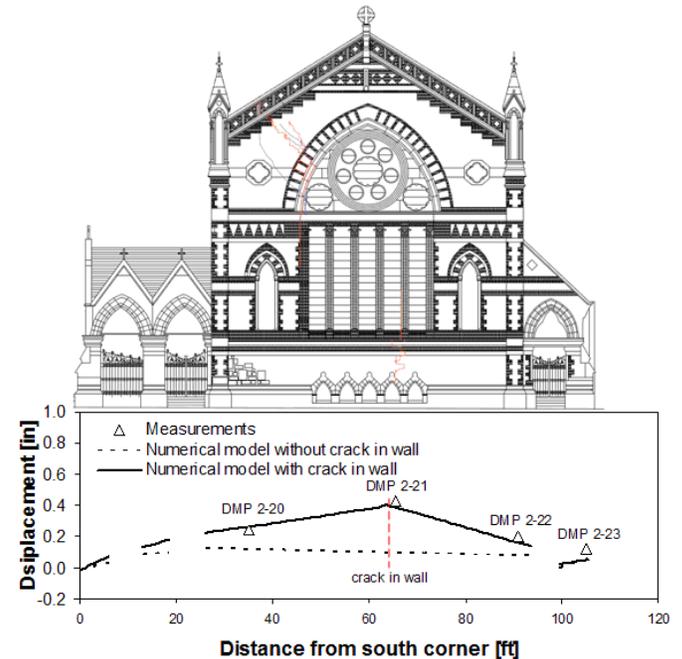
Fig. 12. Vertical displacements along East Wall predicted by numerical model

Figure 12 shows further comparisons of the computations with vertical displacements measured at a series of Displacement Measuring Points (DMP) along the Eastern Wall of the OSC in early December 2008. The figure shows results of two finite element models, one case assumes that the Eastern façade of the Old South Church is intact (no cracks) and the second assumes the full height vertical through-crack described above (Figs. 4 and 5). The results for the intact wall show relative uniform vertical deformations along the wall with a maximum heave on the order of 0.1 in. In contrast, the vertical through-crack model predicts much larger deformations (0.4 in) hinging at the assumed crack location. These results are in very good agreement with the magnitude and distribution of DMP measurements (with maximum 0.43 in). Hence, the FE model appears to confirm that volume strains associated with jet grout pile installation are the source of damage to the Old South Church.
