Repair of Sunken Floor by Integrated Approach: A Case Study

REPAIR OF SUNKEN FLOOR BY INTEGRATED APPROACH: A CASE STUDY

P. K. Jain, Professor,
MANIT, Bhopal, M.P. 462051, India,

Rakesh Kumar, Assistant Professor
MANIT, Bhopal, M.P. 462051, India

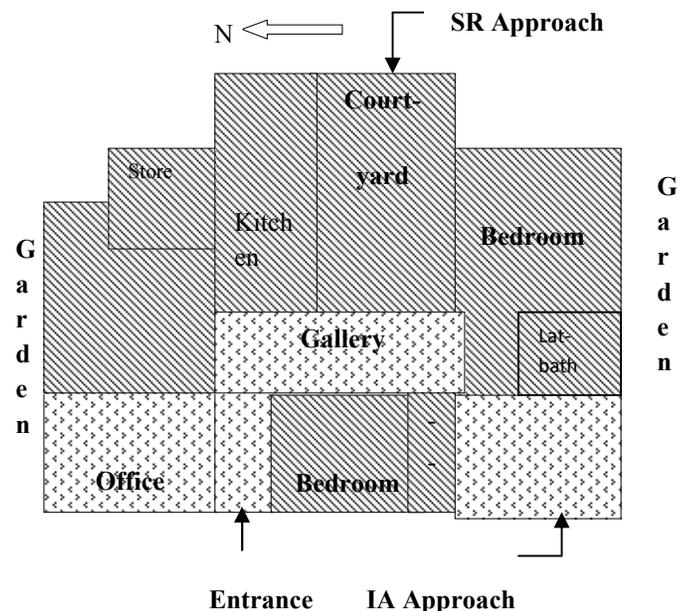
Fig. 1. Plan of house showing repair of floors by two approaches

Soil Replacement (SR) Approach: The removal of soil was planned in SR portion as shown in Fig.1. The damaged floors were removed and soil underneath the floor was taken out up to 1.5m depth. While removing the soil from the rooms the roots of the trees were found at many places. It may also be one of the reasons for moisture fluctuation under the floor resulting in uneven settlement. Locally available non expansive coarse grained red soil and the crusher dust was filled in small thickness and compacted to prepare the base for the floor. After the desired level of the floor base reached cement concrete of grade M15 was laid in 100 mm thickness and mosaic tiles were then fixed. RCC beams of width 20cm depth 30 cm were placed under the partition walls. The beams were resting on the main stable load bearing masonry wall.

Integrated (IA) Approach For repairing the IA portion (Fig. 1) following methodology was adopted:- The damaged floor was removed and the soil for about 500mm was also removed. Using hand auger and a vibratory needle rod, the holes of diameter 50mm in the black cotton soil was then made at every 750mm centre to centre. These holes were filled with stone chips size less than 8mm for about 300mm and followed by filling of Lime slurry up to the top soil level. Commercially available lime powder was used for this purpose. The depth of the lime pile was about 900mm. After all holes were filled in this way, the top of the soil was saturated with water. Stone dust / broken debris of the

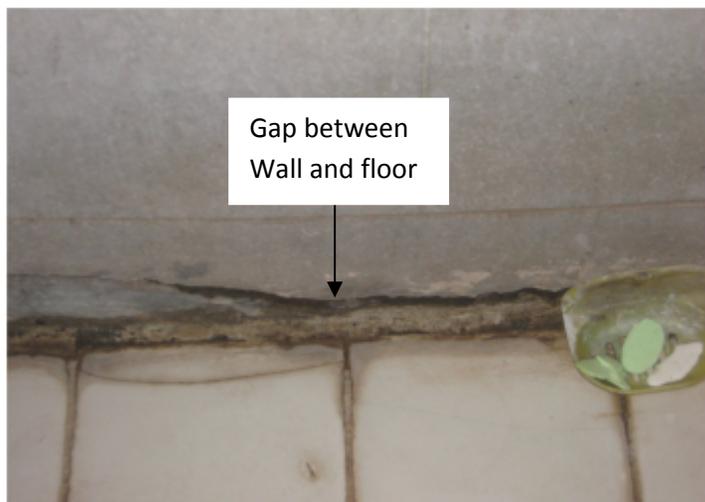
The house is having load bearing walls of stone masonry placed at about 1.5 m below the natural ground level. The floors of the house had been irregularly sunken and cracked nearly in all rooms and courtyard. On walking in the house, one could hear typical hollow sound at many places, perhaps due to the formation of cavity under the flooring. The floor was made up of cement concrete and was about 100 mm. As stated earlier the partition walls had also got severe diagonal cracks at many places and at some places the wall has gap with floor and / or to the roof slab. Figure 2 and 3 depicts the defects as stated here.

Fig. 2. Gap between sunken floor and non load bearing wall

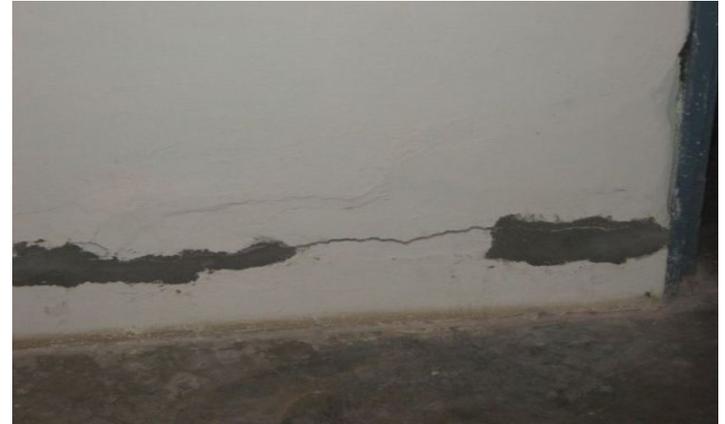
Fig.3. Damaged wall of bedroom
