## Case Histories of Earthen Dam Failures

## CASE HISTORIES OF EARTHEN DAM FAILURES

**R. P. Sharma**

**A. Kumar**

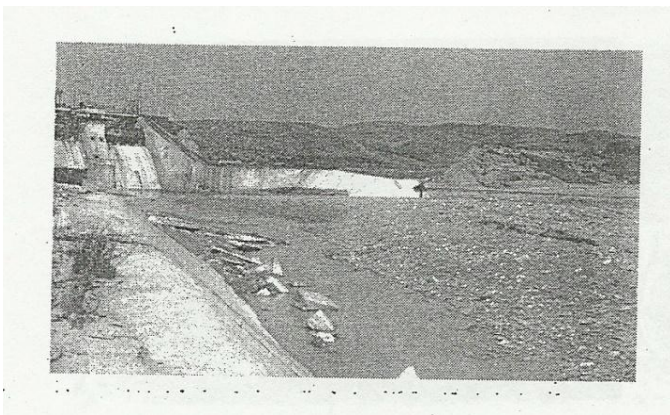
On 28 July 1991 heavy rainfall occurred, which caused the failure of main telephone lines and power supply. Due to failure of the main telephone lines no prediction of flood warnings could be sent from the upstream catchment areas to the dam site. The bottom outlet could not be opened more than 40cm due to power failure at the site. Emergency power was also unavailable and the gates could not be opened manually as timber and debris were blocking the bottom outlet. At 02.15 am on 29 July the dam began to overtop and the reservoir was emptied by 07.15 am. Twenty five people were killed by the flood wave caused by the dam break and 119 houses were destroyed.

The peak inflow of 1200 m<sup>3</sup>/sec measured by a water gauge located at downstream was lower than the later estimated 1-in-100-year flood of 1515 m<sup>3</sup>/sec. The initial dam break occurred at the same point where the dam had been affected by erosion in 1970. The final size of the breach was about 112 m long and 15 m deep (fig.1). Post-failure measurements of the intact dam crest near this initial break showed that the repair works had produced the effect of a natural overflow section. A cable trench that had been dug along the dam crest also had a negative and accelerating influence with regards to the process and dynamics of the breach formation. The dam has not been reconstructed.

Fig. 1. The Belci dam after failure.

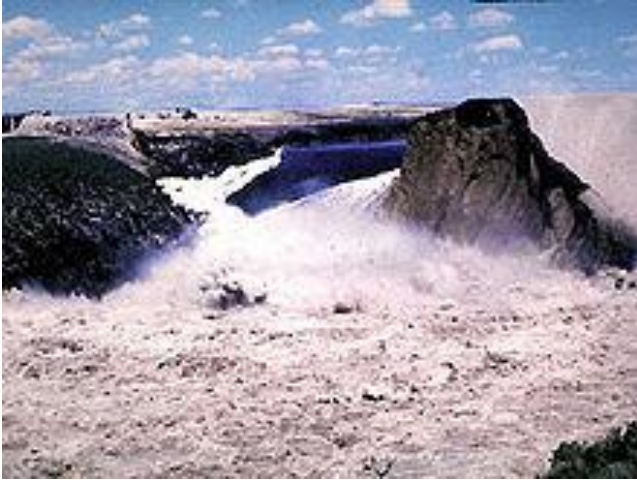
The dam, designed by the U.S. Bureau of Reclamation, failed just as it was being completed and filled for the first time. This failure of a modern dam so soon after construction was a shock to the engineering community. It prompted one of the most intensive investigations of any dam failure. A panel of experts investigated that the failure of dam was related to erosion and piping phenomena which occurred in the key trench fill on the right abutment possibly caused by seepage through cracks.

The expert's panel supposed that the seepage occurred due to either deficiencies of grouting in the sealing of rock joints or differential settlements in the key trench fill itself, or a combination of both causes. Further investigations carried out on the remains of the left embankment detected the presence of 'wet seams' (horizontal lenses varied in thickness from 75

to 200 mm) in some of the construction layers. Such wet seams possibly caused by the unsuccessful attempts to mix dry and wet soils during the construction of core layers, thus creating low-density zones undetected during the earth work controls. The seepage through the key trench fill could have been the seat of intense flow leading to erosion and piping of the core.

Fig. 4. *The Teton dam after failure.*

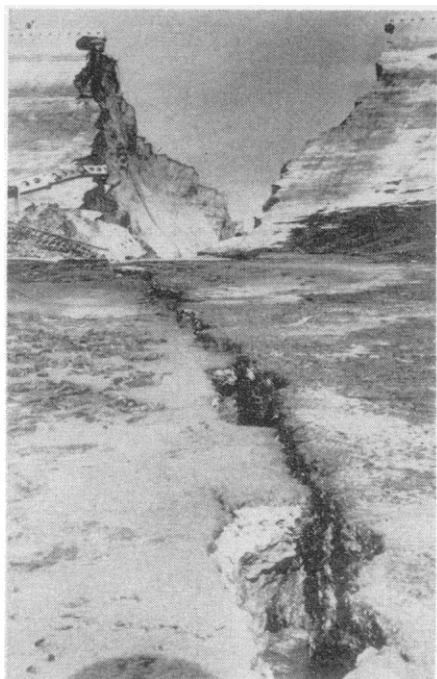
After 12 years of operation, on December 14, 1963, at about 11:15 A.M., an unprecedented flow of water was heard in the spillway pipe at Baldwin Hills Dam. The water came from drains under the reservoir lining. At approximately 1:00 P. M., muddy leakage was discovered downstream from the east abutment of the dam, which formed the north side of the reservoir. At 2:20 P. M. lowering of the reservoir water level revealed a 3-ft-wide break in the reservoir's inner lining. A futile attempt was made to plug the hole with sandbags. Water broke violently through the downstream face of the dam. By 5:00 P.M., the reservoir had emptied, revealing a crack in the lining extending across the reservoir bottom in line with the breach in the dam (Fig. 5).

Mr. R. B. Jansen, Chairman Engineering Board of Inquiry Baldwin Hills Reservoir Failure, immediately after failure of the dam constituted a panel of experts to investigate the cause of failure of the dam. Expert's panel in his investigation report stated that a gradual deterioration of the foundation took place during the life of structure and culminated with sudden failure on December 14, 1963. The porous concrete drain was damaged by early small movements at the fault, and leakage water found its way into the fault. These earth movements were mainly caused by land subsidence, locally concentrated along the fault which was a weak plane. During the life of the reservoir, erosion took place in the fault under the undamaged blanket and partially damaged drain. The narrow width of the fault permitted the porous concrete drain to span openings that were developing under the drain. These occurrences were gradual and progressive. The perviousness of the fault permitted the water to disappear into the hill without emerging on the downstream abutment. Movement occurred at the fault on December 14, rupturing the impervious blanket and admitting full reservoir pressure to the fault and to the drainage system for the first time. The full reservoir pressure in the fault forced an outlet to the surface at a point low down on the east abutment of the main dam. Flow developed in the pervious and erodible fault zone and foundation rock. The flow and erosion increased rapidly, a cavernous opening piped through the abutment, the overlying foundation and embankment collapsed into this opening and the reservoir drained quickly and completely.

In summary, the reservoir and its immediate environs were subjected to many adverse forces, including horizontal and vertical displacement due to subsidence; local breaking of the weak foundation; some erosion at the faults and rebound effects due to oil field re-pressurization, reservoir loading and unloading in 1951 and 1957, and the final inrush of water into the Fault I-II zone at time of failure.

Fig. 5. *Breached Baldwin Hills dam Embankment.*

careful design, construction and constant surveillance, the reservoir failed, and lessons are to be learned from the failure. Facing the same site conditions now, and equipped with the knowledge of what went wrong at Baldwin Hills, designers could make several improvements. The obvious first step would be to avoid rigid drains so close to the water face and to the unstable and erodible foundation. Drains should be amply sized and provided with access, where possible, to facilitate maintenance, and earth linings should have appreciable plasticity. Erodible embankment and foundation elements must have adequate filter protection. Foundations in erodible

rocks must be thoroughly explored to disclose any pre-existing cavities or other defects. Finally, the use of heavy construction equipment must be carefully controlled to avoid the damage of critical reservoir feature on soft foundations.
