Damage on a Main Gas Pipeline Due to Landslide of Soils Derived From Volcanic Ashes in Colombia

DAMAGE ON A MAIN GAS PIPELINE DUE TO LANDSLIDE OF SOILS DERIVED FROM VOLCANIC ASHES IN COLOMBIA

In December 2011 a great proportion slope failed affecting the main gas pipeline (20" diameter) that supplies Colombia's southwest area. The landslide involved materials formed by soils derived from volcanic ashes and residual soils, typical in Colombia's central zone, which acquired great energy flowing in an avalanche through the natural watercourse. The avalanche generated soil erosion over the torrent banks, generating the watercourse deepening and the deterioration of adjacent slopes over which the pipeline runs.

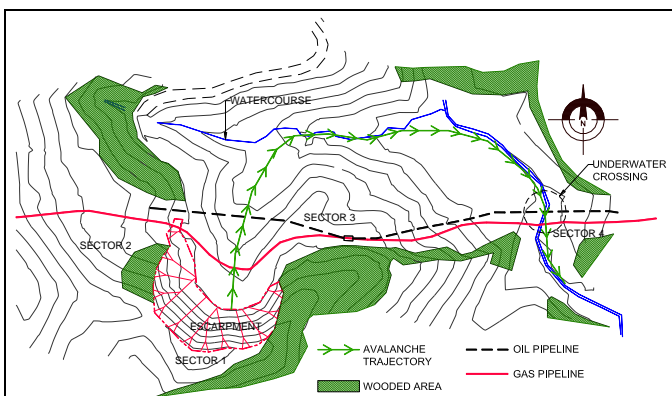
Fig 1. Sector and main features location

The avalanche consequences caused the need of geotechnical evaluation in the following sectors, whose localization is presented in Fig. 1:

Sector 1. Principal escarpment- directly affected by the landslide. There were evaluated the landslide triggering factors, the long term remaining stability and the possibility of damage of the pipeline air crossing and underwater crossing.

Sector 2. Western slope where the pipeline runs longitudinally in which is located one of the foundation structures for the air crossing built as contingency measurement. The stream removed the soils located on the base, reactivating a former instability processes. The new movements were evident due to tension cracks and displacements to occur on the order of centimeters.

Sector 4. Gas pipeline underwater crossing, located downstream the landslide position. Quantification of the pipeline hazard level for possible displacement of the soils deposited along the watercourse (landslide remaining) or soils produced by a reactivation of the main escarpment.

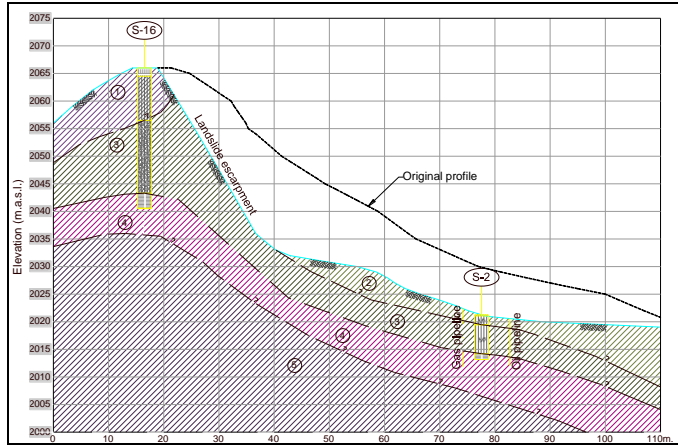
Fig 2. Sector 1 stratification

This sector corresponds morphologically to a narrow top of a hill, which north front slide. The stratification, shown in Fig. 2, is formed superficially by soils derived from volcanic ashes, differentiated along depth due to their grain size variation. This grain size variation is attributed to different volcanic eruption events and later deposition spaced along time, as well as the weathering level increment with depth (Lizcano, A. et al., 2006). These soils are described as pale yellow clayey silts of volcanic origin with soft to firm consistency (Stratum

1) transforming with depth into yellow sandy silts of volcanic origin with soft to firm consistency (Stratum 2). Subsequently, there are found sandy silts of residual origin, dark yellow with oxide veins with medium to high density (Stratum 3) as transition to saprolite, weathered claystone in sandy-silty matrix with high density (Stratum 4). The oxide veins could indicate water table seasonal fluctuations.

Figure 2 shows the original slope profile and failure surface geometry corresponding to the remaining escarpment after the landslide. A stability back analysis based on the two geometries described previously, the laboratory tests for the determination of the initial shear strength parameters and a superficial water level hypothesis (valid for a rainy period) was performed. In the calculation, there was considered the lateral undermining of the slope base due to the existing water course. With these calculations there were adjusted the shear strength parameters (ϕ , c) of the soils derived from volcanic ashes in order to obtain a factor of safety $F.S.=1$, with which failure was simulated.

After the back analysis and aiming to evaluate the slope stability under current conditions, there were performed stability calculations under static and pseudo-static conditions. The results show acceptable stability under static conditions

($F.S. = 1.23$) and marginal stability under pseudo-static conditions ($F.S. = 0.94$). In order to increase the factor of safety, the slope intervention could include a morphological reconfiguration (terracing) to acquire the reduction of mobilizing forces.

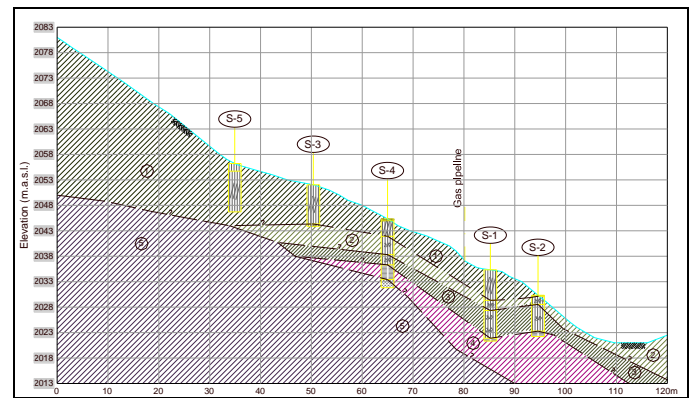
Fig. 3. Sector 2 stratification

For this sector analysis there was established the stratification shown in Fig. 3. The installation of Casagrande piezometers for the constant monitoring during several months allowed to conclude the inexistence of a defined water table in the soils derived from volcanic ashes and the existence of piezometric levels produced by artesian water in the inferior stratum formed by saprolite. This conclusion was verified during the horizontal drains and anchors boring execution, in which the operator reported the inexistence of free water in the soil and water rising through the boring pipe once the saprolite stratum was reached.

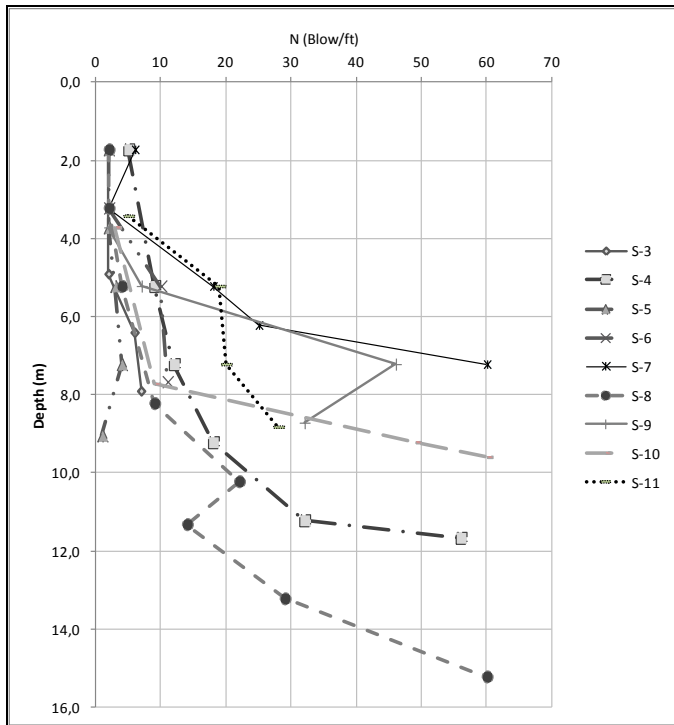
Fig. 4. Standard penetration test (SPT) results

As it was mentioned before, the material flow produced by the main landslide removed the soils located on the base of the sector 2 slope, reactivating a former instability processes evidenced by displacements on the order of centimeters and superficial tension cracks. To determine the failure surface depth location there were employed the standard penetration test (SPT) results to identify the rigidity and resistance main variations (Soils derived from volcanic ashes contact with residual soils and saprolites) (Fig. 4). On the surface, the failure geometry was limited by the cracks observed on field.

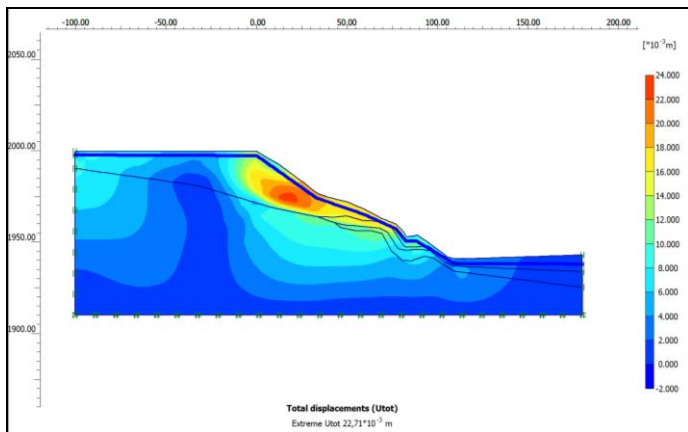
Fig 5. Total displacement (superficial piezometric level)

With the parameters presented in Table 2 and the piezometric level near to the surface (rainy season) there were obtain displacements on the order of 2cm (Fig. 5), mainly on the horizontal direction. The pipeline reaches displacements on the same order of magnitude. The later piezometric level lowering (horizontal drains) induces total additional displacements on the order of 1.5cm.

According to the results, the maximum momentums on the pipe are located at the pipeline change of direction, being vulnerable points. The maximum registered momentum is 45 KN-m/m.
