Earth Dam Failure by Erosion, A Case History

Bechtel Power Corporation, Frederick, MD

Seventh International Conference on Case Histories in Geotechnical Engineering

EARTH DAM FAILURE BY EROSION, A CASE HISTORY

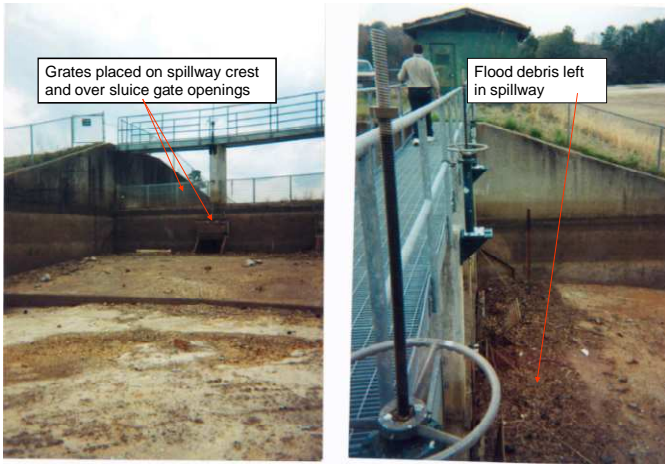
In the 1980s, the principal spillway was fitted with an inflatable gate; this configuration was modified in 1994 due to ongoing problems with maintenance and vandalism. In 1994, the spillway was modified with an ogee crest and series of sluice gates through the ogee. The crest and the gate inlets were all fitted with fish-retaining screens. Figure 2 illustrates these spillway modifications. Notably, the fish-retaining screens clogged with debris during the failure storm and contributed to breaching by restricting spillway capacity.

Fig. 2. Photo showing spillway modifications.

The modification to the principal spillway added another element for potential failure. Changes in the principal spillway included the addition of an ogee weir with manual sluice gates. The gates and the weir crest were all fitted with fish-retaining grates, as illustrated in Fig. 2. As Fig. 2 illustrates, the grates collected significant debris during the storm event, consequently restricting flow capacity through and over the spillway. The reduced capacity from the clogged grates was probably never envisioned or accounted for in the dam modification. While the disadvantage of grates over the spillway openings is evident, there is little known benefit.

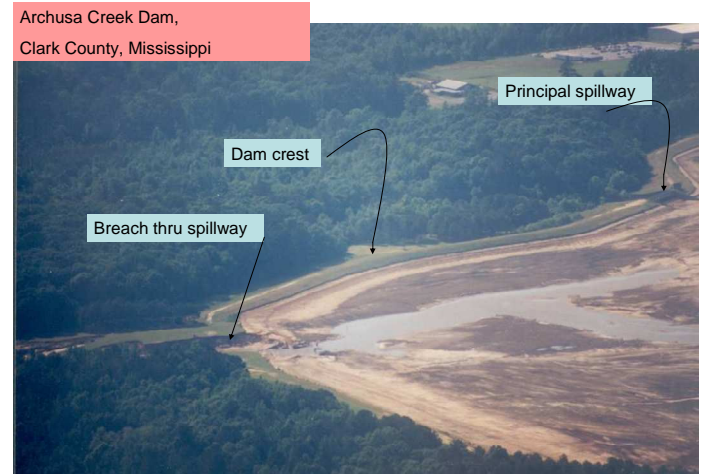
Figures 1 and 3 illustrate the position of the emergency spillway on the dam. It is located near the middle of the dam at the maximum section as opposed to one of the abutments. Consequently, the soils below the emergency spillway were primarily fill, not native in-situ soil. The soil forming the emergency spillway was fine silty sand placed as fill. When the emergency spillway was widened, the excavation was extended into the sand fill placed to build the dam.

The breach was formed by the erosion of soil within the vegetated earth emergency spillway due to the high discharge velocity, which the spillway surface could not sustain. Figures 3 and 4 illustrate the position of the breach within the dam. The storm causing the failure was an event corresponding to a 5-year return period. Rainfall from this storm was nearly 16.5 cm (6.5 in.) in a 3-day period. However, the dam's failure was preceded by intense rainfall of 10.8 cm (4.25 in.) over a period of only a few hours. Figure 5 illustrates the grass lining on the emergency spillway, and shows the fine sand soil within the spillway. Figure 6 illustrates the lake's shallow depth (note

Fig. 3. Breach through emergency spillway.

A concrete labyrinth weir spillway was selected as the main repair component; it was built within the gully made by the breach. This new concrete spillway, now used as an auxiliary spillway, has helped designers solve the problem of flow over an earthen emergency spillway at a 2-year frequency and should prevent such a disaster in the future.

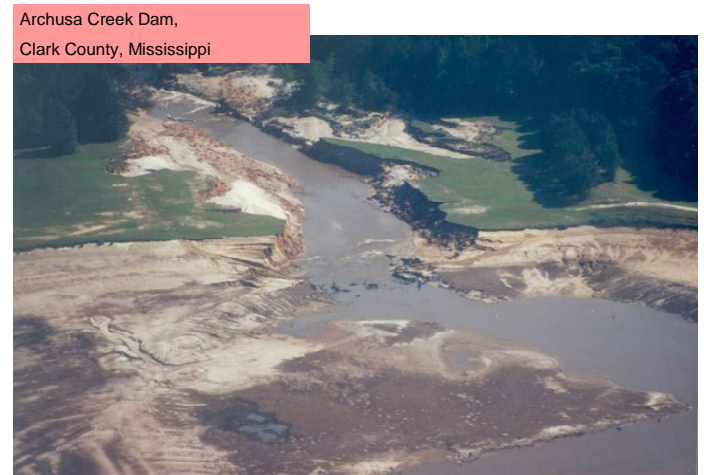
Fig. 4. Close-up view of breach.

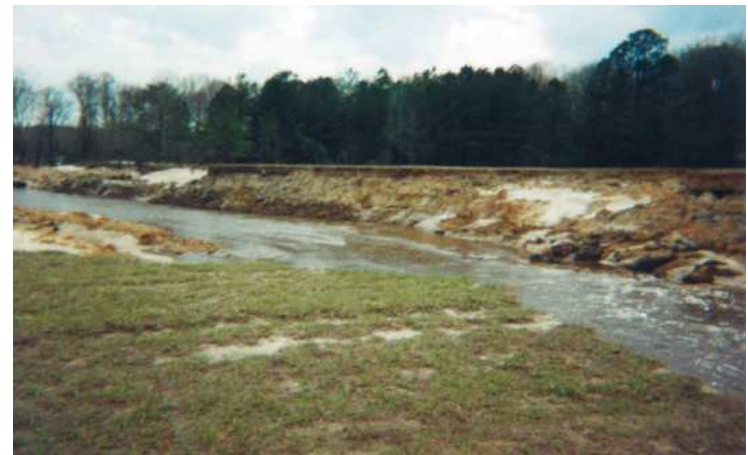
Fig. 5. Photo showing grass surface on spillway.

The type of fine silty sand soil used as fill in the emergency spillway has a low resistance to erosion. According to the criteria in Fig. 7, maximum sustainable velocity on the Archusa Creek Dam's emergency spillway is 0.8 m/s (2.5 ft/s). Based on the calculated velocity during the 1998 failure storm near 1.5 m/s (5 ft/s), erosion through the spillway material would have been expected. The calculated velocity is based on the broad, flat spillway; the ditch excavated into the emergency spillway would have resulted in velocity exceeding 1.5 m/s (5 ft/s).

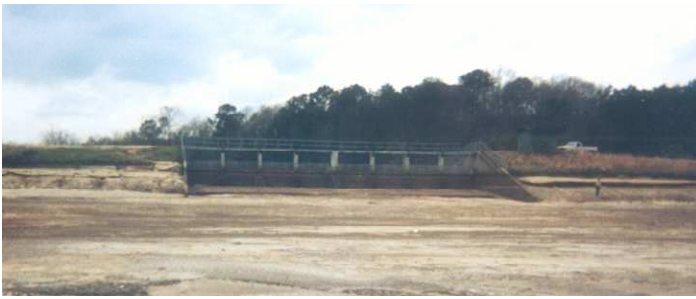
the person standing to the right of the spillway, indicating relative scale).

Fig. 6. Photo illustrating principal spillway and typical depth of lake.

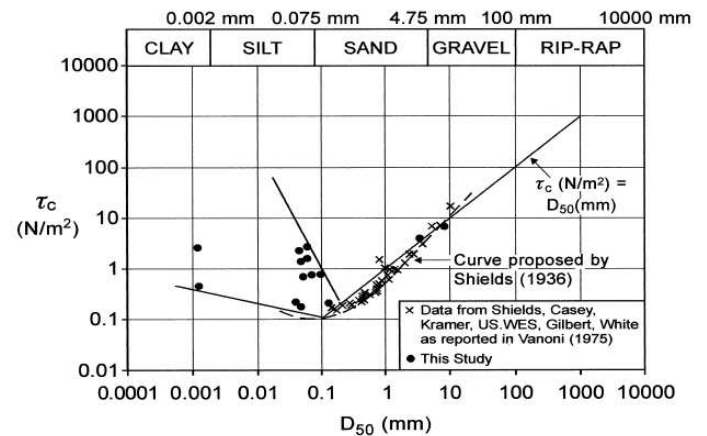
Figure 8 illustrates that the fine silty sand soil within the dam's emergency spillway is generally the most easily eroded soil category and that erosion will result in this soil at a shear stress of about 0.1 N/m², the minimum for all soil types.

Fig. 8. Quantified measure of erodibility—critical shear stress versus mean soil grain size (Seed et al. 2006).

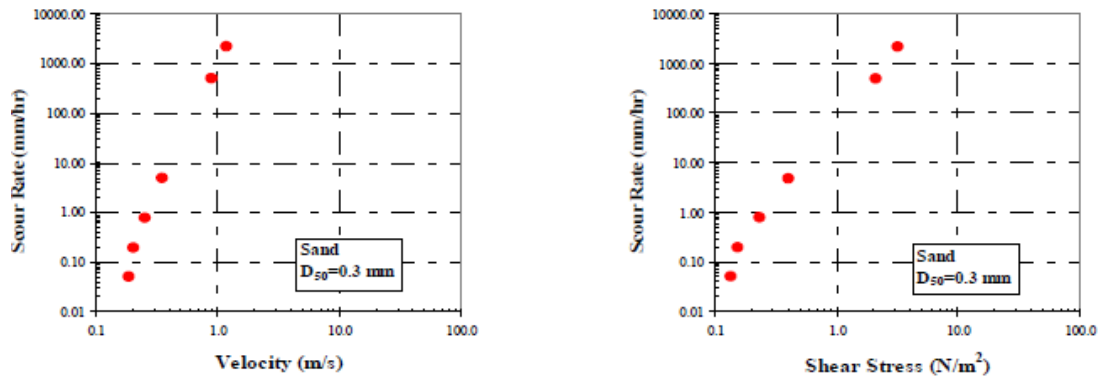
Figure 9 shows that for shear stress above the threshold value for fine sand, 0.1 N/m², a significant scour rate results. For the water velocity imparted to the spillway during the failure storm, exceeding 1.0 m/s, Fig. 8 indicates that the fine sand in the spillway would erode at a rate exceeding 1,000 mm/hr. These values apply to a bare soil not protected by vegetation. Accordingly, the values do not establish specific parameters

Fig. 9. Erodibility function for a sand (Seed et. al. 2006).

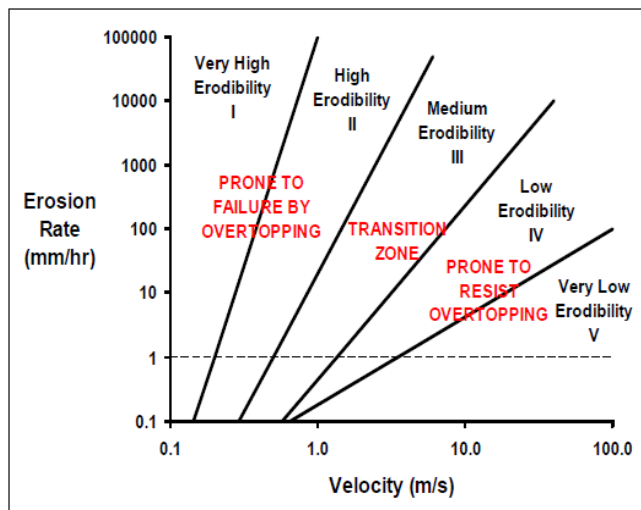
With the expected scour rate over 1,000 mm/hr and velocity imparted to the spillway exceeding 1 m/s, Fig. 10 illustrates that the spillway would have been highly erodible and prone to failure by overtopping. The levee study results depicted in Figs. 8 through 10, combined with the sustainable velocity range portrayed in Fig. 7, explain why erosion resulted in the spillway during the breach storm event.

Fig. 10. Proposed guidelines for levee overtopping (Seed et al. 2006)

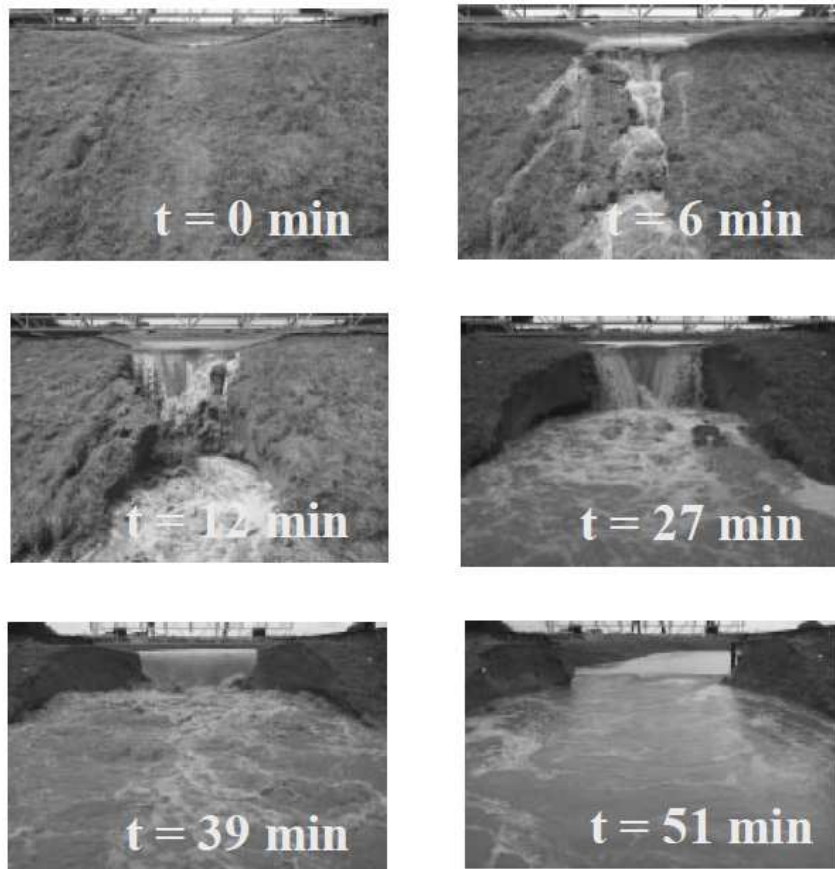
Figure 11 illustrates the three-phase mechanism described above for over-topping failure in earth dams. Failure is initiated by erosion of the soil particles due to excess velocity. A near-vertical face is formed, which travels progressively toward the reservoir during the erosion process (head-cutting). Finally the head-cutting process effects complete breach of the dam.

Fig. 11. Illustration of dam breach by overtopping- embankment breach test of a homogeneous non-plastic sandy soil conducted at the ARS Hydraulic Laboratory, Stillwater, OK (FEMA 2001).

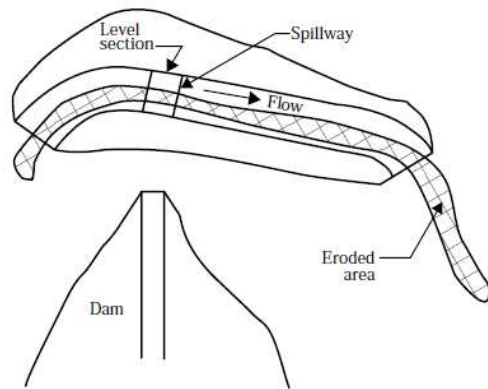
The earthen emergency spillway design for the Archusa Creek Dam did not conform to these criteria. The spillway was located in the middle of the dam, with its bottom in fill where it should have been at an abutment in cut. The spillway did not have a control section sufficient to lower velocity to a sustainable level. Further, the drainage ditch excavated into the spillway concentrated flow and increased velocity, initiating erosion during the failure storm.

Figure 50-4 Spillway gully resulting in breach of spillway

Fig. 12. Diagram illustrating proper emergency spillway layout (From NRCS (1997)).

With the emergency spillway out of conformance with these guidelines, erosion was a threat to dam safety. The choice of grass for the emergency spillway lining was inappropriate. Some armored lining, e.g., rip-rap, would be required for the emergency spillway geometry in order to prevent erosion that could result in dam breach.
