Failure Investigation and Restoration of Two Cellular Sheetpile Structures

FAILURE INVESTIGATION AND RESTORATION OF TWO CELLULAR SHEETPILE STRUCTURES

Frank M. Clemente, Jr., Ph.D., P.E.

AECOM

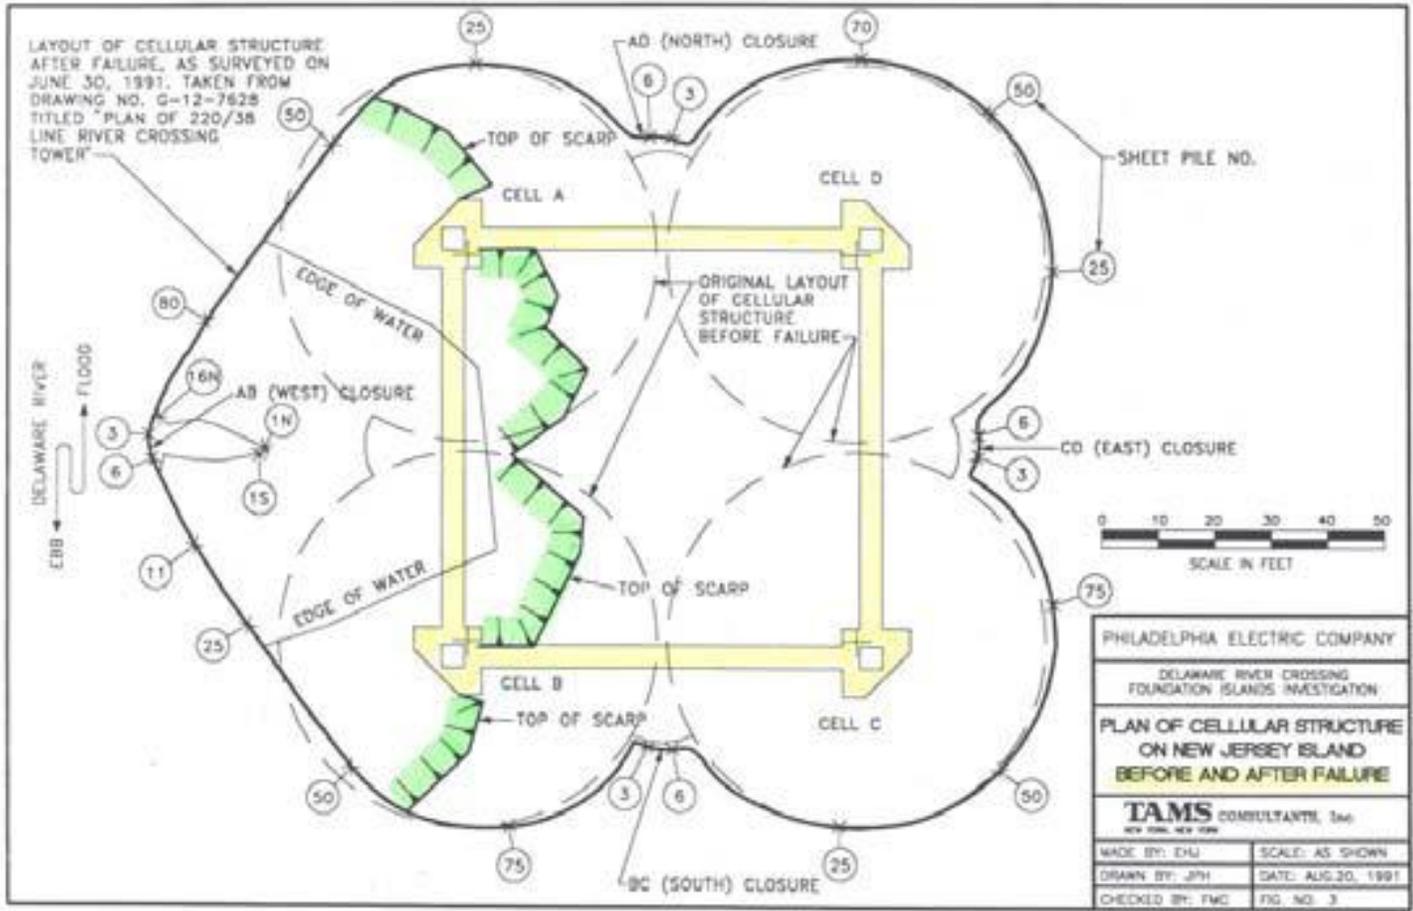
Fig. 3: Before and After Failure

New Jersey Island. Additional observations that may have a bearing on the failure of the New Jersey Island are summarized below. The numbering system used to identify specific sheetpiles that are discussed in this section is shown in Fig. 3.

PECO personnel surveyed the New Jersey Island to record the present configuration of the island. A plan of the New Jersey Island before and after failure based on the survey data is presented in Fig. 3.

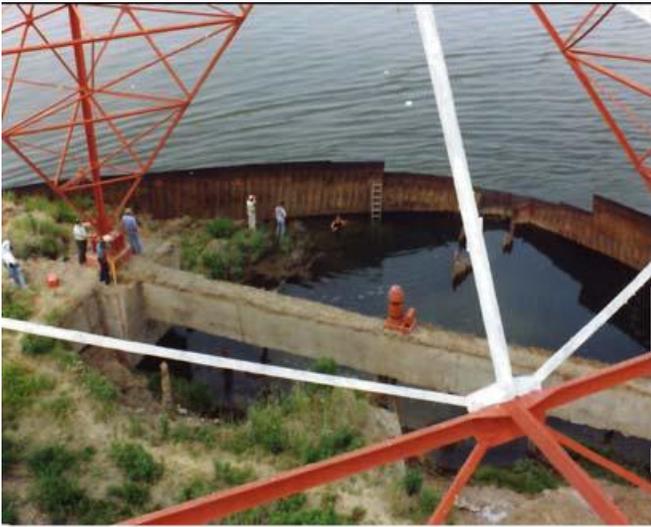
Fig. 5: Partial Collapse Exposing Pile Caps and Tie Beams

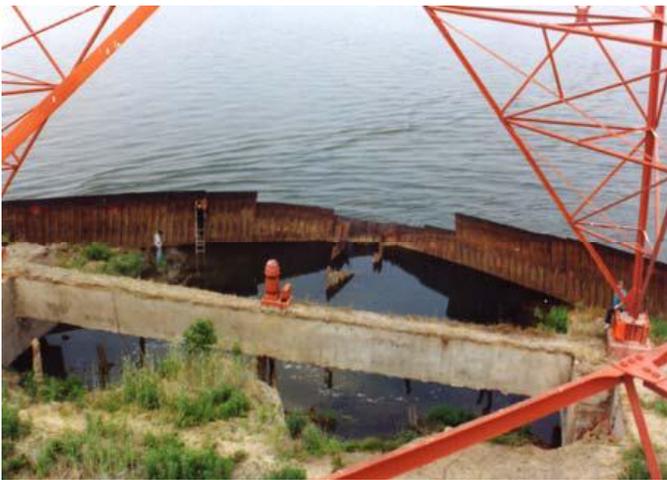
Fig. 6: Partial Collapse Exposing Pile Caps and Tie Beams

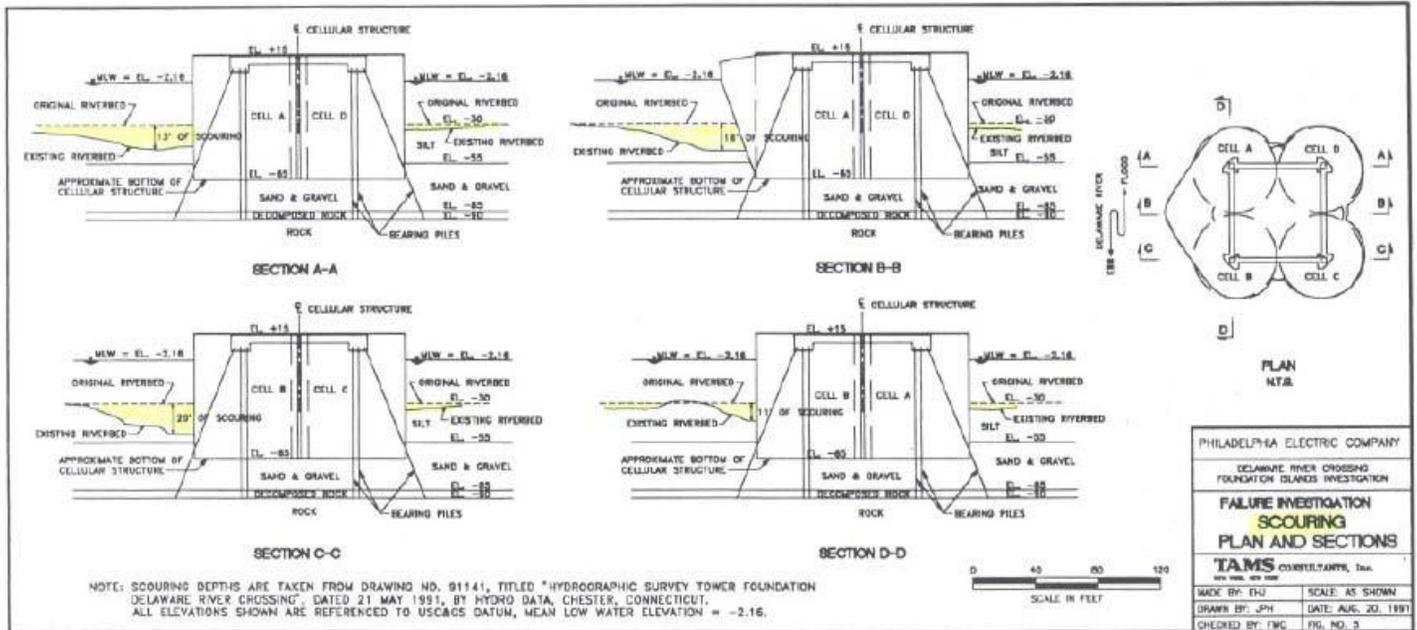
Fig. 7: Depth of Scour

The divers performed a pneumo-fathometer survey around the perimeter of the islands at the mudline. The results of this survey were consistent with the precision hydrographic survey, and indicated that about 20 ft of scour had occurred on the channel side of both islands since original borings were conducted in 1959. Divers observed several 1 to 6-ft vertical drops in the mudline profile around both foundation islands. These appeared to the divers to be at locations where current velocity increased.

Hydrographic surveys were carried out in order to investigate general river bottom conditions in the vicinity of the two islands and to document scour near the structures. Depth soundings taken by the Corps of Engineers in 1954 and riverbed elevations from the 1959 borings were compared with 1991 soundings. Soundings were not available for the period immediately before or after construction. Based on the comparison, approximately 20 ft of scour had occurred on the channel side of both islands.

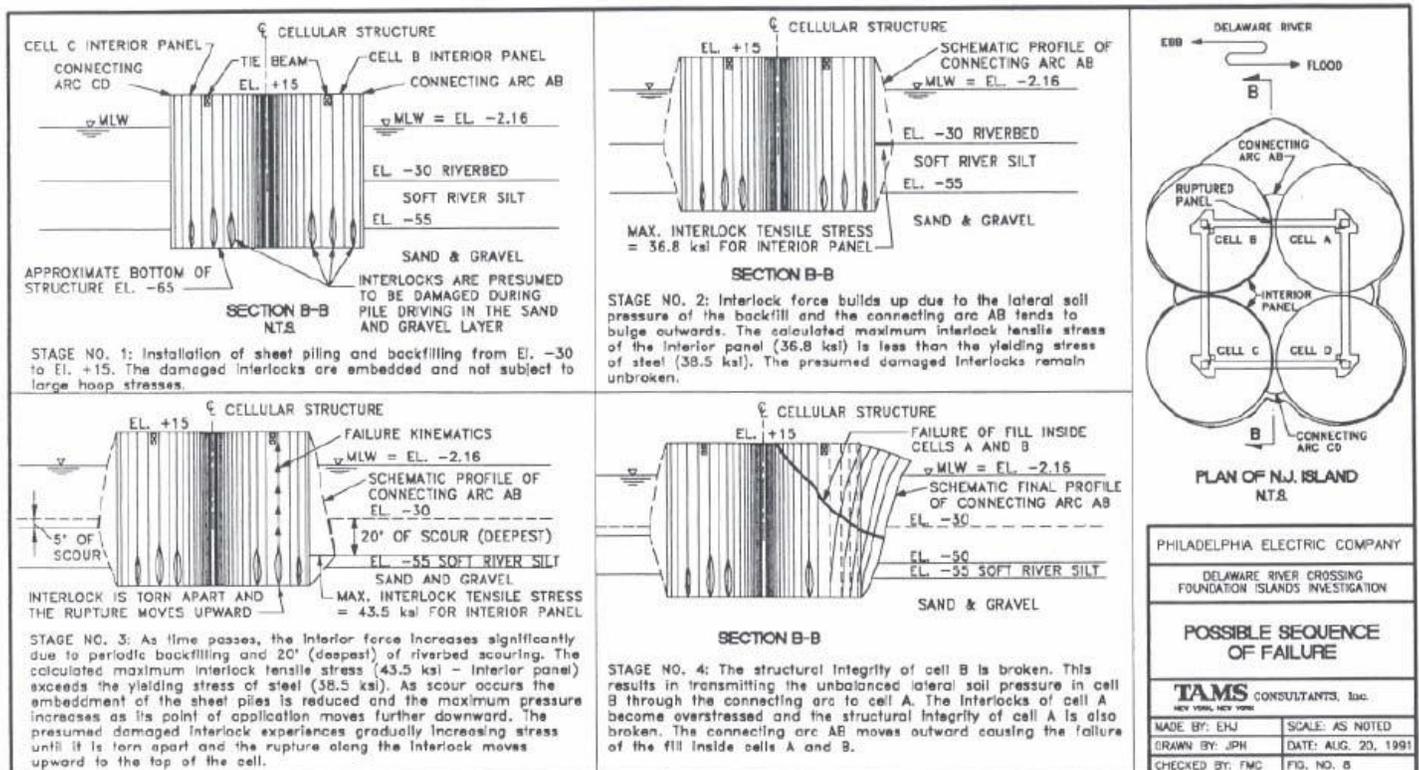
The following paragraphs describe the several factors that contributed to the failure. The role of each of these factors in leading to the eventual failure mechanism constitutes a failure hypothesis. The inferred sequence of events leading to failure is depicted in Fig. 8.

Fig. 8: Possible Sequence of Failure

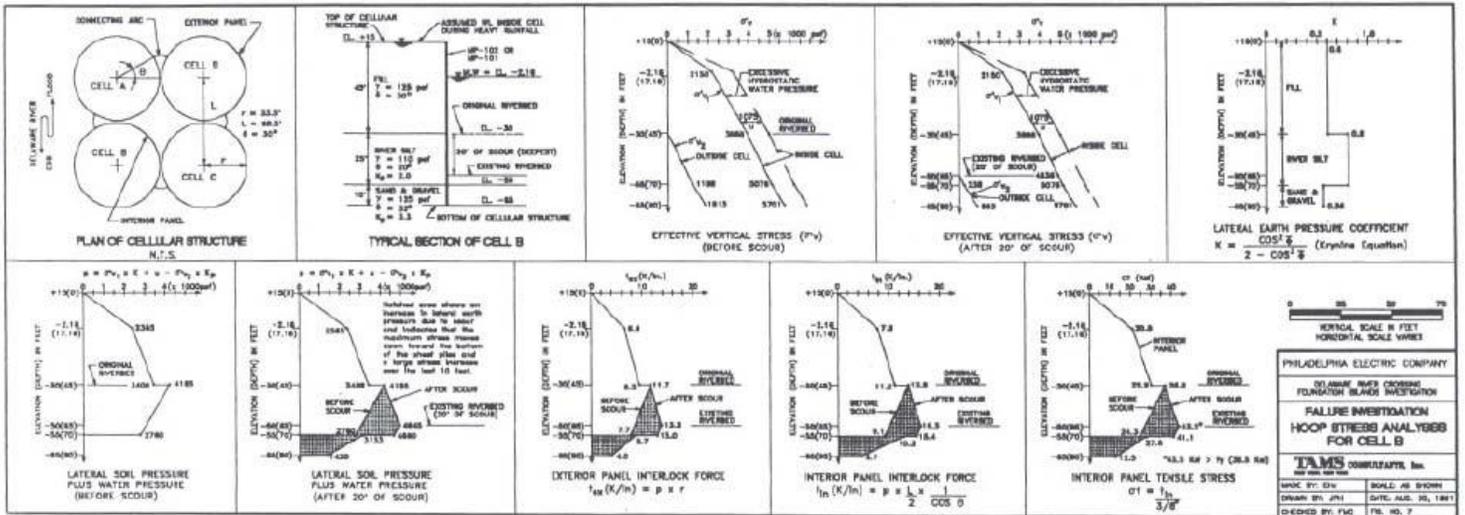
stress analysis of Cell B shown in Fig. 9 was conducted to estimate the maximum hoop stress in the cell, which occurs on the interior sheets at or near the connecting arc (TVA, 1957), the depth to the maximum stress was assumed to correspond to the depth of scour outside Cell B. This is based on Maitland and Schroeder (1979) who recommend a plane of fixity concept to estimate the location of maximum lateral earth pressure. The weaker the soil in which a cell is embedded, the greater the depth to the plane of fixity. Therefore, the maximum interlock tension should be calculated at a lower level for weak soils compared to strong soils, and may even occur at or below the dredgeline.

Fig. 9: Hoop Stress Analysis of Cell B

The analysis arrived at an estimated circumferential tension of 16.3 kips per inch under the conditions of scour, saturation of the backfill above MLW, and the presence of soft sediments inside the cell. This value exceeds the allowable force (8 kips per inch) as well as the ultimate interlock strength of 16 kips per inch. The corresponding stress is 43.5 ksi, which exceeds the yield point of 38.5 ksi. The analysis demonstrates that the tension was sufficiently high to exceed the ultimate strength for separation of interlocks and the yield point of the webs on the interior sheetpiles.

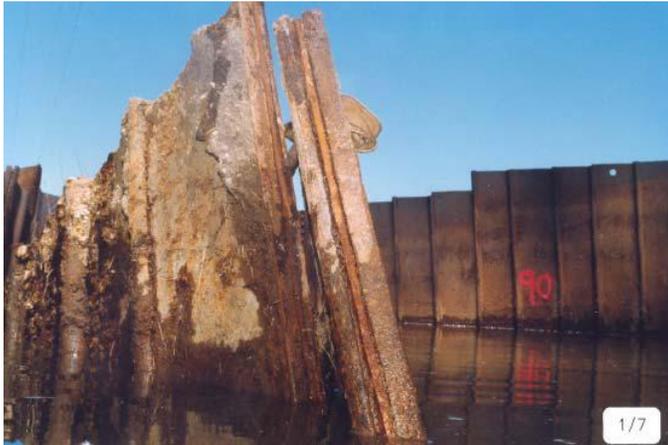
In the majority of interlock failures the contact friction between the interlocking fingers and thumbs holding adjacent sheetpiles together is overcome by circumferential stress and separate entirely one sheetpile from the other. However, this mode of failure was not evident at the New Jersey Island. Instead the failure mechanism consisted of the steel fracturing vertically through the narrowest dimension (root) of an interlocking thumb, leaving it behind and inside the thumb and finger of the other interlock. That is, the steel fractured before the interlocks could separate (Fig. 10).

Fig. 10: Brittle Fracture through Interlock

The fracture occurred along a vertical plane. Chevron or herringbone markings pointed downward, an indication that the fracture began below the mudline and proceeded upward unabated.

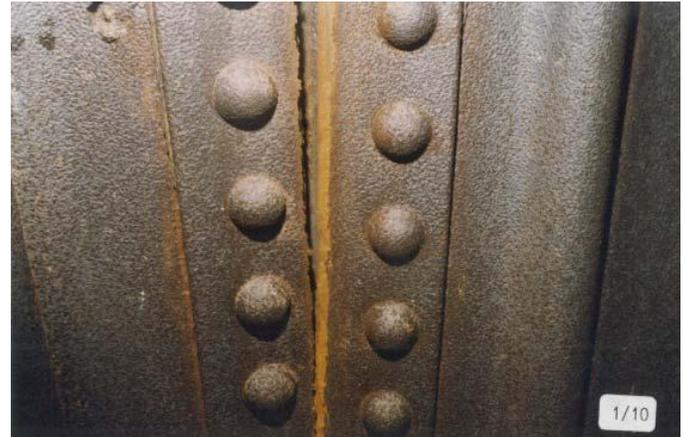
As the two cells failed behind the connecting arc they lurched outward trying to individually open up, but were restrained by their mutual connecting arc, as evidenced by the distortion and slight pulling apart of the T-connection from the top of the sheeting to a point several feet down (Fig. 11). This latter damage is a result of the collapse, not the cause.

Fig. 11: Connecting Arc A-B in Distress
