Failure of Embankment on Soil-Cement Columns for Thi Vai Port, Vietnam

FAILURE OF EMBANKMENT ON SOIL-CEMENT COLUMNS FOR THI VAI PORT, VIETNAM

ABSTRACT

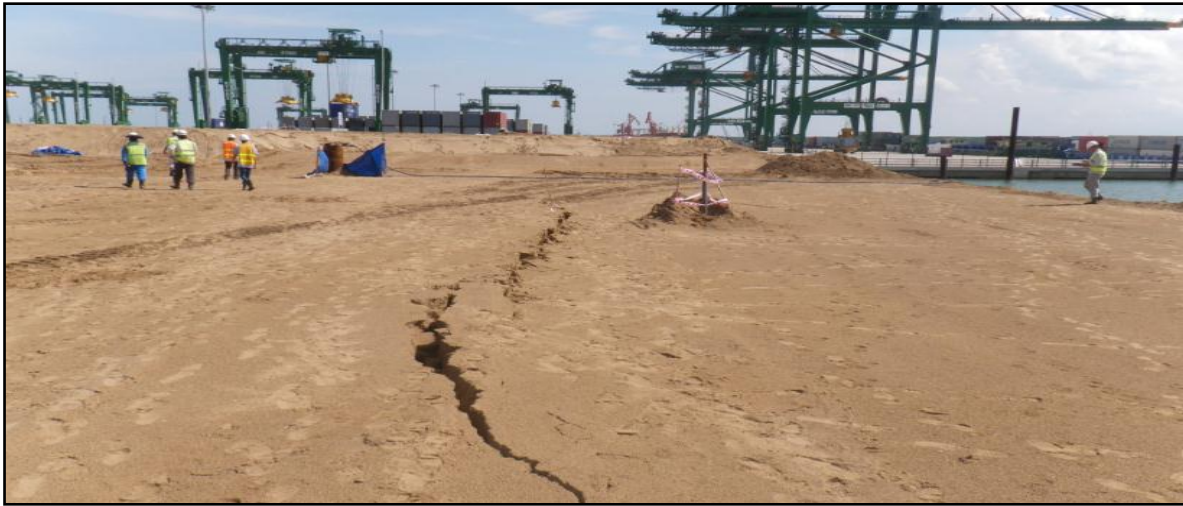
On March 29, 2010, when the final surcharge level was being approached, some lateral displacements were noticed to have occurred, and, on April 5, 2010, cracks appeared on the fill

surface about 30 m from the bank along about 100 m length. The cracks are shown on the photograph in Figure 1. In the morning of July 12, 2010, the width of the crack noticeably and progressively increased until, at 07:50h, the river bank failed along an about a 200 m long stretch. Figure 2 shows a photograph of the failure. A significant crack developed parallel to the river about 30 m inland, extending about 400 m along the river bank. All soil-cement columns along that length broke about 11 m below the fill surface. Figure 3 shows an artist's view of the future Port with the failed area marked out.

Fig. 1 Downstream view of the first cracks that appeared along the riverbank on April 5, 2010

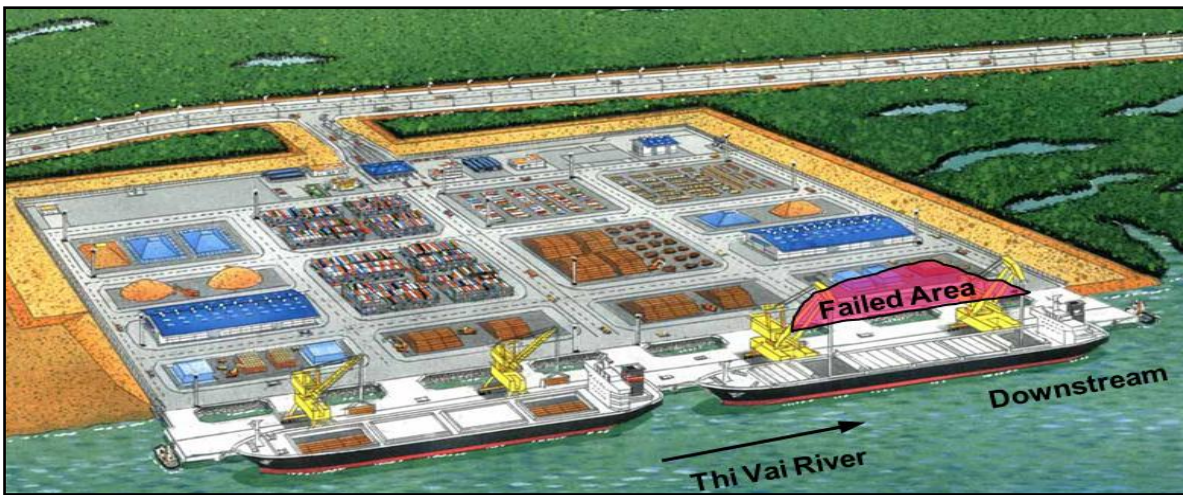
Fig. 3 Artist's view of completed Port with slope failure area overlaid (JICA 2006)

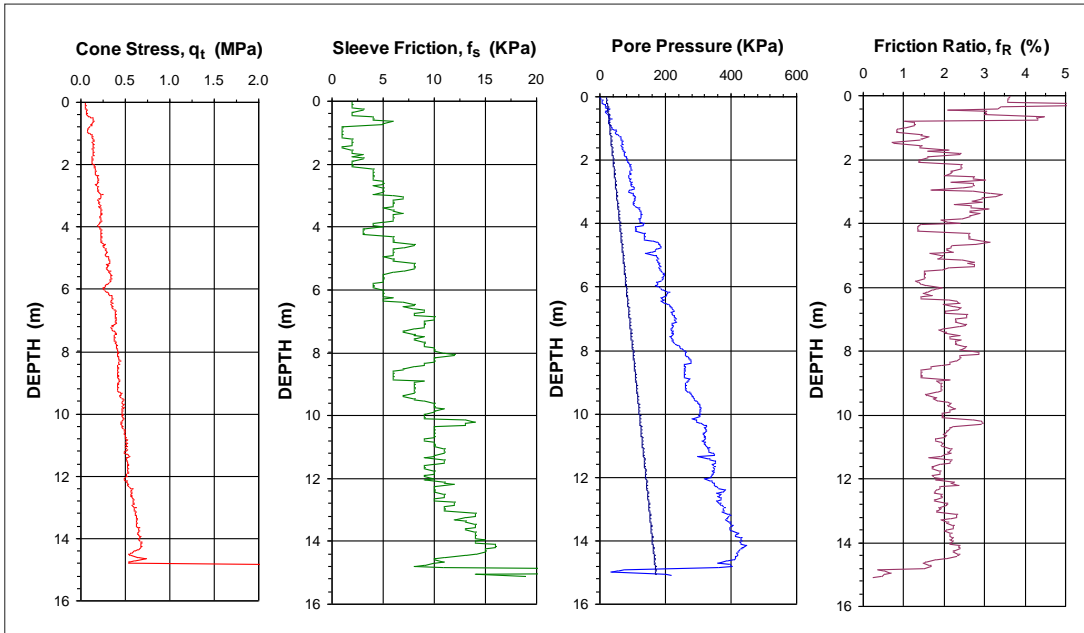
Fig. 4 Diagram of CPTU sounding pushed before construction start

The soil profile is illustrated in Figures 4 and 5. Figure 4 shows the results of a typical CPTU sounding pushed at the site before construction start. Figure 5 shows the distribution of the basic soil parameters. The natural water content of the clay is 70 to 75 % and the total saturated density is about $1,500 \text{ kg/m}^3$. The density of the sand below the clay is estimated to $1,800 \text{ kg/m}^3$. The field vane shows the clay to be very soft above 10 m depth and soft below. The correlation

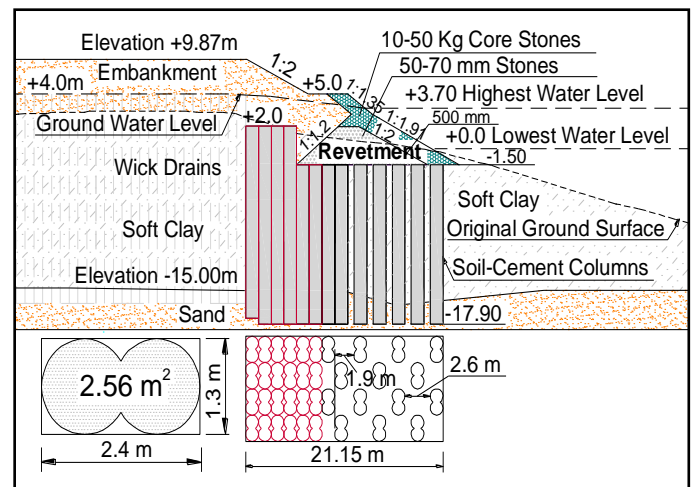
Fig. 7 Typical Cross Section of Embankment on Soil-Cement Columns

Figure 7 shows a section of the river bank with the treated ground before slope failure. The soil-cement columns were constructed through the soft clay using the wet deep mixing method designed to have an unconfined compressive strength of 500 KPa and, therefore, an undrained shear strength of 250 KPa. The column diameter was 1,300 mm. One group of columns was constructed with each overlapping the next by 0.1 m. A second group was constructed as similarly overlapping pairs with open spaces between pairs of 1.3 m, 1.9 m, and 2.6 m. The shear strength of the original soft soil was not considered to contribute to the stability. For use in the stability analysis, the average shear strength of improved ground was estimated to be 200 KPa. About 26 m² of 50 to 70 mm stone and 21 m² of core stones with weight in range of 10 to 50 kg were placed on the soil-cement columns to form a revetment for protecting the toe of the slope along the river bank from erosion (total area of about 47 m²).

Wick drains were installed behind the soil-cement columns at a 1.5 m spacing through the clay and into the surface of the sand layer. The wick drains were not installed in the soil-cement column area as it was expected that the soil-cement columns would act as vertical drains.

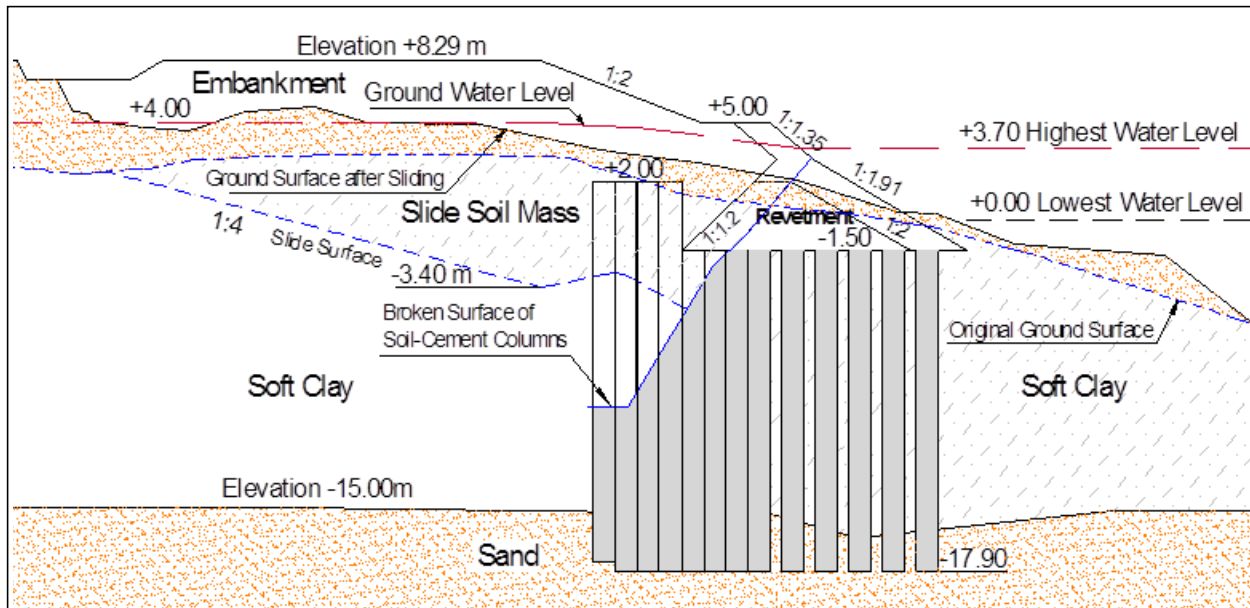
Fig. 10 Cross section of failed embankment

Figure 10 indicates the slide surface starting about 30 m from the river bank and sloping down at 1(V):4(H) toward the soil-cement columns at a depth of about 11 m below the original ground surface, breaking the columns. The lowest location of sliding surface was at Elev. 3.4 m, and the fill and ground surface after slope failure was lower than groundwater level (Elev. +4.0 m). The columns failed along an approximately horizontal plane, which suggests that the type of failure was by translational sliding and wedge.

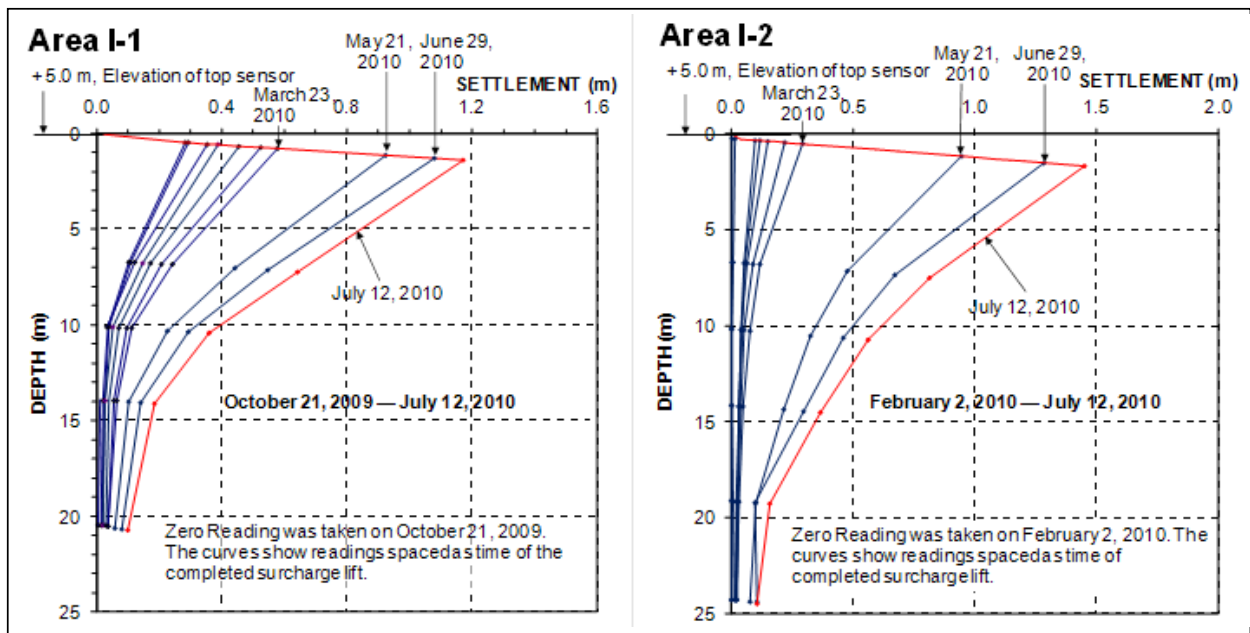
Fig. 11 Distributions of settlement with depth below original ground surface at Areas I-1 and I-2

Figure 11 indicates the distribution of settlement versus depth at monitoring stations SS 1, P2 at Area I 1 and SS 3, P1 at Area I 2 just outside the failure area. The records were taken at the occasion of the completion of the placing of each, approximately equal, fill lift at the monitoring point. The recorded settlements are also indicated by the figure showing the records at the gradually increasing depth of each particular settlement anchor point.

The settlement readings in extensometer stations E1 and E2 in Areas I-1 and I-2 started on October 21, 2009 and February 2, 2010, respectively. The final set of readings (the red curve) is from July 12, 2010, the day of the slope failure. The records show increasing settlement between March 23 through May 21, 2010, in Area I-1, and March 30 through May 29, 2010, in Area I-2 respectively. This increase coincided with lateral displacements observed in inclinometer measurements taken during the surcharge lift to Elev.+8.1 m in Area I 1 and to Elev.+8.9 m in Area I 2.

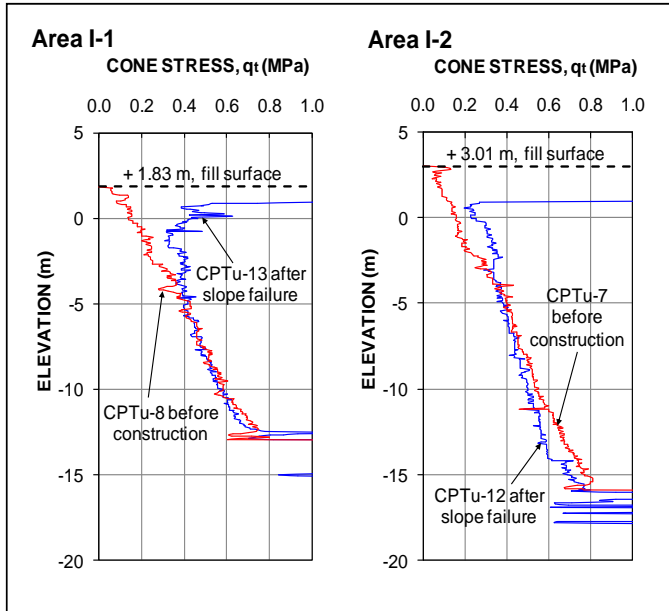
Fig. 17 Cone stresses, q_b , versus depth in Area I-1 and I-2

Figure 17 indicates a comparison between the distributions of cone stress from the CPTU soundings performed before and after the slope failure (correlated to elevation), suggesting little or no change between the cone stress for before and after the slide. An increase of shear strength would have resulted in an increase of cone stress. Instead, the cone stress from Area I-2 below Elev.-3 m even showed a decrease for the sounding after the failure.

5. The CPTU soundings before the start of placing the surcharge and after the slope failure showed about equal distribution of cone stress, which suggested that no increase of clay shear strength occurred during the consolidation as opposed to what was assumed in the design. The CPTU soundings before the start of placing the surcharge and after the slope failure showed about equal distribution of cone stress, which suggested that no increase of clay shear strength occurred during the consolidation as opposed to what was assumed in the design.
