## Lessons Learned from the Disaster at Lippe Canal Bridge

Markus Herten

### ABSTRACT

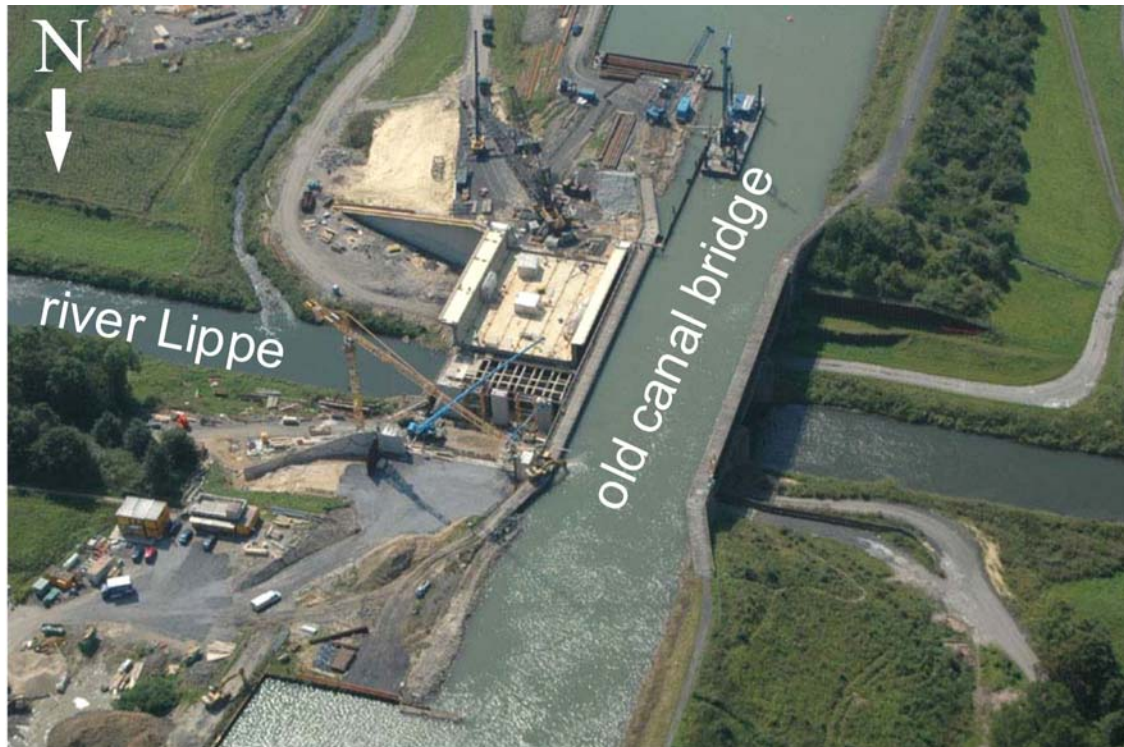
Fig. 2: Aerial photograph of the construction works (August 18th, 2005)

The DEK is being expanded to meet the requirements of larger motor cargo vessels. This measure requires the renewal of the canal bridges spanning the Ems and Lippe Rivers. Construction works at the Lippe canal bridge started in spring 2004. The construction of the Ems canal bridge is planned to start soon. The aerial photograph of the Lippe canal bridge (Fig. 2) shows that the construction area is situated in an above-ground canal stretch of the DEK. The embankment crest is at approx. 15 m above the natural terrain. The regular water level of the Lippe River is about 16 m below the regular water level in the canal. The DEK embankments are made of silty sands. The building ground consists of sandy marl. During construction works continuous ship traffic is maintained. This is why a new steel trough was installed directly adjacent to the existing trough made of concrete. It was not until the new trough was put into operation that the old canal bridge was supposed to be sealed off and demolished. The old aqueduct is supposed to be replaced by another new trough at the same location. At the time of the accident, the construction works on the new trough at the north side had almost as much progressed as the works on the south side in August 2005, as shown in Fig. 2.

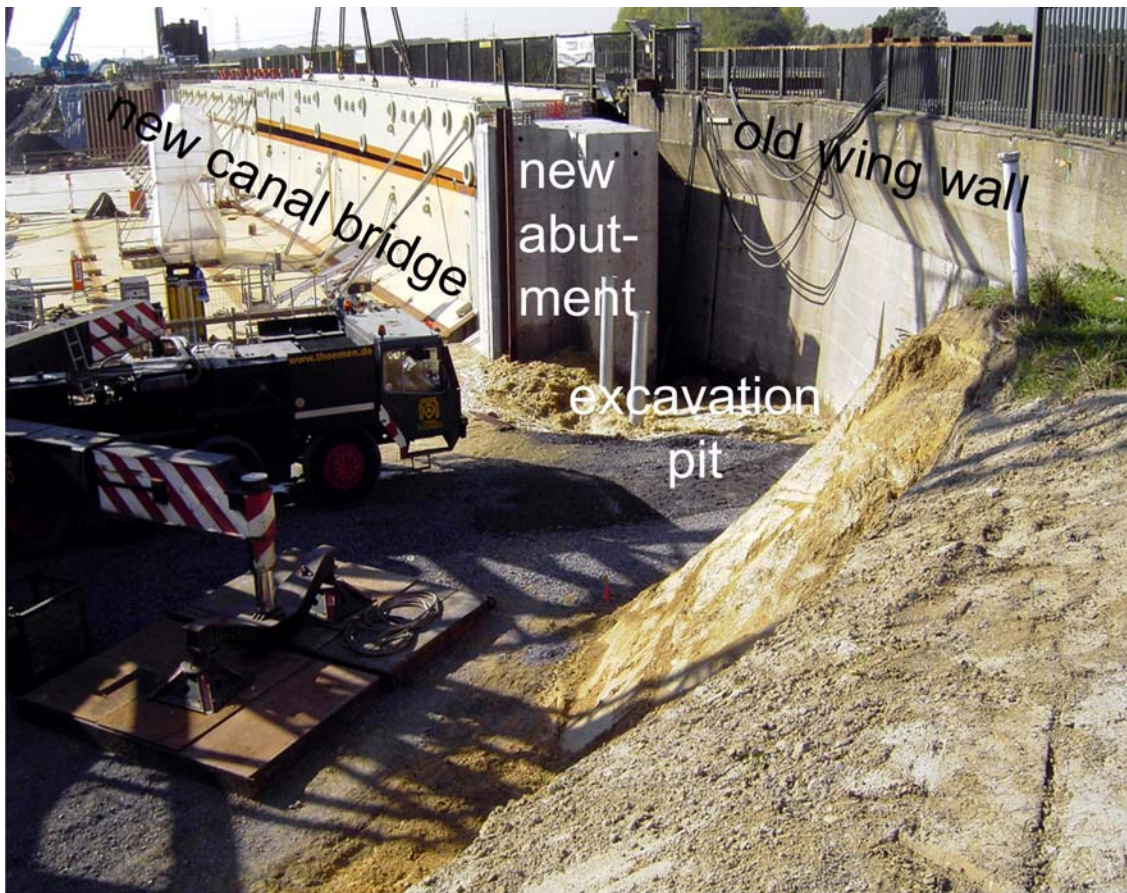
*Fig. 4: View of the construction pit between the two abutments*

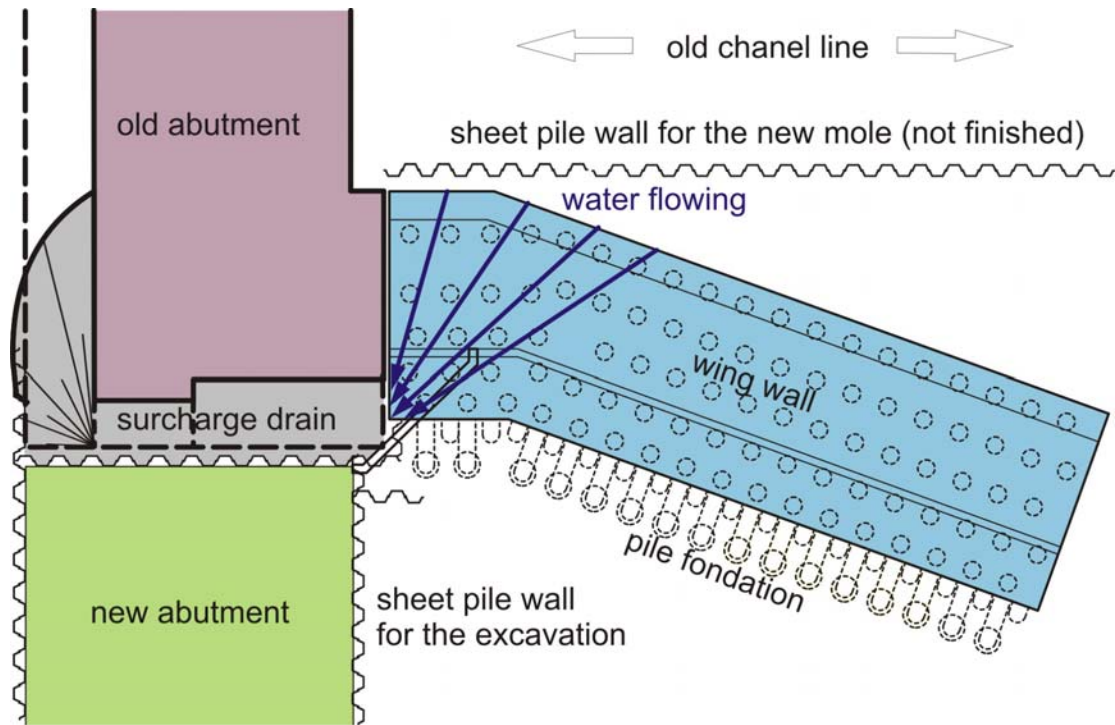
On the day of the accident large steel parts were delivered by ship and unloaded by a truck mounted telescope crane. Shortly before noon, a worker observed leakage between the northern abutments of the old and the new canal bridge. Members of the construction supervision were immediately informed. They found a water whirl in the canal in front of the wing wall of the old northern abutment (Fig. 3). The leakage increased substantially within a short time period. The water from the canal flew first into a small construction pit (Fig. 4), passing under a wing wall footed on piles (Fig. 5). This construction pit was supposed to be protected by a surcharge drain. Then the water flew through the two abutments into the Lippe River (Fig. 6).

Fig. 5: Cross section of the footing at level 45 m asl; water flowing towards the surcharge drain

Fig. 10 depicts a cross section of the northeast wing wall between the two abutments. As already mentioned, the wing wall is founded on piles, which reach into the marl layer. If the clay lining fails, canal water can flow through the non-cohesive soil around the wing wall towards the pit bottom (Fig. 5 and 10). According to BAW (2011), potential degradation below the pile head slab is not to be considered in case of structures founded on piles. This means that a hydraulically effective gap is to be expected between the pile head slab and the subsoil. Using a simplified approach, as potential degradation is to be neglected; the thickness of the construction can be reduced correspondingly. The wing wall, which can be up to 8 m wide, may be regarded as a sheet-pile wall (cf. structural scheme Fig. 10).

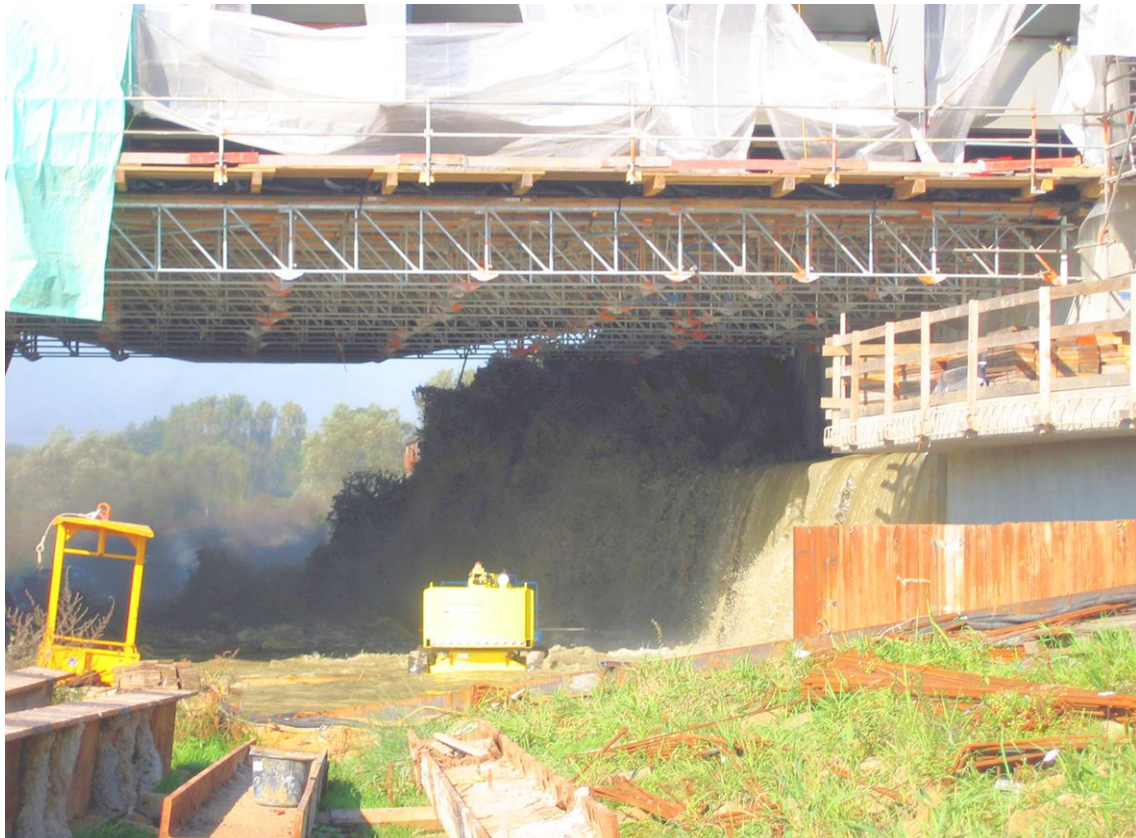
Fig. 6: Violent water flow through the two abutments into the Lippe River

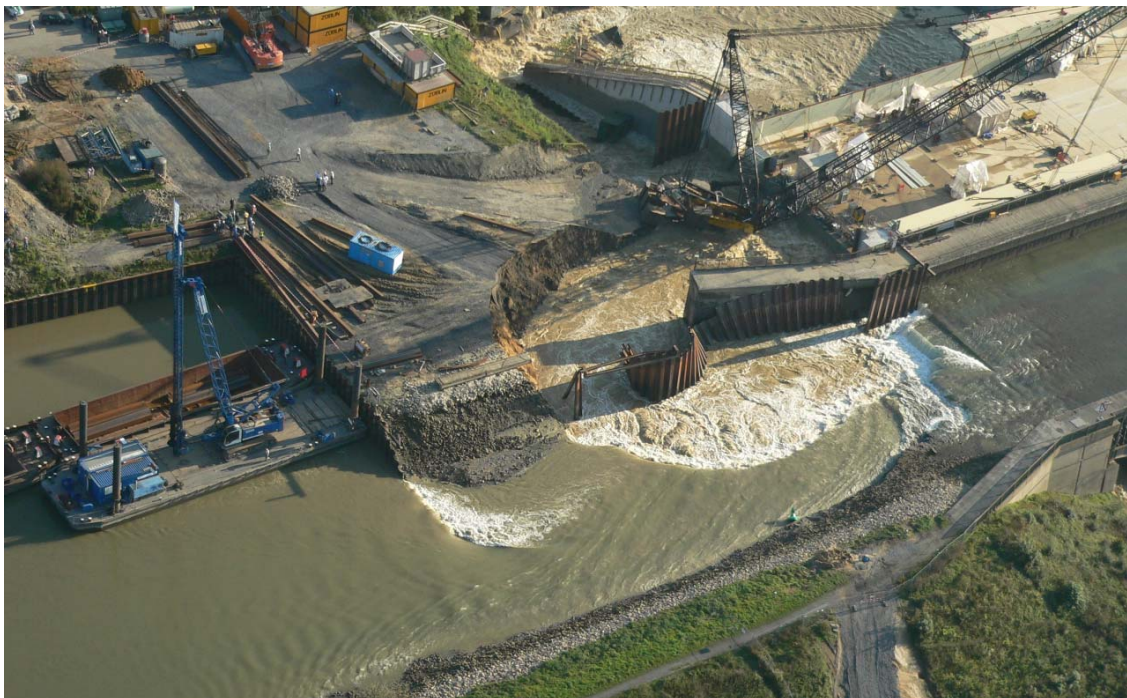
*Fig. 8: Aerial photograph of the failed embankment next to the concerned wing wall*

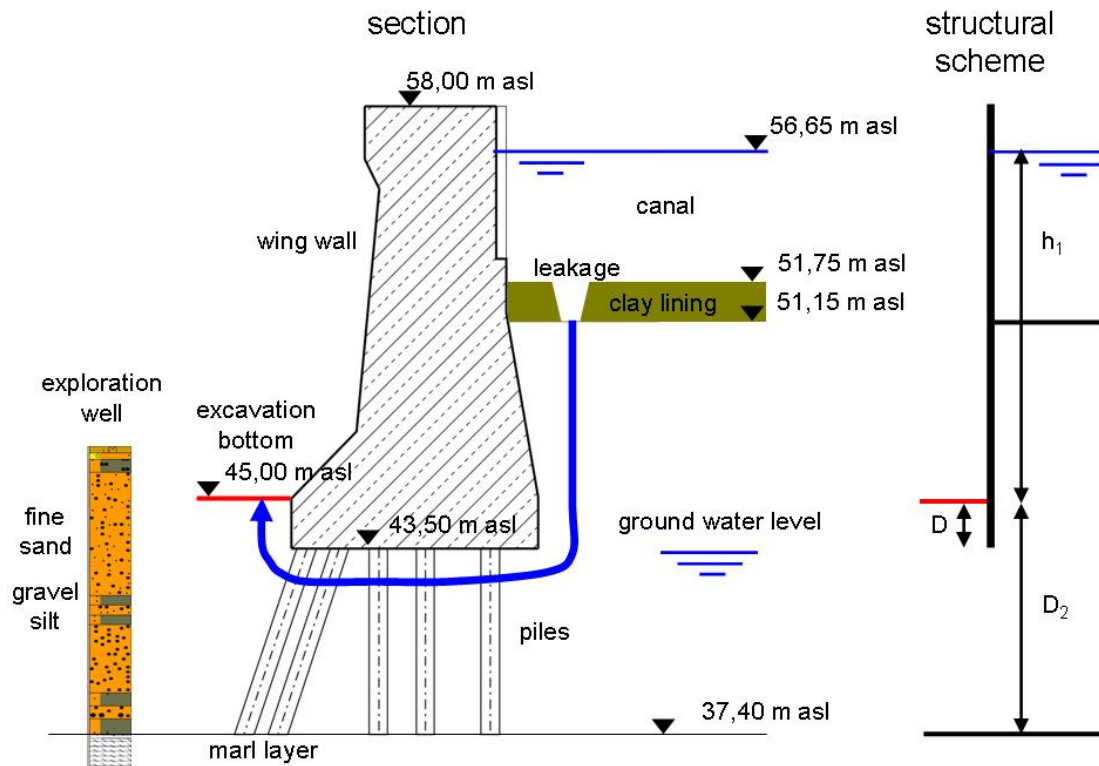
Fig. 10: Cross section of the northeast wing wall and structural scheme

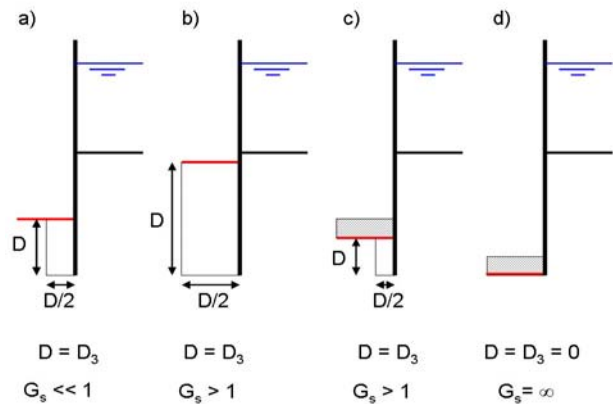
The columns examined are described in Figure 11. The water level on the landward side corresponds to the red line. Assuming that the ground is homogeneous and no surcharge drain is installed, the safety against hydraulic heave would be much smaller than unity in regard to the permitted excavation bottom (Fig. 11a). For sufficient safety, the surface should be much higher (Fig. 11b). However, this was not possible due to the construction progress. Instead, a deeper pit was dug and a surcharge drain applied (Fig. 11c). The surface had to be on the level shown in Figure 11a. The safety was verified with the failure body according to Terzaghi, including the weight on the drain (Fig. 11c). But with a surcharge drain at the bottom of the sheet pile, the calculated safety would be infinite since the excess hydrostatic pressure  $U_e$  is zero (Fig. 11d).

A more realistic result is obtained if, as described in Terzaghi (1947), the balance is considered not only at the wall base but also at other depths  $D_3 \neq D$  (Fig. 9c). Terzaghi writes: "The investigation can be repeated for different horizontal sections through the sand, which are located at different depths  $D_3$  below the bottom of the pit. The critical head is determined by the condition  $h_p = \text{minimum}$ , and the horizontal section to which this minimum refers is the critical section. It represents the lower boundary of the mass of sand subject to lifting in the initial state of the piping phenomenon." However, this was not considered when planning the excavation pit at the canal bridge Lippe and hence a false safety was calculated.

Fig. 11: Different columns reaching down to the lower edge of the sheet pile

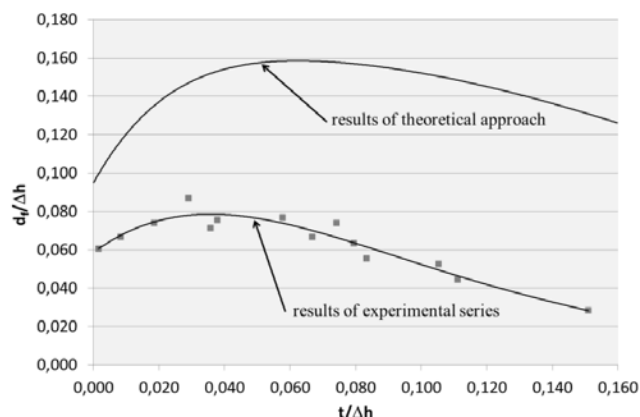
Numerical analyses conducted by BAW show that even if Terzaghi's statements are considered, the necessary thickness of the surcharge drain  $d_f$  becomes less if the leftover soil at the sheet pile bottom is removed. In the diagram (cf. Fig.12),  $\Delta h$  equates  $h_1$  and  $t$  equates  $D$  according to Terzaghi. If  $t/\Delta h$  equates zero, the upper line in the diagram drops after reaching a peak. As this is surprising, BAW ordered experimental tests to be executed at the Bundeswehr University Munich to verify the theoretical results (Schober et. al. 2011). As shown by the lower line in the diagram, the same

effect occurred in the test. The two lines are not identical since the calculation was performed only for the maximum thickness of the surcharge drain  $d_f$  without uniform distribution. Thus Terzaghi's statements were confirmed.

Fig. 12: Results of experimental series as a function of  $d_f/\Delta h$  and  $t/\Delta h$  in: Schober et. al. (2011), Fig. 12
