02 May 2013, 4:00 pm - 6:00 pm

## RECONSTRUCTION OF A DETERIORATING, TIERED, MSE WALL STRUCTURE IN CONNECTICUT

### Paper No. 3.25b

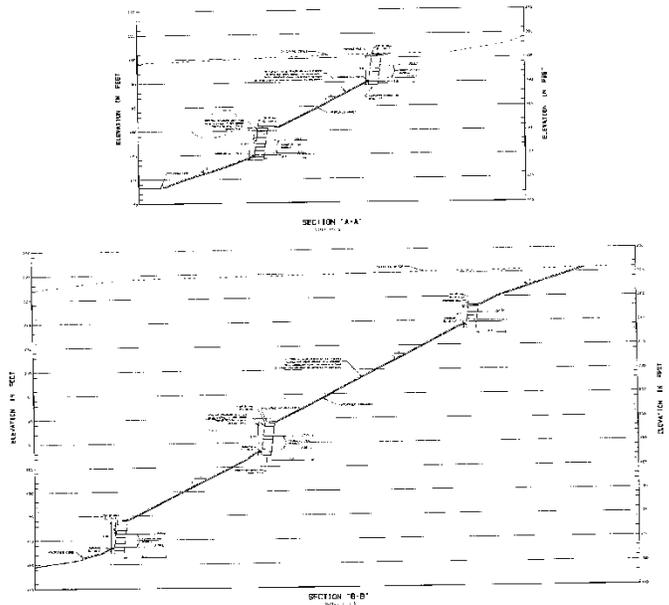
The original cut wall, which was constructed in the early 1990's consisted of a segmental retaining wall ranging from one to three tiers in combination with slopes between tiers; see Figure 2. To provide transitions from the building and perimeter access roadways along three sides of the proposed structure, a single, double and triple tiered MSE wall system in combination with 2H:1V slopes between tiers was utilized. The MSE wall was reinforced with uniaxial geogrid and biaxial geogrids. The uniaxial geogrids were typically equal to the wall height and positioned at spacings of approximately two to three feet vertically. The biaxial geogrids were four feet long and positioned between and above the uniaxial geogrid.

Figure 2 – Original Segmental Retaining Wall Cross-Section

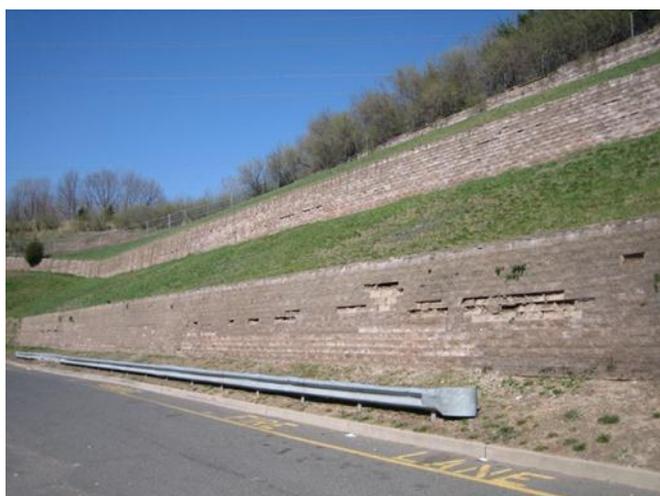
Due to the lack of available information regarding the freeze-thaw effects on the modular block facing at the time of construction, the impact of this behavior was not properly considered in the original design. Consequently, less than 20 years later, freeze-thaw effects deteriorated the majority of the facing to the point where the overall stability of the wall was in question. Specifically, facing block failure was leading to localized raveling of soils and creating erosion zones at the face of the wall. If left unchecked, these areas of erosion would have continued to extend deeper into the slope, compromising the integrity of the MSE structures, and thereby the overall slope.

In 2003, approximately 10-years after completion of installation, significant deterioration of the facing of the modular block system was documented with further deterioration being documented between 2003 and 2007. In 2004, studies were completed to determine the mechanisms of deterioration and potential causes for the significant reduction in design life of the modular block system. The conclusions of these studies indicated that the modular blocks utilized were susceptible to freeze thaw cycles and mitigation would be required in the future. The details regarding the material components, specific manufactured block makeup and causations of the reduced design life are beyond the scope of this paper. In 2007, the level of deterioration of the facing had progressed to a point where the stability of the retained soil and slope would become a concern at some point in the future; see Figure 3. In 2007, a design effort was undertaken to evaluate potential mitigation techniques in combination with continual observation/assessments of the condition of the walls and slopes relative to the need to provide immediate mitigation should a condition develop which would jeopardize the stability of the slope and the operations of the existing facility.

Figure 3: Typical Deteriorated Conditions

Following several iterations of the various design concepts outlined above, discussions with the owner, and pricing exercises with the Contractor, the decision to go with a tiered reconstruction of the existing walls was made. Specifically, a concept which incorporated the construction of new, large-block Stone Strong gravity wall in front of the existing lower and middle-tier walls combined with significant grading improvements over much of the upper slope was chosen. A cross-section of the chosen alternative is shown in Figure 4.

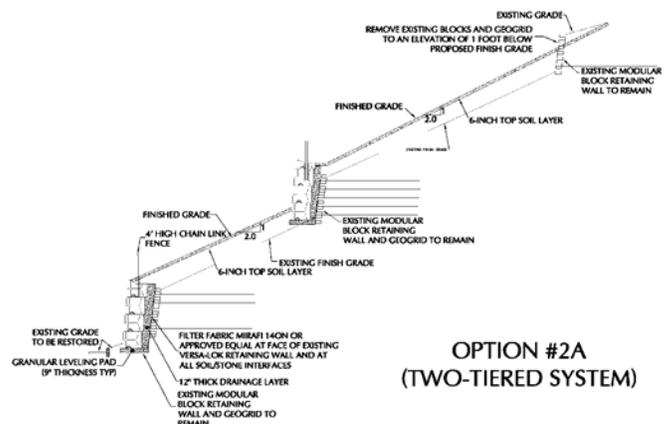
Figure 4: Typical Cross Section of Chosen Alternative

Perhaps the most important consideration, however, of the ultimately chosen design concept was the ability to incorporate the original construction into the final design, while at the same time, not overstressing the existing geogrid which was part of the existing wall. Specifically, just as standards and quality used in creating masonry blocks used in MSE wall construction has improved over the years, the strength, durability, and longevity of geogrid materials also continues to improve year by year. The grid that was used in the original wall construction, when compared to materials available today, was significantly less durable and had a considerably lower allowable tensile strength. As such, significant loading introduced above the existing walls as part of the new construction would most likely overstress the existing grid, leading to a failure in the lower tier of the wall. The chosen approach achieved a balance of minimal new load being introduced as part of the proposed grade modifications with the construction of an overall new retaining system.

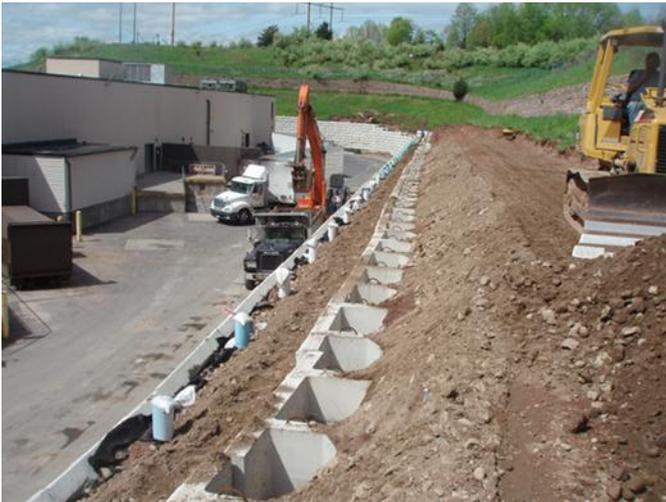
*Figure 5 – Construction of the Temporary Roadway between Wall “A” and Wall “B”*

As construction of the second tier wall restarted in April 2009, the first order of business was to construct a temporary access road in front of the second tier wall to provide access to the Contractor to construct wall “B”. The temporary road construction was started on the slope on the southern portion of the site and proceeded moving north. Grubbing and removing the topsoil from the slope was the first step for the construction of the temporary road. Using a relatively lightweight excavator, the Contractor proceeded to cut into the slope, allowing enough soil to remain in front of the existing second tier wall so its stability would not be jeopardized, while at the same time staying far enough away from the lower wall to avoid imposing excessive temporary surcharge loads. A photo of the temporary roadway construction is shown in Figure 5. Incidentally, this turned out to be one of the most critical aspects of construction-phase design. To verify that the temporary conditions during construction were safe, intermediate slope stability analyses were completed prior to the Contractor proceeding with the temporary roadway/bench.

benches, and to allow the Contractor to complete construction of the temporary road. A combination of excavated soils and imported fill material was then placed in 8 to 12-inch thick lifts and compacted with several passes of a walk-behind vibratory roller to a minimum of 95% of the soils maximum dry unit weight as determined by ASTM D1557. This process continued until the entire temporary access road was completed and the temporary road was wide enough to allow trucks, dozers and other construction equipment to safely operate on it.

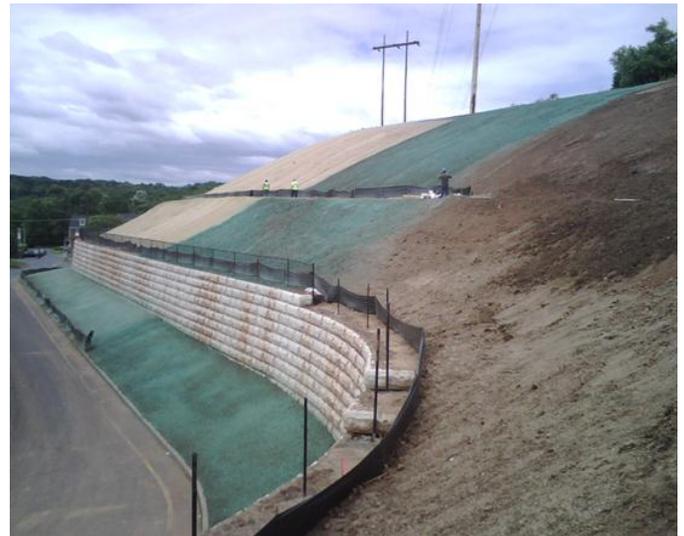
*Figure 6 – Slope Stabilization Methods during Earthwork*

Coincidental to wall “B” construction, the topsoil material on the slope starting in the northern portion of the site was grubbed and removed, and the existing third-tier retaining wall was partially demolished and hauled off-site. The exposed slopes were then regraded, generally to a slope on the order of 2H:1V. The slopes were established through the placement of compacted fill, similar to the criteria used to create the temporary road through the site. The grading work on the slopes then continued moving from north to south across the site. To provide a densified surface and stabilized slope face, the slopes were over-built and then cut back with a dozer, such that the firm, compacted soil slope was exposed at the design grades. Once the proposed grades were established, an erosion control blanket which was designed to facilitate vegetative growth on the face of the slope was then installed;

see Figure 6. Also, as the slopes were being created, a 6-foot wide swale was constructed at approximately the midpoint of the slope to collect stormwater runoff down the face of the slope. Four yard drains were then installed along the alignment of the swale; the drains were then connected to the existing stormwater system on the site.

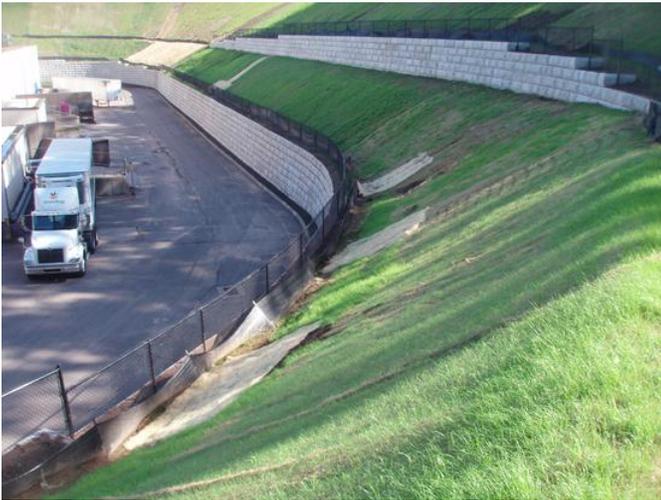
Figure 7 – Post-Construction Conditions

One challenge that was encountered during slope grading activities was that between the months of July and August 2009, several heavy rain storms passed through the Southington area, often in very short periods of time. Due to the fact that no vegetation had grown on the eastern and southern portion of the site at this time; the heavy rain storms had eroded several areas along the slopes. Luckily, access to these areas was still viable along the temporary roadway, and the Contractor proceeded to remediate these eroded areas using the on-site fill material. Hydroseeding and erosion blankets were then re-installed in the remediated areas. Construction of the retaining walls and slopes was completed in mid-August, 2009; see Figure 7.
