HIGH-RISK FLOOD CONTROL DAMS ON DIFFICULT SOIL FOUNDATIONS

Gary S. Chow, P.E.
 U.S. Army Corps of Engineers
 Galveston, Texas, U.S.A.

Addicks and Barker Dams are two flood risk management structures owned and operated by the U.S. Army Corps of Engineers (USACE) and recently classified as extremely high risk. These dams were built in the 1940's in west Houston, Texas, upstream of a densely populated metropolitan area. The dams consist of 11 and 13 miles of rolled earth embankments, outlet structures with five barrel conduits, and uncontrolled spillways at both ends of both dams. The original design of both dams provided for four of the five outlet conduit barrels to be ungated, permitting a combined uncontrolled discharge from both dams of 15,700 cubic feet per second into Buffalo Bayou. Due to urban development throughout the 1940s and 50s, all conduit barrels of both dams were gated by 1963 to allow restricted discharge flows into Buffalo Bayou during normal operating conditions.

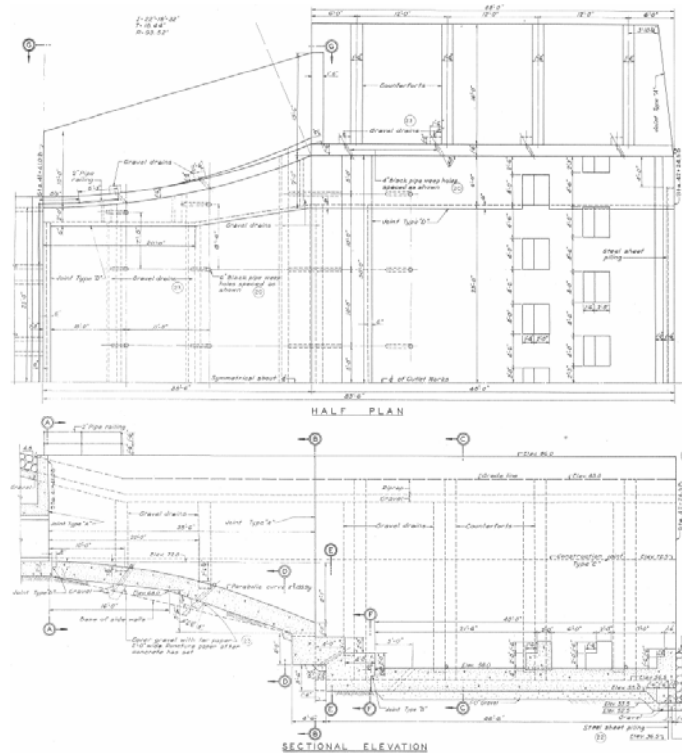
Figure 10 - Addicks Dam Spillway and Stilling Basin Slabs

Spillway Cavity Repair, Addicks Dam. In 1968 a large cavity was discovered under the southeast cantilever wall base and the parabolic spillway slab. The cavity was assumed to have

been caused by flow into upper weep holes, expansion joints, and cracks. The foundation material was apparently washed out through weep holes at the base of the spillway slab due to the lack of a properly installed filter preventing the foundation materials from exiting the structure. Investigations revealed that the cavity was extended under about two-thirds of the spillway slab and had a maximum depth of about 10 feet. Samples obtained from the bottom of the cavity through the weep holes revealed that the soils under the spillway slab range from sandy clay to silty sand with some sandy silt and clayey silt. Observations during these investigations revealed that the silty and sandy silt were readily transported by the flowing water and that the clay was being eroded by the flow of water. Figure 10 shows the spillway and stilling basin slabs of the original installation for Addicks dam. Expansion joint material between the spillway slab and cantilevered walls was replaced and the small crack in the toe of the east cantilevered wall was repaired. Figure 11 presents the typical arrangement of the expansion joints between the spillway slab and wall. Well screens were placed in the lower weep holes, and filter sand was flushed through the upper weep holes and some intermediate holes that had been drilled for the repair. After placement of the filter sand, the intermediate holes were plugged and relief valves were inserted into the upper weep holes.

Additional Repairs to the Cantilever Wall, Addicks Dam. In 1973, the measures taken in 1968 to repair the crack in the toe of the east spillway wall were discovered to be ineffective. Foundation material beneath the spillway wall and the spillway slab was still being lost through the crack. Approximately 10 cubic feet of spalled concrete was removed from the cracked area. The existing reinforcing steel was cleaned, then Dow Earthfoam (joint filler) and sealant were used at the vertical and horizontal expansion joints. An epoxy binder was applied to the cleaned concrete surface prior to placing the replacement concrete. The eroded filter sand was replaced.

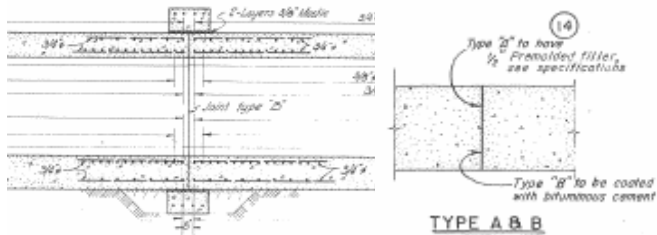
Figure 15 - Typical Conduit Joints For Addicks Dam

Additional Repairs to Outlet Works, Addicks Dam. Figure 15 shows how the conduit joints were constructed at Addicks dam. Inspections of the joints indicated that the filler or coatings between the joints have deteriorated. Repairs to the outlet works in 1979 consisted of sealing conduit joints. Repair works also included screening existing weep holes,

adding weep holes in the stilling basin slab, adding relief wells, and backfilling beneath the spillway slab. Additional sealing, inspection and repair to relief wells, and additional replacement of filter sand, and repair of spalled concrete areas were completed in 1989.

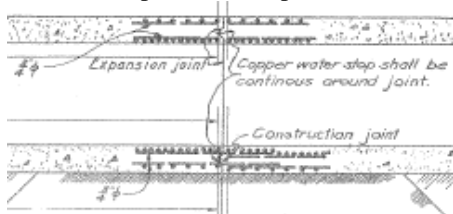
Figure 16 - Typical Conduit Joints for Barker Dam

Repairs to Outlet Works, Barker Dam. Figure 16 shows the typical conduit joints at the Barker dam. Inspections of the joints also indicated repairs were required. Repairs to the outlet works in 1982 consisted of sealing conduit joints and installing additional weep holes and screens in the stilling basin slab. In 1989, additional repairs included sealing joints, inspection and repair of relief wells, repair of spalled concrete areas, and repair of stone protection.

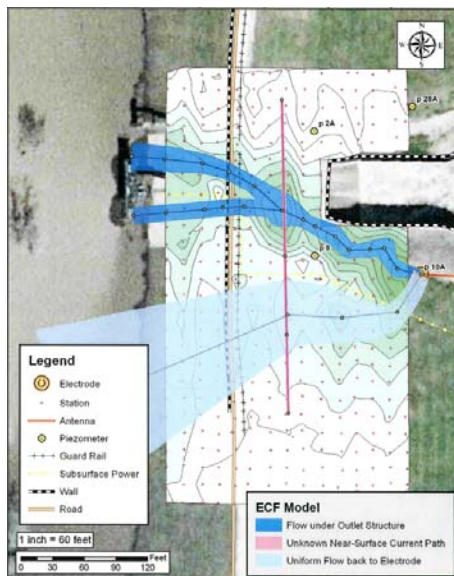
Figure 20 - Electric Current Flow Model, Barker Dam

Electric Potential Survey. In September 2008, a geophysical investigation using electric potential technology was conducted to study the seepage flow potential at the outlet works of both dams. The investigation concluded that seepage was believed to be flowing beneath the outfall conduits at Barker Dam. Figure 20 presents the results of this investigation at Barker Dam. The investigation also indicated that there was more mass flow and not a significant preferential seepage flow paths identified at the outfall of Addicks Dam.

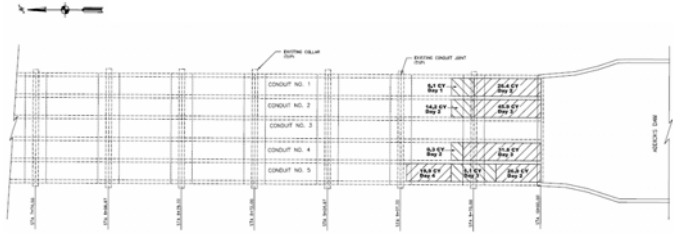
Figure 21- Polyurethane Material Grout Volume, Addicks

Phase I Polyurethane Grouting. In May 2009, a near record high pool occurred at Addicks and Barker Dams. Due to the suspect of voids beneath the conduits of the outlet works from previously investigations, an urgent and compelling contract was executed to fill voids beneath the conduits. Because of the high pool and the anticipated seepage flows, it was believed that cement grout would not be effective. With this in mind, a hydro-insensitive polyurethane material was recommended

for the grouting. Figures 21 and 22 show the grout volume fill recorded during the operations at both dams.

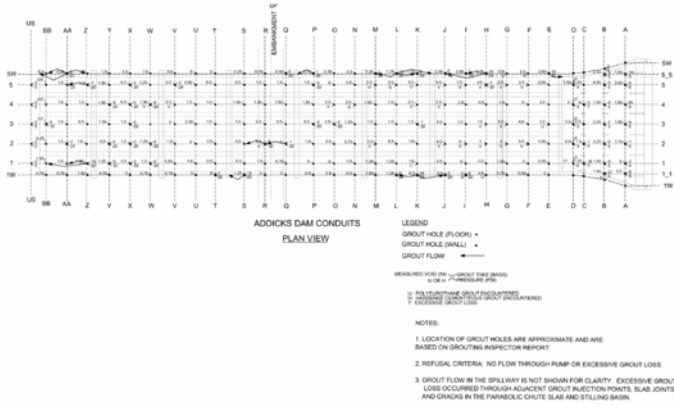
Figure 23 - Phase II Cement Grout Records, Addicks Dam

Phase II Voids Filling. Following the baseline risk assessment, USACE decided to follow up the polyurethane grouting with Phase II cement grouting to ensure all voids were effectively filled. In March 2010, Phase II cement grouting was initiated to fill all voids that might not have been filled during Phase I as well as additional voids that had been created since May 2009. Grout holes were drilled in the floor of the conduits the spillway and stilling basin as well as the outer walls of structure. Prior to initiation of grouting operations, the holes were probed to try and ascertain the depth of void beneath/behind the concrete. Voids were detected beneath the conduits, the spillway and the stilling basin. Figures 23 and 24 show the measured voids and the grout take volume beneath the structure during the Phase II grouting operations.

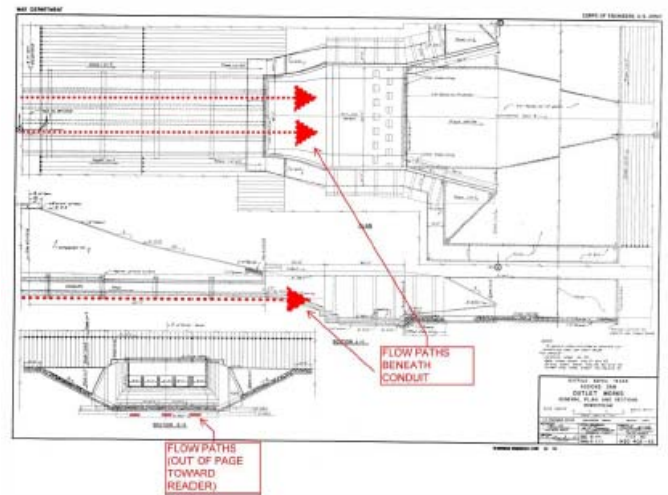
Figure 25 – Plan and Profile View of PFM 1

PFM 1 – Seepage flow along or beneath outlet works structure due to low stress areas leads to headcut erosion beneath outlet works structure. This failure mode is known to be credible because of the voids were discovered beneath the structures in 2009 and 2019 for both Addicks and Barker Dams.

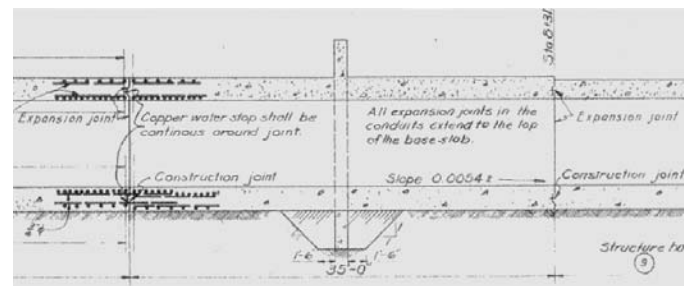
Figure 26 – Typical Conduit Joint Plan at Barker Dam

PFM 21 – Hydraulic pressure in the conduit exceeds pressure outside the conduit which leads to seepage through conduits joints and erosion along conduits. This PFM is credible because of the lack of effective waterstops in the joints on the conduits at both dams.

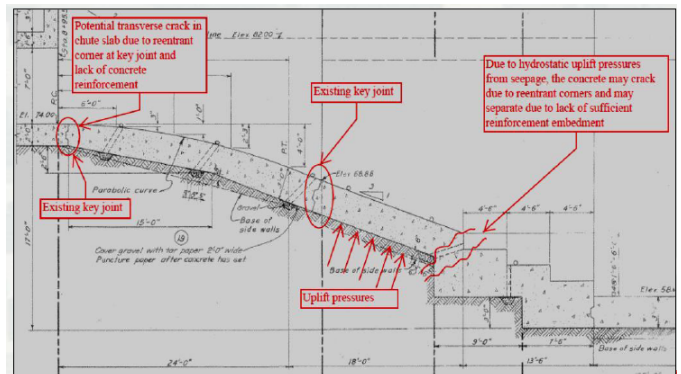
Figure 27 – Potential Uplift Pressure on Parabolic Chute Slab

PFM 22/23 – Instability of the outlet works parabolic slab and stilling basin training walls due to uplift caused by excessive seepage and/or high tailwater. The uplift relief drains that were beneath the spillway and stilling basin were grouted during the 2010 Phase II grouting efforts. These drains were reestablished as point drains, but the relief is only provided at the location of the drain.

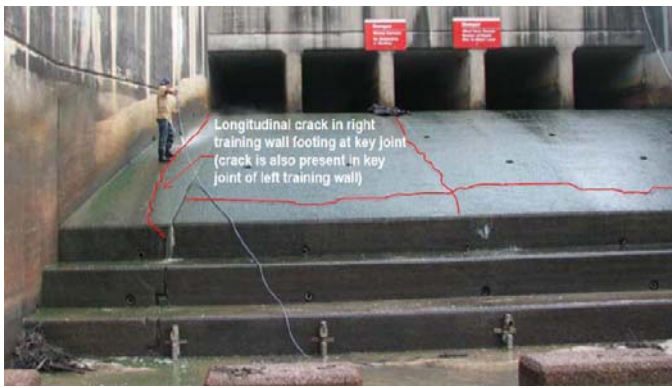
Figure 28 – Addicks Dam Parabolic Chute Slab with Existing Longitudinal and Transverse Cracks

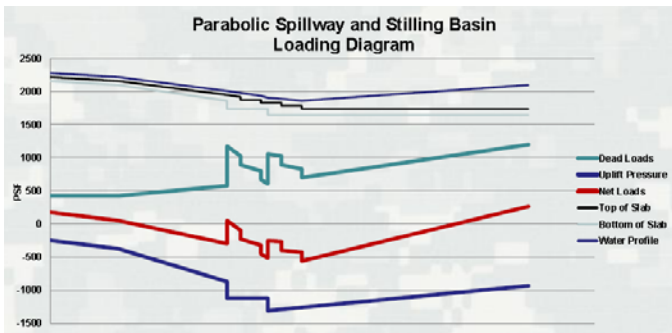
Figure 29 – PFM 22/23 Uplift Pressure Causing Instability to Outlet Parabolic Slab and Stilling Basin Training Walls
