Landslide Stabilization Along The Ohio River Using Cantilevered Stub Piers

LANDSLIDE STABILIZATION ALONG THE OHIO RIVER USING CANTILEVERED STUB PIERS

Paper No. 3.34a

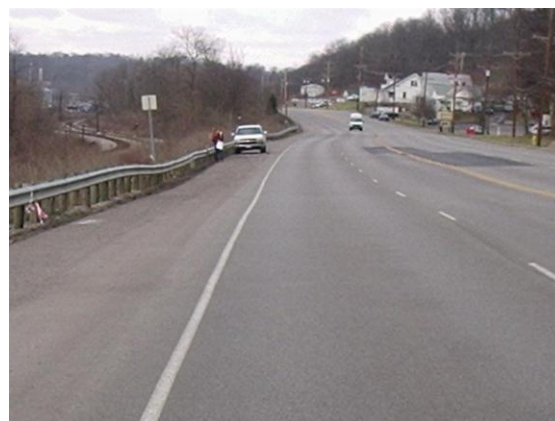
Fig. 1: Pre-repair road distress (2005).

After only a few weeks of monitoring, the inclinometer casings sheared off about 50 feet below grade, near the soil /

bedrock interface (see Figure 1). Soon after, the roadway distress worsened, causing ODOT to close 3 of the 4 lanes to

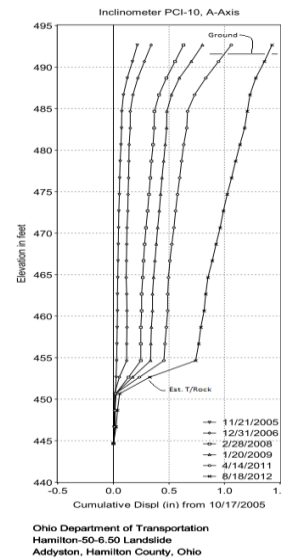
Fig. 14: Inclinometer located downslope of the stub pier.

Figure 14 shows an inclinometer located just downslope of the Stub Pier referenced in Figure 12. As shown, creep movements along the original soil/bedrock shear plane have

continued since construction, but at a much lesser degree than pre-repair landslide conditions.

Results are similar for the two inclinometers installed just downslope of the Stub Piers. Movements at the soil/bedrock shear plane range from about ¼ to ½-inch, but have shown continuing creep since the 2005 repair.
