RECONSTRUCTION OF ROAD EMBANKMENT FAILURE USING REINFORCED GEOGRID: REVISITING THE SITE AFTER 15 YEARS

A case history of repair works of road embankment failure at KM39, Route 68, Kuala Lumpur – Bentong Road in the state of Selangor, Malaysia and an observation on the condition of the site after 15 years and some tensile strength testing carried out on buried and exposed geogrid was presented in this paper. Due to heavy rainfall in 1995, about half of the road embankment which was located at the alluvial fan of an upslope stream valley was washout. For the reconstruction of the alignment, the existing half of the alignment was converted into a buffer zone with a row of gabion as a barrier to trap any fallen debris from the upslope stream valley. A geogrid reinforced embankment was constructed to provide an additional area for the new alignment of the road.

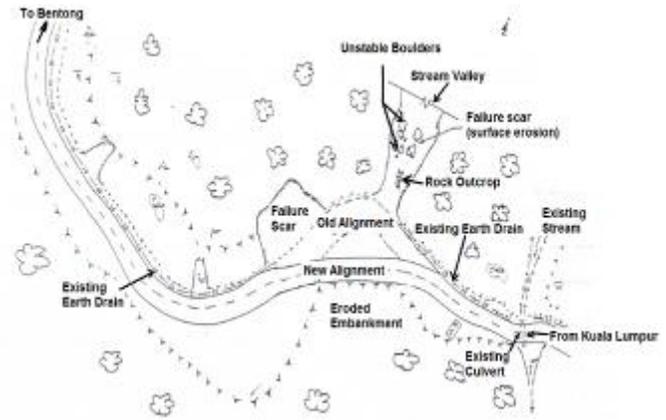
Scouring of down slope embankment was due to seepage and surface flow from upslope. Seepage flow underneath the road embankment resulted blow out of piping of road embankment materials. This initiated the scouring of the embankment surface. Flow of surface runoff over the road downwards, causing further scouring of the down slope embankment surface (RAS, 1996).

Fig. 3. Sketches of failure area

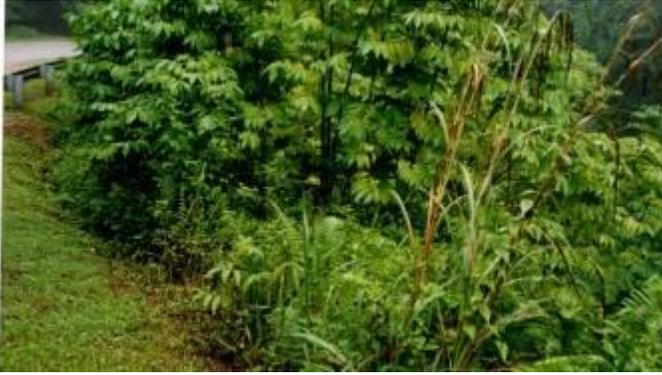
Figure 13, 14 and 15 is a series of photo taken on various times shows progress of vegetation growth on the slope surface. Within four years construction completed, fast growing vegetation covers transformed the constructed slope surface into thick bushes as shown in Fig. 15.

There is no evidence of any crack or settlement on the road surface or at the top of the geogrid embankment on the last visit to the site in 2001.

Fig. 15. Photo taken in 2001

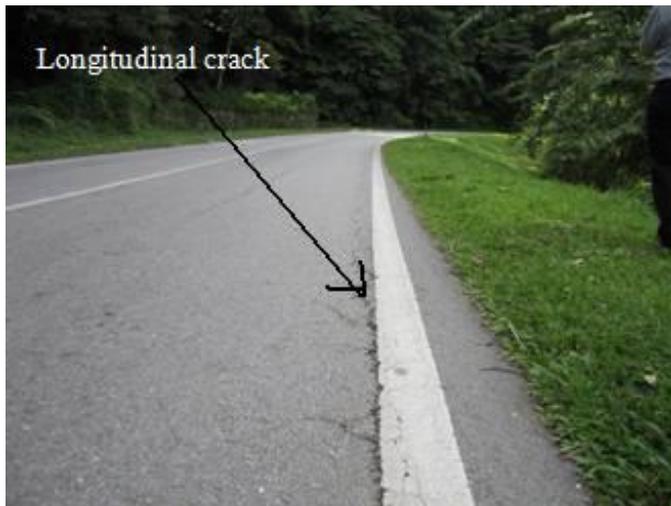
Fig. 16. Longitudinal crack was observed parallel to the edge line of the road

There is single longitudinal crack observed parallel to the edge line of the road on the reconstructed side of the embankment (Fig. 16). The crack is relatively small and if the time after construction was considered (15 years), it was acceptable. The crack is minor and maybe just shallow crack on the road pavement only.

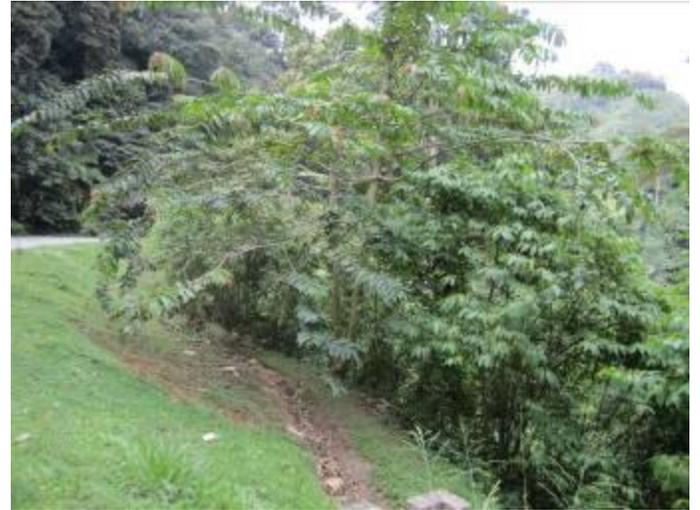
After 15 years, the vegetation or bushes covering the slope surface are more mature as shown in Fig. 17 compared to condition 11 years before as shown in the photo in Fig. 15

Fig. 17. Photo taken on September 11, 2012 shows the site was covered with thick vegetation

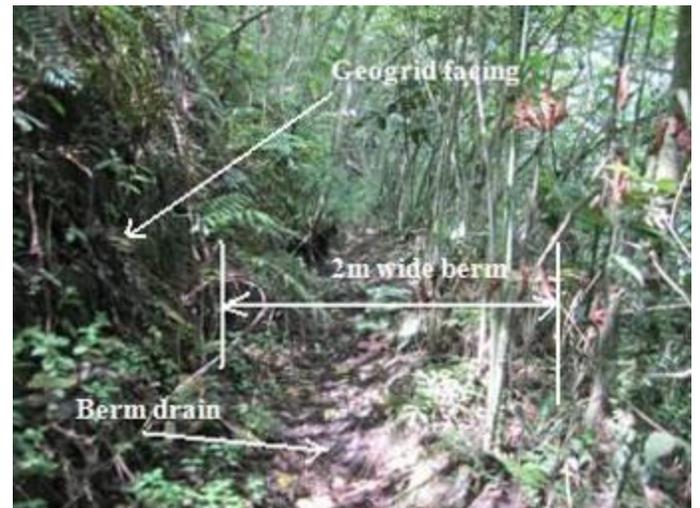
Fig.18. Photo at first berm taken on September 11, 2012 shows the site was covered with thick vegetation

Down to the first berm from top (Fig. 18), the slope surface was covered by 3 to 5m thick bushes. The berm drain was intact, still functioning with no sign of cracking along the berm. Layers of full layer thickness (500mm) of geogrid facing were intact, covered by thin layer of fern and shrubs (Fig. 19). The layers of sandbags used as geogrid facing or temporary formwork during construction were also intact, in the original form as shown in Fig. 20. As usual, due to wet or moist condition at the floor of most tropical forest, especially at hilly area, the geogrid lines were become a medium of algae growth.

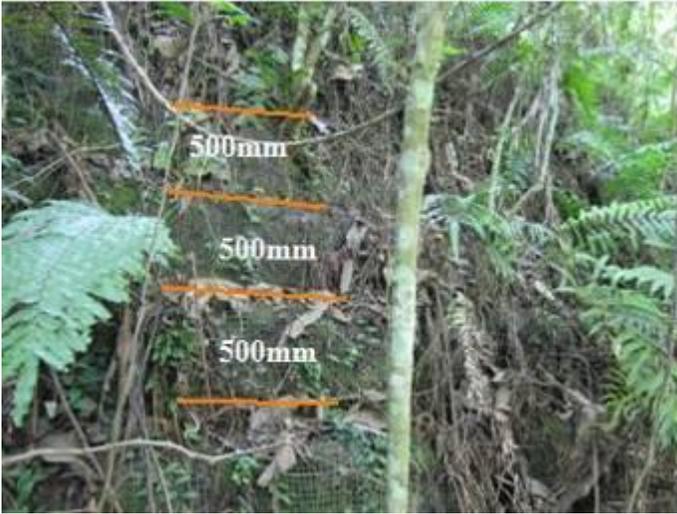
Fig.19. Photo taken on September 11, 2012 shows layers of full layer thickness (500mm) of geogrid facing

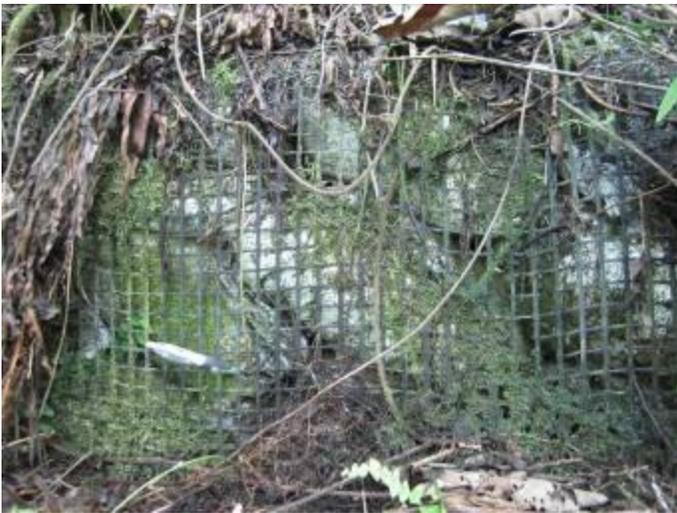
Fig. 20. Photo taken on September 11, 2012 shows geogrid facing clearly intact 15 years after it was constructed

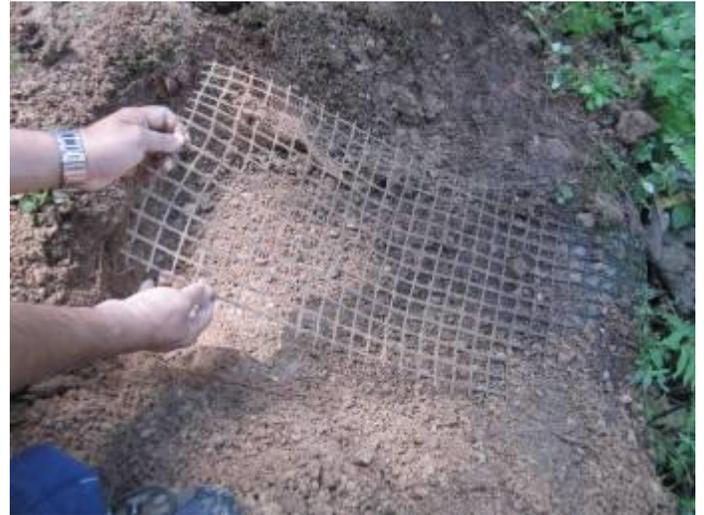
Fig.21. Sampling of buried geogrid from top layer of geogrid embankment

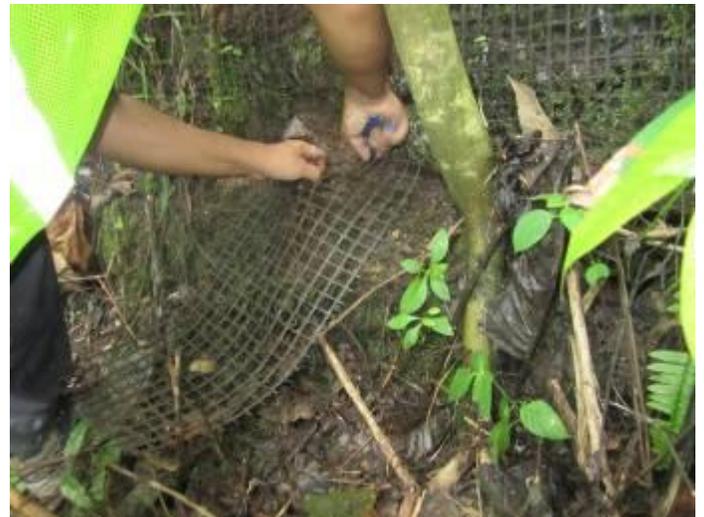
Fig. 22. Sampling of exposed geogrid from the facing
