## Backanalysis of Deformations for Case Histories Involving Flow-Type Failures

John P. Sully  
*GEOHIDRA, C.A., Venezuela*

Paper No. 6.14

**SYNOPSIS:** The results obtained from backanalyses of two case histories of failures of small earth dams resulting from liquefaction of foundation soils are presented. The analyses have been performed in order to evaluate the deformation parameters used in a finite difference model (developed by Woodward-Clyde Associates), specifically those relevant to the liquefied soil layer. For both case histories, the final deformed shape of the earth dam is known and serves as a basis for comparing the results from the numerical study, in terms of the deformation moduli employed.

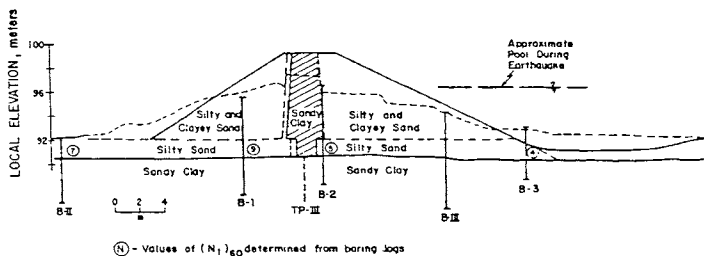
Fig. 1 Cross-section of La Marquesa (De Alba et al. 1986)

As a result of the 1985 (03/03/85) earthquake, both upstream and downstream sliding occurred, the largest movements being recorded on the upstream side. A 2 m loss of freeboard occurred in the central area of the dam. Extensive longitudinal cracking was visible in the upstream slope after the reservoir level had been drawn down. Crack widths up to 0.8 m were measured with crack depths achieving 2.0 m. Horizontal displacements of about 11 m at the toe of the upstream slope and 6.5 m at the downstream toe were measured. De Alba et al. (1986) argued that the level and pattern of deformation experienced by the dam slopes were indicative that the principal mode of failure was that associated with liquefaction of the granular soils in the dam foundation. Details of the initial and failed cross-sections are given in Fig. 1.

Subsequent boreholes B1 and B2 (Fig. 1) and SPT testing (energy calibrations using a Binary Instruments 102 SPT Calibrator) gave  $(N_1)_{60}$  values of 4 for the upstream foundation and 9 for the downstream foundation below the dam. The respective fines contents at these two locations were 30% and 20%, giving fines-content corrected  $(N_1)_{60}$  values of 6 and 11.

Based on a series of backanalyses for the failed upstream and downstream sections, De Alba et al. (1986) evaluated a range of yield accelerations and residual strengths for the liquefied material. Yield accelerations varied from 0.012 g (upstream) to 0.03 g (downstream) and the backcalculated residual strength values were in the range 76 to 340 psf (3.6 to 16.3 kPa) for the upstream area and 266 to 580 psf (12.7 to 27.8 kPa) for the downstream foundation. (It is interesting to note that these values would correspond to a  $S_r/\sigma_v'$  ratio varying from approximately 0.09 to 0.18).

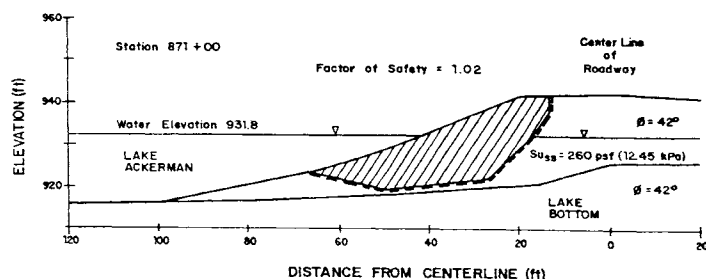
Fig. 2 Geometry for Lake Ackerman failure (Hryciw et al. 1990)

loose hydraulic fill as deep as 3.7 m. Above lake level, the fill was moderately compacted. On July 24, 1987, a six-truck crew were performing seismic reflection studies on the Lake Ackerman fill when a 91 m long section of the embankment failed as a result of liquefaction of the loose hydraulic fill described earlier. The signal generation technique was estimated to have induced a cyclic stress ratio of 0.12 in a material having corrected SPT  $(N_1)_{60}$  values of between 1 and 4. Residual strength upper and lower bound estimates ranged from 8.1 to 12.4 kPa, corresponding to approximate strength ratios of 0.19 to 0.30.

No detailed information on the magnitude of the deformation of the embankment/slope is given in the paper. However, from Fig. 8 of the paper by Hryciw et al. (1990), at Station 871 + 00 the deformed embankment can be seen to have suffered a vertical displacement of about 10 ft (3.05 m) below the crest and is, on average, just above lake level. Lateral displacements are much more difficult to estimate from the information provided, but are roughly of the order of 40 to 50 ft (12 to 15 m).

The slope geometry at Station 871 + 00 is shown in Fig. 2 and the schematic failure profile in Fig. 3. This section was chosen for performing the deformation backanalysis.

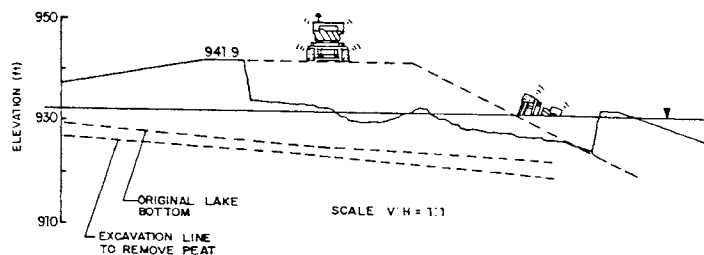
Fig. 3 Failed cross-section at Lake Ackerman (Hryciw et al. 1990)

The deformations in the area of the slope crest were compared with the values estimated from Fig. 8 of the paper by Hryciw et al. (1990) (Fig. 3 in this report). In terms of vertical movements, a range of values between 1.6 m and 2.0 m was obtained, while the horizontal displacements ranged between 2.6 m and 3.4 m. However, as indicated in Fig. 5, the deformations do not represent the profile shown in Fig. 3. Furthermore, even varying the values of the modulus parameters outside the range given above it was not possible to obtain a good representation of the field measured response. In an attempt to consider all possible factors, it was decided to consider the static loading imposed by the presence of the trucks performing the seismic refraction survey. A static distributed surface pressure of  $8 t/m^2$  over a 2.5 m width (to represent a 20 t truck) was considered at the top of the slope.

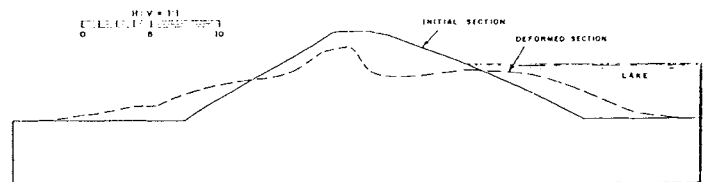
Fig. 4 Results of deformation analyses for La Marquesa dam

reflect possible upper and lower limit estimates for the post-seismic deformations, should the foundation soils liquefy as a result of ground shaking. The residual strength of the liquefied layer is also important in terms of controlling the mode of deformation. For these analyses, a residual strength of  $1 t/m^2$  was used for all the liquefied layers. This value is within the range determined by De Alba et al. (1986) based on stability calculations. The deformations at several locations on the dam are presented in Table 1. As can be seen the variation of the modulus number from 0.76 to 48 does not have a major effect on the final displacements. The general deformation pattern for the dam is shown in Fig. 4 where it can be seen to be in good agreement with the measured deformed section shown in Fig. 1.

Location on dam	$(\delta_v)_{max}$ (m)	$(\delta_h)_{max}$ (m)
D/S toe	1.0 to 1.3	2.3 to 2.7
D/S crest	1.5 to 1.7	2.4 to 2.7
U/S crest	0.6 to 1.1	3.2 to 3.7
U/S toe	0.4 to 0.7	3.2 to 3.7

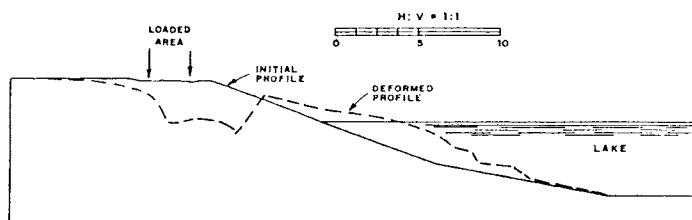
Fig. 6 Deformation pattern considering surface distributed pressure

The results from the deformation analyses considering the presence of the surface distributed pressure are shown in Fig. 6. As can be seen, the results are more representative of the deformed profile measured in the field after the failure due to liquefaction. For this analysis, the calculated vertical deformations in the area of the surface load were in the range 2.7 m to 3.6 m while predicted horizontal deformations were in the range 3.6 m to 4.7 m. These values are in better agreement with the field measured values.
