Behavior and Damage of Dams Under the 1993 Big Earthquakes in Japan

Behavior and Damage of Dams Under the 1993 Big Earthquakes in Japan Paper No. 6.23

SYNOPSIS By analyses of the acceleration records at dams during the two big earthquakes which hit in Hokkaido of Japan in 1993, the maximum acceleration at damsite rock, the maximum acceleration amplification ratios at crest and the natural periods of dam bodies were evaluated and were compared the results with empirical equations. Damage to the dams was described, and the mechanism of the deformations was examined.

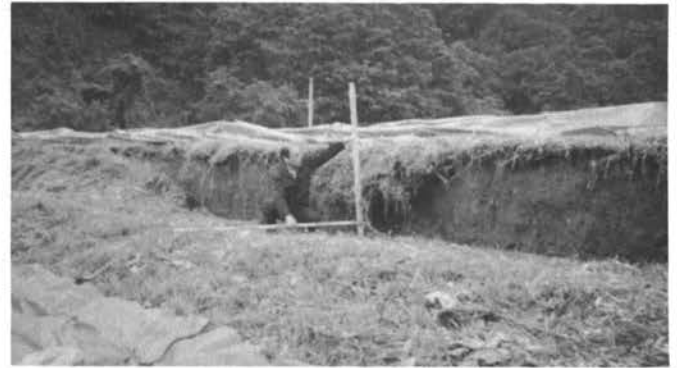
Fig. 6 Settlement of the Upstream Side Body of Niwa-Ikumine Dam

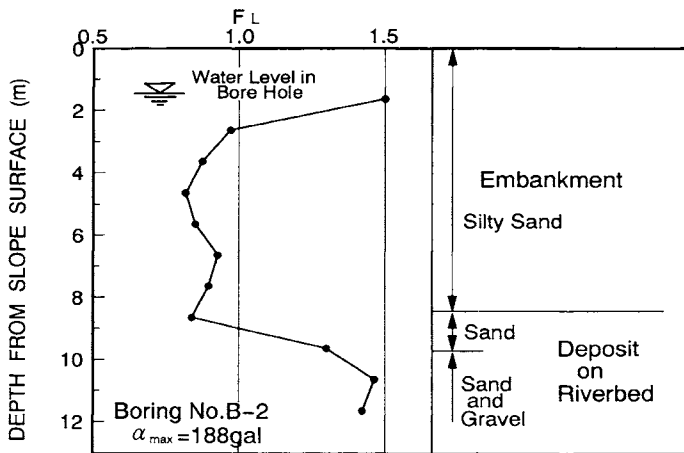
Fig. 9 Liquefaction Resistant Factor at Niwa-Ikumine Dam

reduction coefficient along depth, g is the gravitational acceleration, and α_{max} is the horizontal maximum acceleration, as which we used the value of 188 *gals* from the equation (1). Figure 9 shows the depth distribution of FL in the drilling hole of the upstream side of the dam. The values of FL at the embankment and the upper riverbed deposit are smaller than unity, hence the embankment apparently liquefied and the liquefaction caused the upstream dam body to settle. This liquefaction occurred for two reasons; one is the fact that the dam embankment was badly compacted on the loose riverbed deposit, and the second is that the embankment between the two cores without drainage was saturated.
