Bank Instability Problems Associated With the Riverside Construction

BANK INSTABILITY PROBLEMS ASSOCIATED WITH THE RIVERSIDE CONSTRUCTION

ABSTRACT

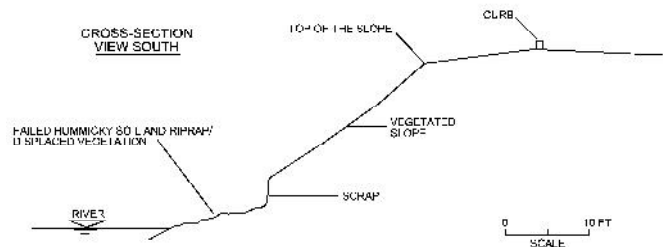
- Upper vegetated unfailed slope
 - Below (west of) roadway
 - Approximate inclination: 40 to 46°
- Immediate steep slope face (scarp)
 - Approximate inclination: 78 to 90°
 - Typical height: 4 to 7 ft
- Lower flatter slope made up of failed soil and displaced vegetation
 - Approximate inclination: 10 to 33°
 - Typical land width: 5 to 17 ft (east-west)
 - Typical land height: 2 to 9 ft

Fig. 5. Typical cross-section of failed slopes east of riverside drive in project location

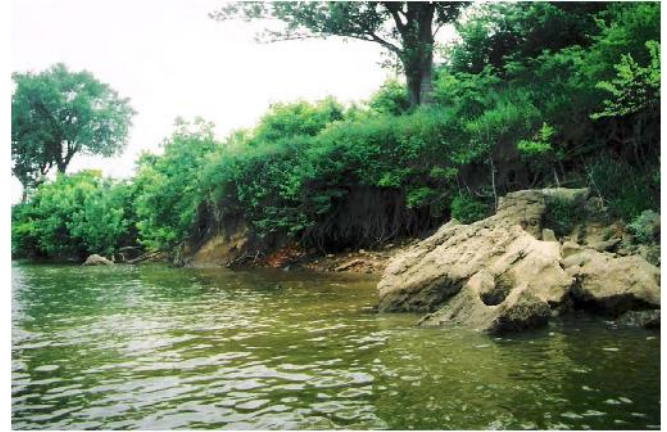
LOCATION: 770 FT SOUTH OF PIPELINE (VIEW NORTH)

At some locations, overhangs have developed along the tops of the immediate slopes as a result of bank failure/erosion and the presence of a thick root mat (see Fig. 7). It is important to

Fig. 7. Overhangs above failed slopes related to bank instability and root mat
