BANK INSTABILITY PROBLEMS ASSOCIATED WITH THE RIVERSIDE CONSTRUCTION

Gennaro G. Marino, Ph.D., P.E.
Marino Engineering Associates, Inc.
Urbana, IL-USA 61801

Abdolreza Osouli, Ph.D.
Southern Illinois University Edwardsville
Edwardsville, IL-USA 62026

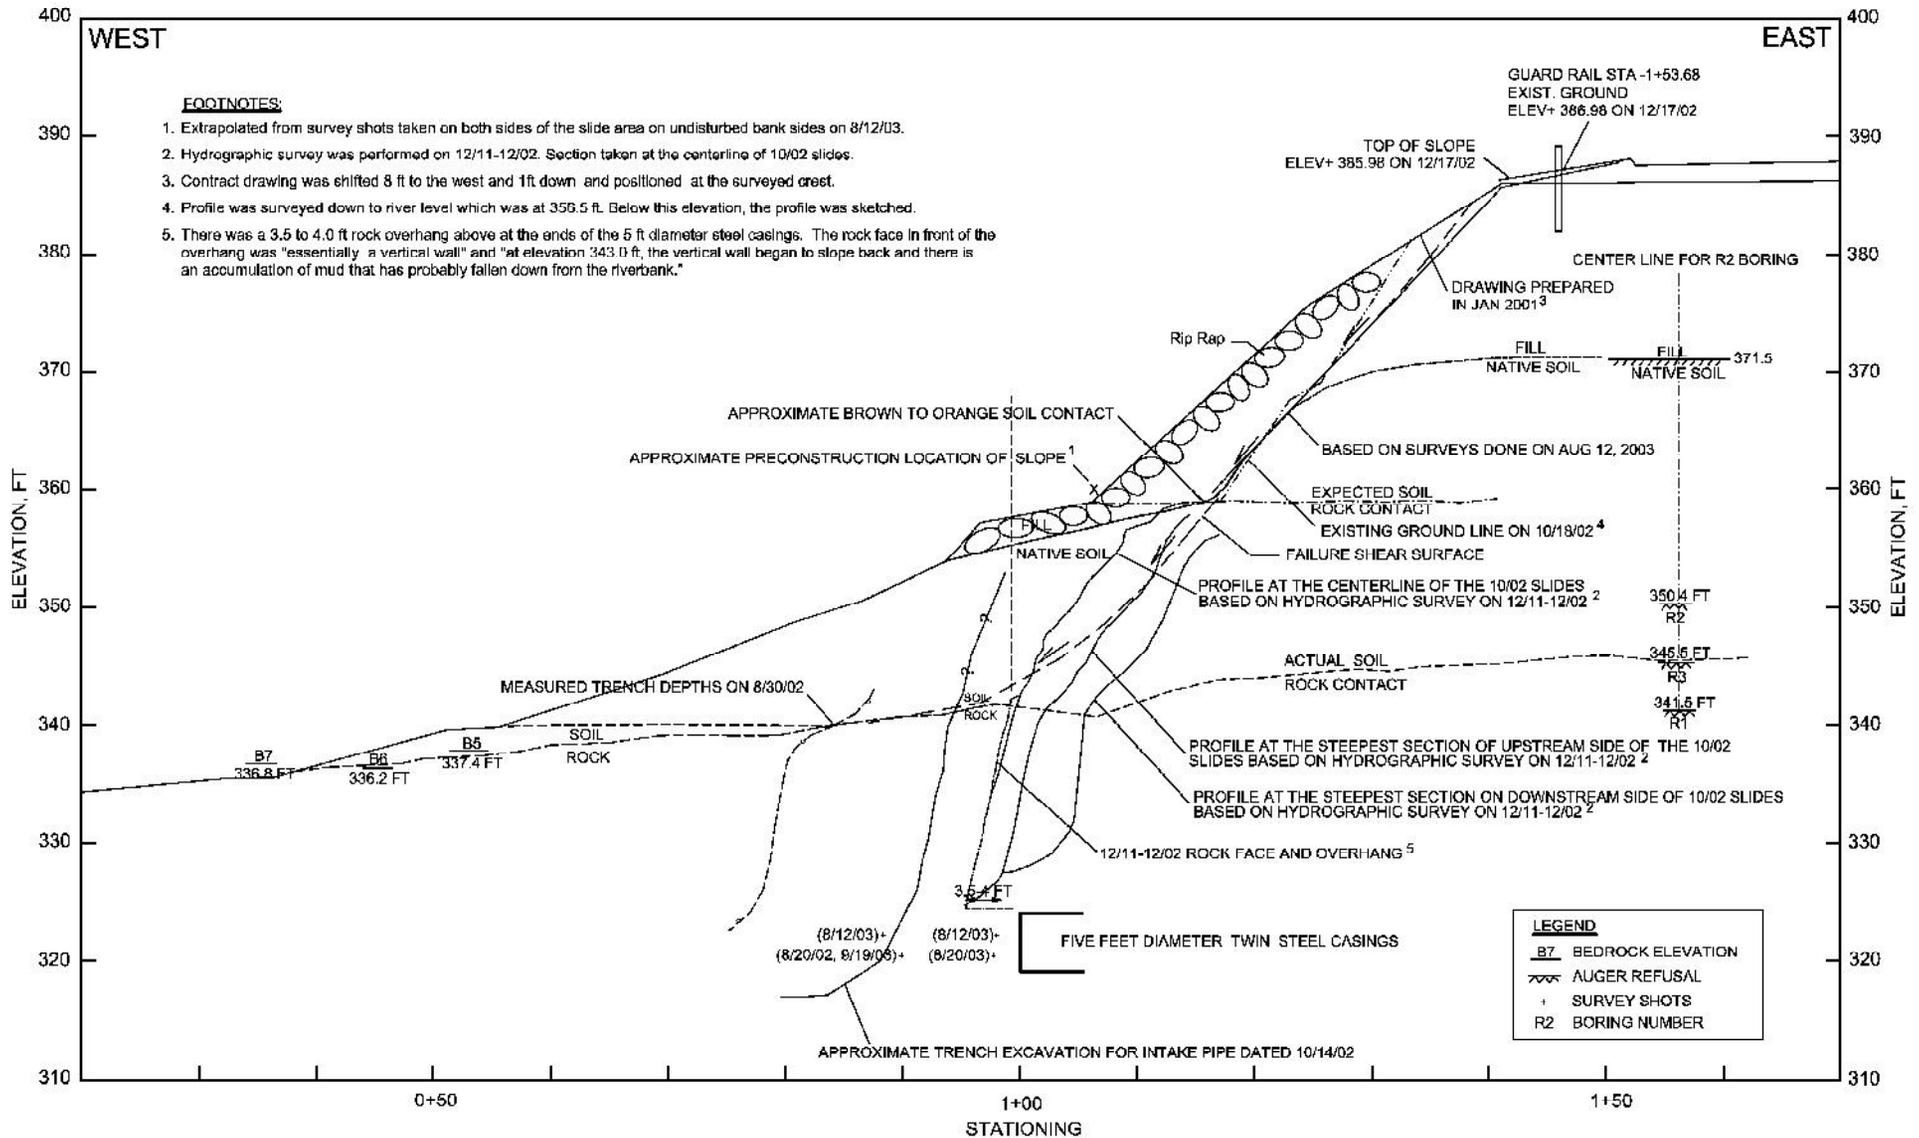
Fig. 2. Topographic profiles with ground conditions along the river bank during trench excavation

Figure 2 shows the subaqueous trench excavation limits as the work approached the riverbank. Available slope surveys performed above the water are on October 18, 2002 after the October 10-11, 2002 sliding and on August 12, 2003 after the February 20, 2003 adjacent downstream slide; thus these profiles approximate the sliding surface.

Also, superimposed on Fig. 2 is data from surveys performed on December 11-12, 2002. The profiles which were taken from the survey are located at the approximate centerline of the October, 2002 sliding and the greatest undercuts on the upstream and downstream sides.

The ground condition information presented on Fig. 2 consists of the approximate fill/native soil and soil/rock contacts. The soil/rock interface was determined from the “B” and “R” borings, and is consistent with the sliding surface contour map, project photographs, and field mapping.

As can be seen in Fig. 2, the soil portion of the slope was undercut as the trench excavation preceded towards the bank. On October 10, 2002 the approximate location of the cut was at about Station 0+95. The “clamming” which was done by the contractor on this same day resulted in the nearly 12 ft soil undercut closer to the bank. Clearly this undercutting resulted in the bank instability as the sliding commenced later that same day. Based on the above data, a more representative depiction of the slide configuration is shown on Fig. 2. Consequently, the unstable slope condition resulted in the February 2003 embankment failure triggered by the rapid drawdown of the river.

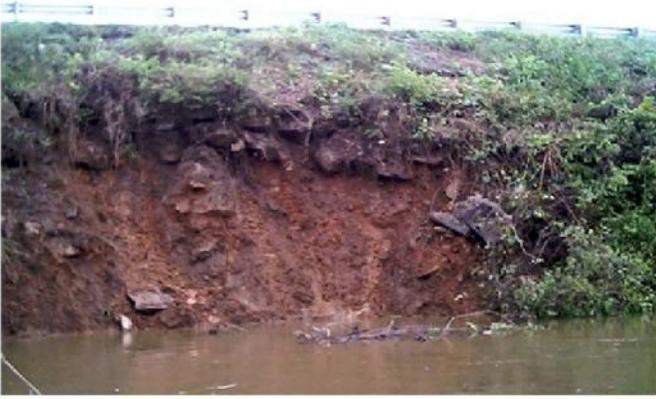
The first above-water slide occurred in the latter part of October 10, 2002. This slide was located about 5 ft upstream

to 20 ft downstream of the planned centerline of the intake pipes up to near the crest of the embankment. A photograph of this slide is shown in Fig. 3. On October, 11, 2002, there were two large cracks reported by the guardrail. Later in the day, this cracked portion of earth also slid off and the slide reached to only 4 ft from the back of the guardrail. It should also be noted that the recorded change in water level in the adjacent river from the period of October 1 to October 10, 2002 was only 555 ft to 559 ft.

Fig. 3. Photograph taken on 10/11/2002 of slide on 10/10/2002. Note pre-existing rip rap covering the slope and that the slide progressed up the slope by the end of the day

The bank sliding configuration in October 10-11, 2002 was assumed "bottoming out" at about 361 ft Elevation, which is consistent with the presumption that the bedrock surface is at this elevation. Therefore, the contractor attempted to place riprap on the slide surface to stabilize it.

Because the bedrock surface was actually over 17 ft deeper, the riprap would not stay on the slope and raveled down to the river bottom. After this attempt failed, the construction team concluded that the best solution was to tarp the slide surface until the intake pipe connections were made. After the bank had steepened for the October 2002 event, the slope became more susceptible to future failure from sudden drawdown conditions.

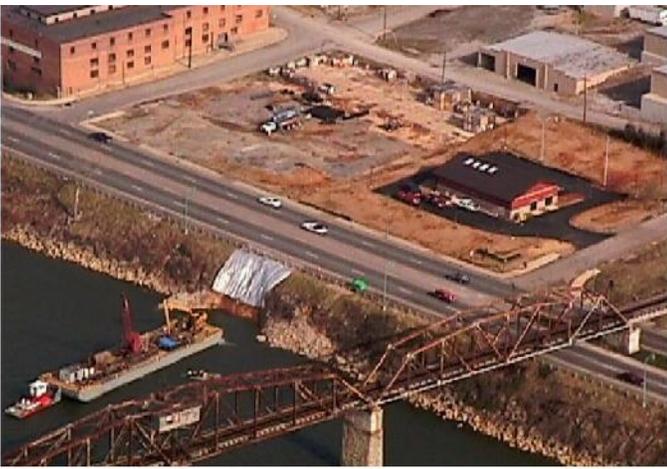
The contractor attempted to stabilize the above slide by placing riprap on the failed embankment section assuming bedrock was present, however, without toe support it raveled off the slope. As an alternative, it was decided to merely cover the slope with a tarp to prevent or minimize precipitation for saturating the slope surface (see Fig. 4).

Fig. 4. Air photo taken on 1/22/2003 of tarp covered slide area with orange soil beneath tarp. Note river level on this day varied from Elevation 355.6 to 356.3 ft

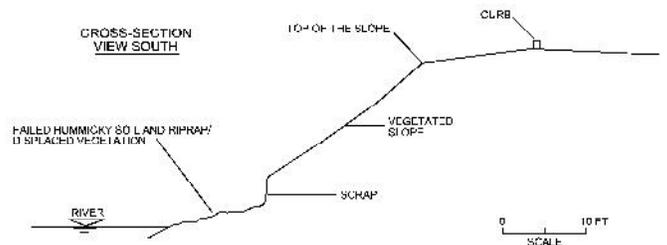
- Upper vegetated unfailed slope
 - Below (west of) roadway
 - Approximate inclination: 40 to 46°
- Immediate steep slope face (scarp)
 - Approximate inclination: 78 to 90°
 - Typical height: 4 to 7 ft
- Lower flatter slope made up of failed soil and displaced vegetation
 - Approximate inclination: 10 to 33°
 - Typical land width: 5 to 17 ft (east-west)
 - Typical land height: 2 to 9 ft

Fig. 5. Typical cross-section of failed slopes east of riverside drive in project location

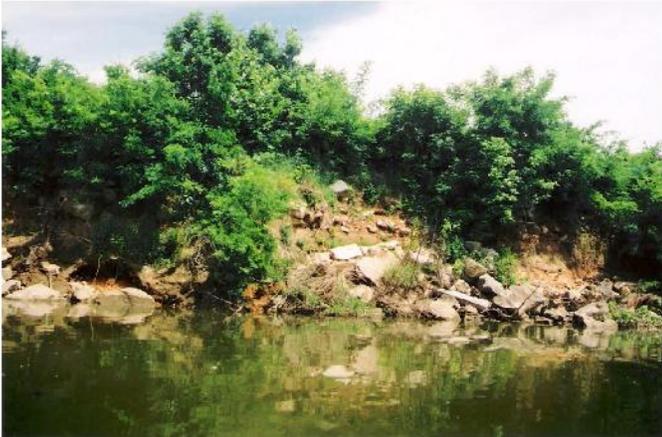
Fig. 6. Failed slope in east bank of river 210 ft south of intake pipeline

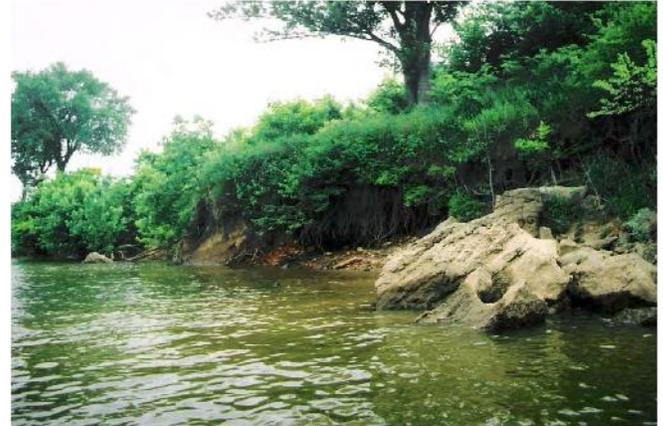
LOCATION: 770 FT SOUTH OF PIPELINE (VIEW NORTH)

At some locations, overhangs have developed along the tops of the immediate slopes as a result of bank failure/erosion and the presence of a thick root mat (see Fig. 7). It is important to

Fig. 7. Overhangs above failed slopes related to bank instability and root mat

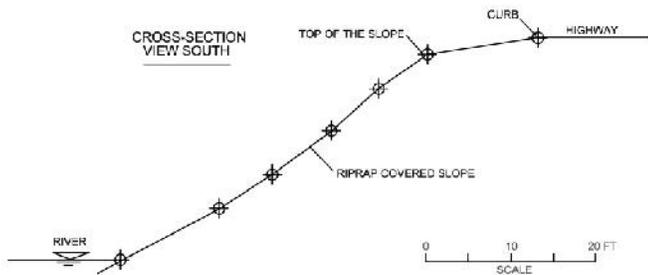
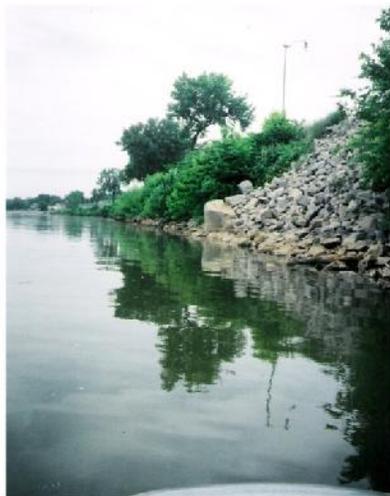
At the time of the site visit, the slope above the intake pipeline was covered by rip rap from the crest down to some unknown distance below the water line. The general profile of the repaired project slope above the pipeline was mapped as well as the slopes immediately adjacent to the project alignment (see Fig. 8). The inclination of the rip rap slope varies between 27° and 42°. The steepest portion of the repaired failed slope is 4 ft below the crest. The vegetated slopes north and south of the pipeline alignment are inclined at angles ranging between 36° and 46°.

Fig. 8. Cross-section along riprap slope above intake pipeline

The 40 to 60 ft wide repaired slope is bounded by upstream and downstream banks that failed in the past and older riprap was visible above and below the water line. Clearly based on a simple site investigation, there was ample evidence of potentially unstable slopes at the river line near the intake pipeline alignment indicating the bedrock surface at some distance below the river level. Due to the close proximity of the roadway to the edge of the bank (approximately 13 ft) and the presence of visible slope failures upstream and downstream of the intake pipe alignment, protection of the roadway during tunnel/open cut construction would be a key design issue.
