# Damage to Agricultural Facilities Caused by the 1993 Kushiro-oki and Hokkaido Nansei-Oki Earthquakes

Paper No. 9.15

S. Tani

**SYNOPSIS** Two large earthquakes struck Japan during only a 6 month period in 1993: Kushiro-oki on January 15 and Hokkaido Nansei-oki on July 12. Both caused a lot of damage to facilities, including installations such as farm roads, reclaimed farmland, channels, head works, drainage pump stations, pipelines and fill dams. In this paper, we present an outline of the damage to agricultural facilities and its features.

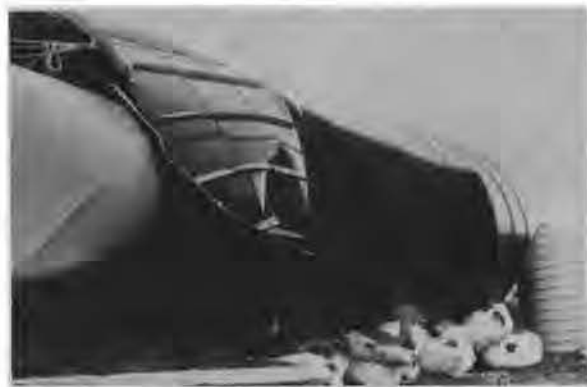
(3) Silos: Three silos in the town of Bekkai were damaged. One was completely destroyed (Fig.3) and in the case of other two, panels on the side walls were damaged and anchor bolts fixing the silos were broken. It is presumed that acid silage had corroded the bolts.

Fig.3. Collapse of Silo in Betsukai City.

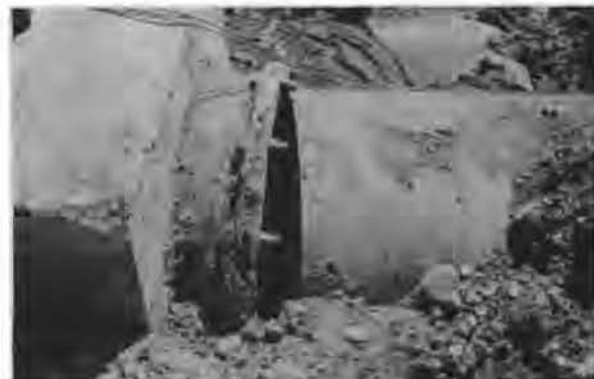
- (3) Pipelines: The Makomanai first main pipeline in the Kitahiyama district was damaged. Fig.5 shows the damage of Makomanai pipeline. Mostly, pipes were removed because thrust blocks moved, pipes came up to the surface and joints were dislocated. Large traces of sand boil were observed around

the damaged places. The sand boil seems to have been caused by ground and back-filling sand. Additionally, sand boil occurred when pipes were removed due to high pressure applied to the pipelines. The main cause of damage can be attributed to liquefaction and the accompanying excessive thrust forces working on the blocks, because large damage was observed in the place near the thrust blocks where topographic features suddenly changed.

Fig. 5. Damage of Makomanai pipeline.

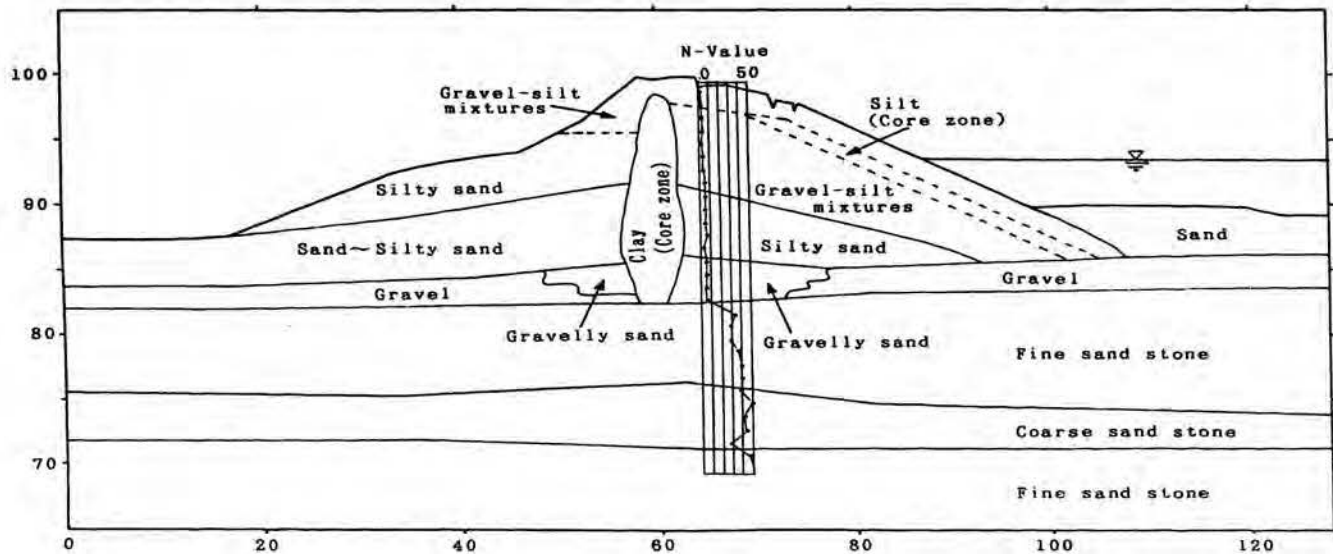
Niwa-ikumine Dam is an earth dam, with the height of the dam being 10 m, and is located about 71 km away from the epicenter. The dam suffered heavy damage, and almost the full length of the crest in the upper stream suffered faulting, which resulted in a 1-1.5 m difference of levels in the direction of the axis of the dam. In addition, a swelling was observed in the bottom part of the slope in the upper stream. This dam was built by settlers at the end of the Taisho era and collapsed once in the beginning of the Showa era and was repaired. A detailed survey of the dam and base ground was conducted after the earthquake. Fig. 7 shows a rough cross section of the dam and base as well as the composition of soil. Although it is basically an earth dam with a core, the composition of soil in the random zone in the down stream and upper stream is complicated. The bank is composed of a mixture of gravel and silt, while the base is composed mostly of fine sand and silty sand with N-values of less than 5. Sandstone with an N-value of more than 40 appears in the layer of -17 m from the crest.

Fig. 7. Cross-section through Niwa-Ikumine Dam Damaged by the 1993 Hokkaido-Nannsei Oki Earthquake.

According to soil test results, it was confirmed that excessive water pressure in the base ground soil easily increases. It is therefore concluded that the major cause of the damage to Niwa-Ikumine Dam was the collapse of bank which was brought on by the decrease in the bearing capacity of the ground as excess pore pressure in the ground increased. Analytic study of the cause is now under way. With regard to small earth dam damage, two in Kitahiyama collapsed, 12 other earth dam suffered slight damage, including cracks and sinking. The locations of these earth dam are shown in Fig. 4 with numbers. Most of the damage is concentrated in the town of Setana near the epicenter.

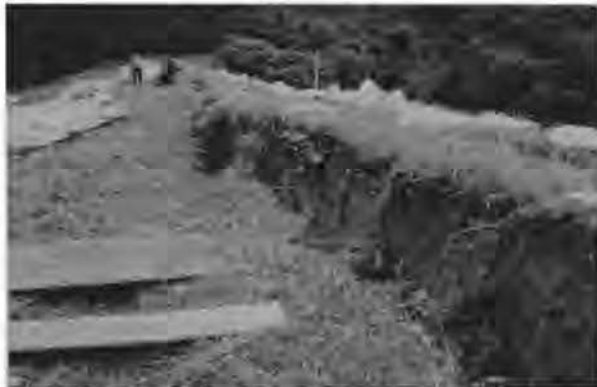
Fig. 8. Damage of Niwa-Ikumine Dam.
