The Dahshour (Egypt) Earthquake of 12th of October 1992

Paper No. 7.25

M.M. Soliman

SYNOPSIS On the 12th of October, 1992 an earthquake of 5.7 moment magnitude hit Dahshour (Egypt) and the surrounding area. The characteristics of the building stock exposed to this earthquake is firstly presented in the paper. Then, the Dahshour earthquake is discussed in terms of the lessons that can be learned by engineers. The paper presents a short description of the geotechnical effects and the observed patterns of damage of the existing building categories and monuments. Finally, a list of the most important conclusions is introduced.

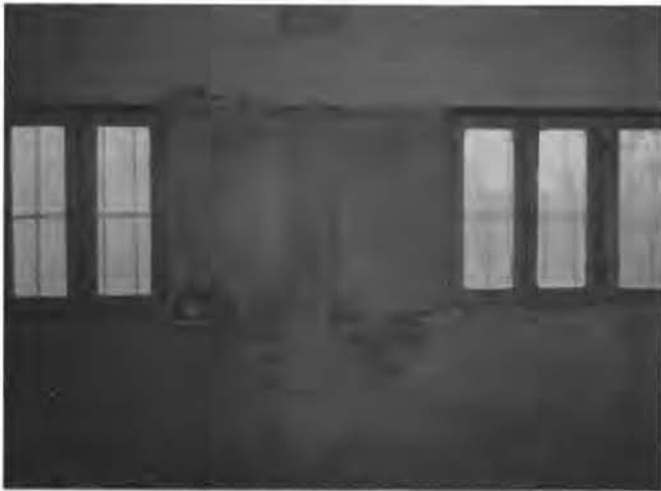
Short column effect was also common in this earthquake, specially in schools where large windows are located in the outer walls to provide ventilation and lighting. Fig 5 presents an example of short column failure as observed in several schools in El-Roddah, El-Ayat and Tameiah Cities.

Fig 5 Shear Failure of a Short Column Arising due to the Existence of Large Windows.

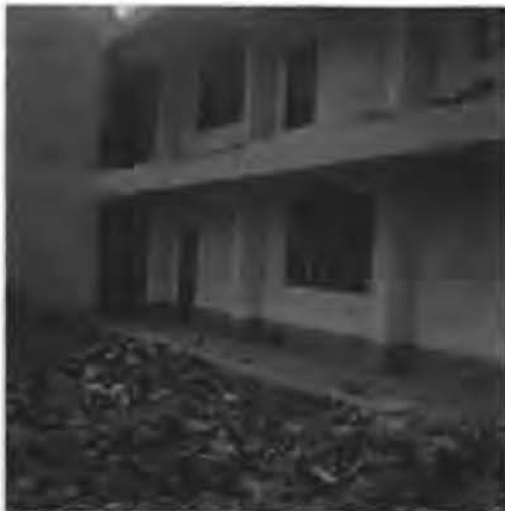
The collapse of parapets was one of the observed failure patterns. Many cases of injuries and fatalities occurred due to this mode of failure. Fig 6 shows the collapse of the parapets of a school building in Tameiah City. Most of the parapet was damaged during the earthquake while the rest was demolished later on.

Fig 6 Failure of Parapets due to the Absence of Lateral Support

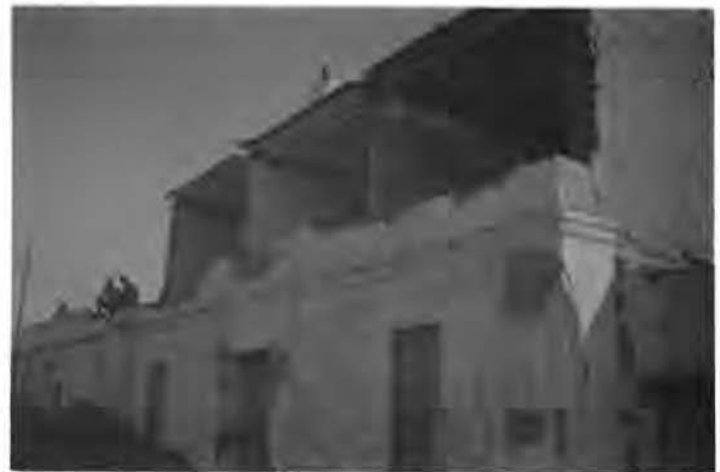
Out-of-plan movements of the outer walls is one of the common damage patterns. This led to the collapse of many walls and parapets of the upper floors causing many cases of injury and death, Fig. 7.

Fig 7 Collapse of Outer Walls of a Two Story Adobe Building

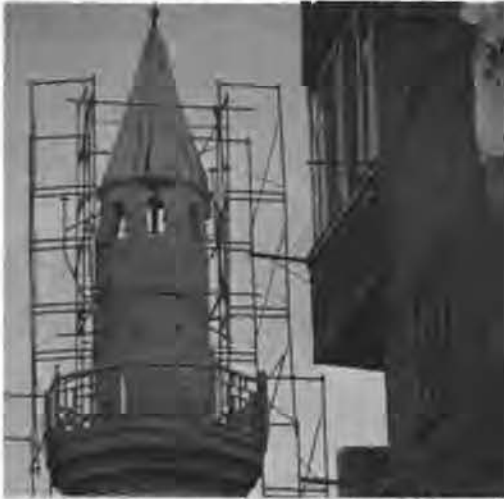
The damage in mosque minarets due to their extensive deformation is another observed pattern in this earthquake. This was combined, in most cases, with the falling down of the heavy metallic crescents on the minaret top. Fig 8 gives an example of this pattern where the damage of the minaret of El-Hady El-Yousefy mosque is shown. Many cracks in the walls of this mosque were also observed. Similar damage was also observed in the historical mosques of El-Azhar, El-Sultan Barkoque, Abou Bakr Mazhar, and El-fakahany. Severe damage in the minaret of El-Sultan El-Ghoury mosque was observed where the minaret was completely separated from the mosque and tilted out-ward.

Fig 8 Damage of the Minaret of El-Hady El-Yousefy Mosque
