ELLIS ISLAND: VIBRATION EFFECTS ON HISTORIC BUILDINGS CAUSED BY PILE DRIVING

Sixto Fernandez, MSc.
Schnabel Engineering
West Chester, Pennsylvania-USA 19382

ABSTRACT

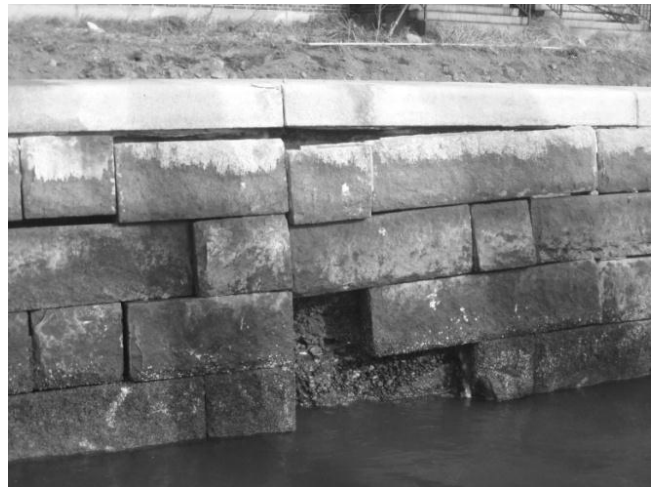
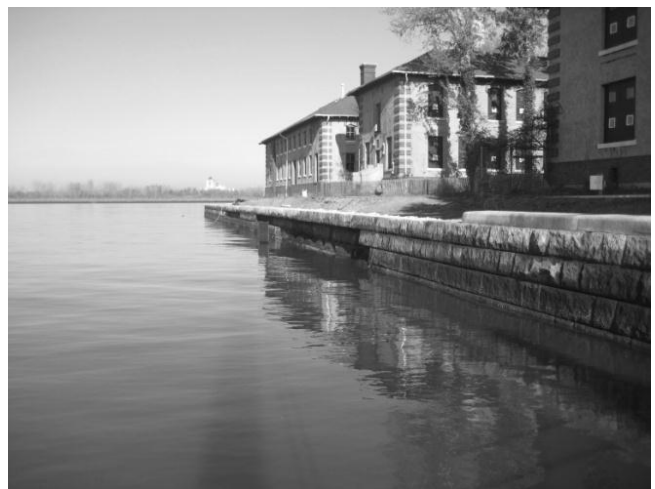
The south island seawalls of Ellis Island show varying degrees of deterioration. The distressed conditions range from aesthetic concerns to wall stability issues (Figure 2). Wall instability was evident in portions of the seawall that are on timber-relieving platforms and those sitting directly on timber cribbing. The wood was decaying and being attacked by marine borers (Robinson and Gomez, 2008).

Fig 2. Ellis Island seawalls condition before remedial stabilization.

As noted in the previous paragraphs, the seawalls at Ellis Island present various grades of deterioration. To prevent further damage to the historic buildings and address the instability of the seawall, the construction of a system that consisted of soldier piles and anchors was undertaken. Sheet piles were also installed (vibrated) at the areas of the island where the seawall is founded on timber cribbing. The objective of the sheet piles is to protect and enclose the cribbing. This paper only focuses on the vibrations induced by pile driving. However, this paper presents the effects of both pile and sheet pile driving on the historic buildings.

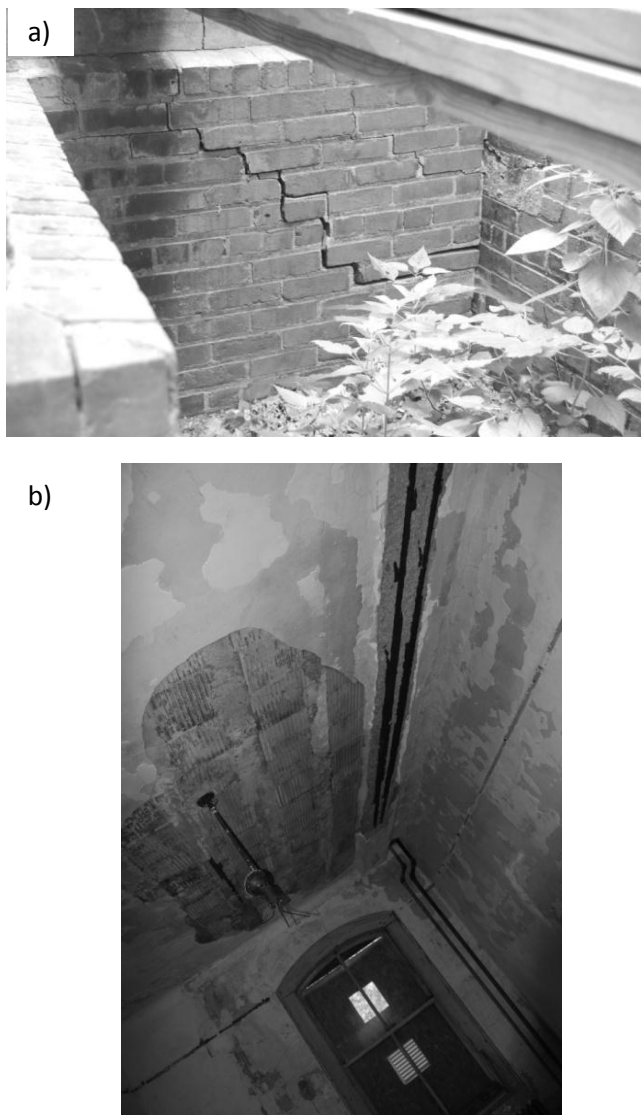
The historic buildings on the south portion of the Island were deteriorated. The signs of deterioration range from plaster loss and hair line cracks to cracks of about 1 inch wide and step cracks that goes from foundations through the 4th floor of some buildings. Figure 3 (a) shows a step crack of about ½ inch at one of the exterior walls of one of the buildings. Figure 3 (b) presents the deteriorated condition of the inside of one of the buildings. It shows the exposed reinforcement of one of the main beams, as well as plaster loss at the ceiling. Many of the buildings at the south island present a similar degree of deterioration and structural damage.

Fig 3. Deteriorated conditions of buildings at the South Island.

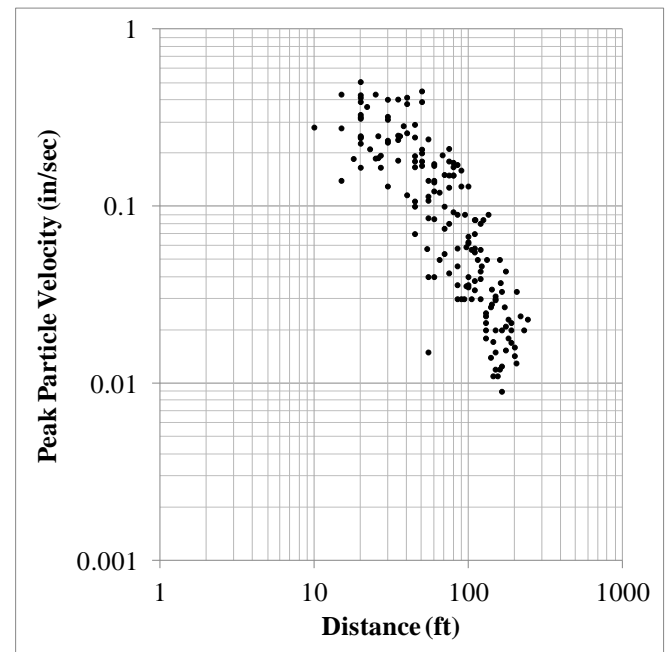
Schnabel recorded vibrations for more than 120 driven piles at the Island. However, for the sake of this paper, only the vibration records of 40 piles are presented. These piles were selected based on the amount of energy that was transmitted to the surrounding soils. We present the piles that generated greater values of PPV. Figure 7 shows the general attenuation of the pile driving vibrations at the Ellis Island site. The PPV values represent the maximum vector sum of the lateral, longitudinal and vertical directions. The distance represents the measured diagonal (in plane) distance from a specific driven pile to the seismographs. From this Figure it is noted that the maximum recorded PPV due to pile driving was about 0.51 in/sec, for a distance of about 20 ft. However, this value of PPV seems to be isolated, with a more typical maximum PPV of about 0.4 in/sec for the same amount of distance. At this site, the energy transmitted from the pile to the ground attenuates quickly. The recorded PPV diminished from 0.4 in/sec at 20 ft, to 0.015 at 200 ft.

Fig 7. Attenuation of PPV with distance.

However, as shown in Figure 7, the recorded PPV well exceeded the limits established for the project.

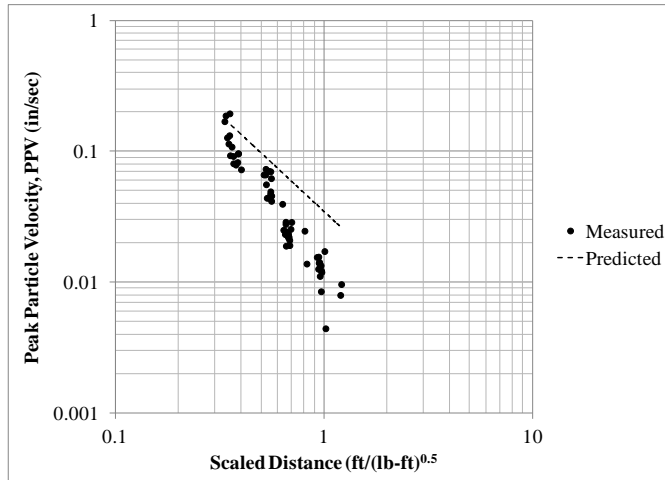
pile was driven from a depth of 36 ft until refusal at a depth of about 57 ft from the ground surface. Figure 8 presents the energy attenuation of the selected pile in terms of the scaled distance. The scaled distance is defined as the distance from source divided by the square root of the transmitted energy. The distance from source was taken as the diagonal distance from the tip of the driven pile to the seismographs. The PPV is presented in terms of the peak vector sum. Also, a comparison of predicted PPV attenuation using Equation 2 is presented. The maximum recorded PPV for this pile is about 0.2 in/sec at the station located closest to the pile, and about 0.01 in/sec at the farthest station.

Fig 8. Relationship of PPV versus scaled distance.

The calculated PPV with scaled distance using Equation 2 suits well the recorded PPV for scaled distance of less than 0.6 $\text{ft}/(\text{lb-ft})^{0.5}$. It over predicts the PPV for scaled distance greater than 0.6 $\text{ft}/(\text{lb-ft})^{0.5}$.

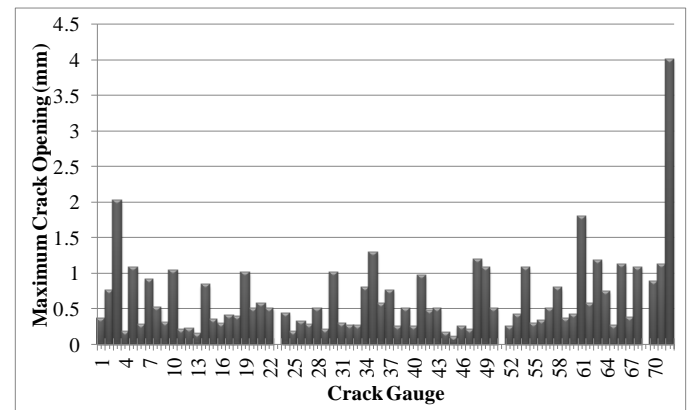
Figure 9 presents a summary of the maximum recorded crack opening for the period of time that the crack gauges were read. The abscissa is the crack gauge number, the ordinate denotes the resultant crack gauge opening from the horizontal and vertical components. The presented maximums include any increase in crack opening caused from pile driving, sheet pile installation, vibrations from equipments and seasonal expansion contraction of the materials were the crack gauges were installed (concrete, brick, etc.).

Fig 9. Maximum recorded crack opening during construction.

The maximum recorded increase in crack opening, with the exception of crack gauge # 72, was about 2 mm (7.87×10^{-2} in). Crack gauge #72 was not installed on a crack, but on a joint between an old and a new construction of a hallway. For this crack gauge, the maximum recorded opening was about 4 mm (0.16 in).

The recorded crack gauges readings indicate that the constructions activities at the Island did little to none effect on the historic buildings.
