Damage of Governmental Building Due to Geotechnical Properties (Case History)

DAMAGE OF GOVERNMENTAL BUILDING DUE TO GEOTECHNICAL PROPERTIES (CASE HISTORY)

This paper is a case study for a governmental building in a site located at Katamia zone (an extension of Great Cairo, Egypt). The site is belonging the Great Cairo Bus Station under the authority of Ministry of Transportation. It consists of two buildings and a shed for buses cleaning and lubrication. The buildings had been constructed since 15 years. However after two years of construction many cracks were noticed in the main building. Furthermore, after another few years, sever cracks had appeared in different parts of the building and the concrete water tank on the roof of same building had suffered from failure. The aim of this study is to know and examine the reasons of these cracks and damages which happened to the building, particularly the other building suffered no cracks or damages although it was built on the same soil and under the same conditions. Observation of the building movements were recorded over several years as well as soil investigation around and under the building. A structural analysis and an estimat

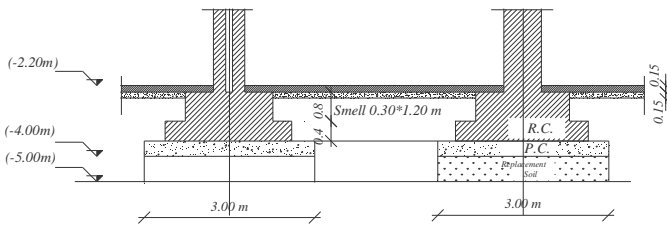
Fig.(2) Excavation around foundation

Around representative number of footings excavation were made until the replacement soil. It was found that the level of plane concrete is 5.5 m below the ground surface. The thickness of replacement soil was about 0.75-1.0m beneath the foundation which consisted of sand and gravel (coarse gravel and medium sand). It was found mixed with water and oil. The reinforced concrete was strip footing, Fig. (2).

The thickness of soil replacement is considered as an effective way in reducing the effect of swelling provided that it must be compacted to the required relative density and must be horizontally confined.

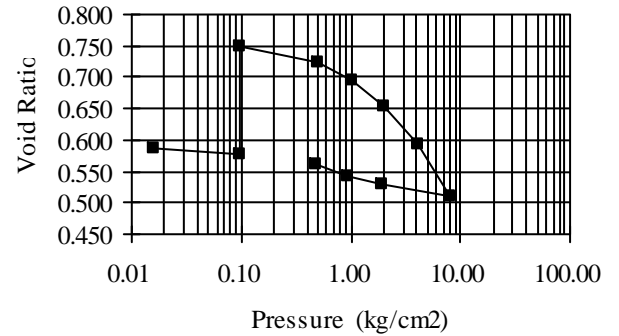
Fig. 3. Consolidation test for a clay sample

Expansive soils swell when subjected to water producing vertical pressure, as well as lateral pressure. These pressures act on the overlying foundation in the form of up lifting forces pushing it upwards. On the other hand as the replacement soil had a relatively small thickness (0.75m).

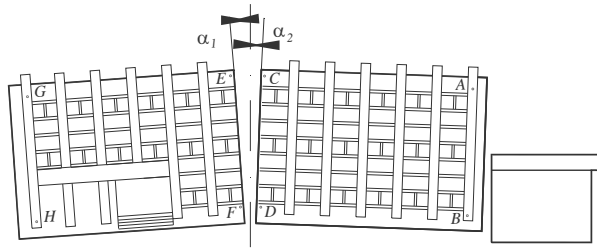
Fig.(5) The Locations of The monitoring Points as well as The Direction of movement of the Building

The building has two expansion joints which were divided into three parts. Twelve points have been used for monitoring the deformation and vertical movement of the building as shown in Figs. (4&5). For the third part, the vertical movement of points (1,2,3,and 4) was greater than the other two parts.

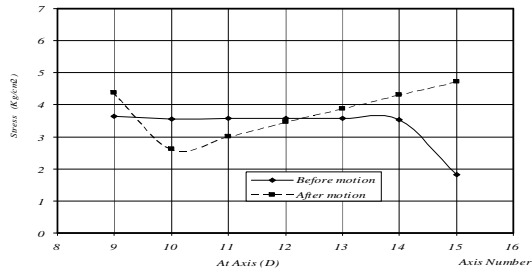
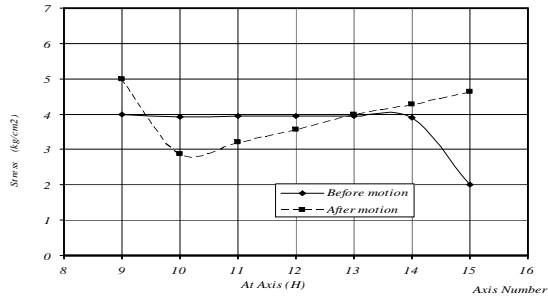
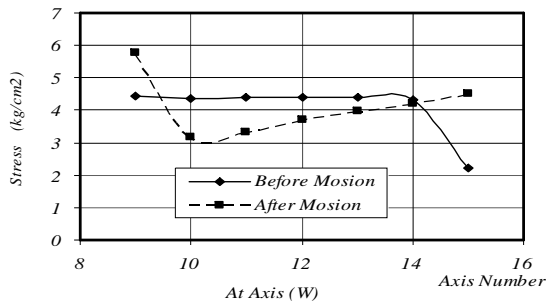
Fig. 8. Stresses before and after movement

As it was noticed the biggest settlement occurred at points 3 and 4 on axis number 15, where there was a big change in stresses. An increment nearly about 50% and sometimes is more than that. For the column at point (1) beside the expansion joint at axis number 9', it was broken near the beam as shown in Pho. (2).

The volume change of soil resulted in movement of the building and caused the expansion joint to open and displaced at the top by 43 cm, the inclination, Pho. (1) This combined movement caused the redistribution of loads and stresses under the foundation as shown in Fig. (7) which caused some concrete elements to break Pho. (2). This was the main reason that caused the damage to the building and the failure of the upper water tank Pho. (3). Beside, the lack in the number of ground beams (semelles) connected to the foundation, especially those near the expansion joint resulting in decrease the rigidity of the foundations.
