Evaluation and Repair of a Subterranean Parking Garage to Resist Hurricane Flood Levels

EVALUATION AND REPAIR OF A SUBTERRANEAN PARKING GARAGE TO RESIST HURRICANE FLOOD LEVELS

Matthew E. Meyer, P.E.
Senior Associate
Langan Engineering & Environmental Svcs.
Miami Lakes, FL - U.S.A

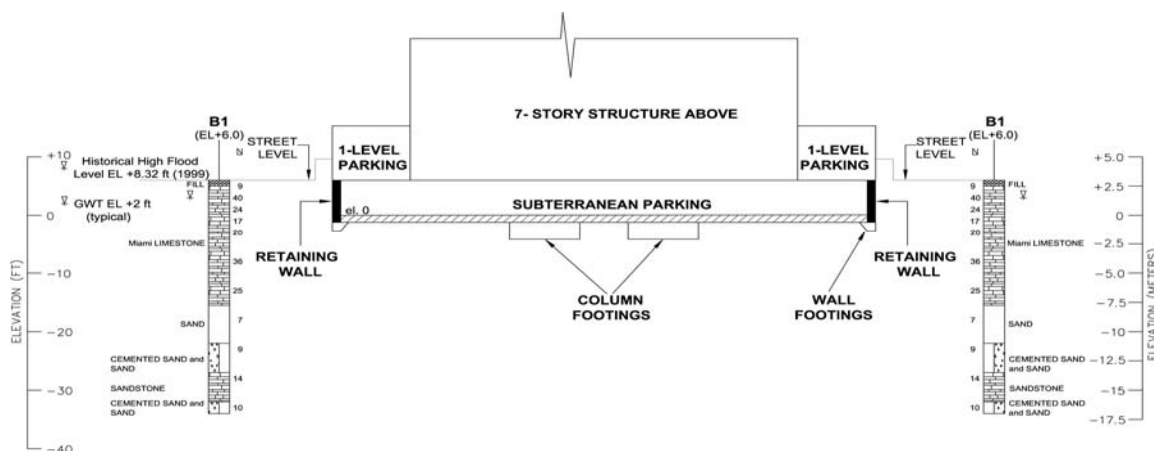
Fig. 3 – Site specific subsurface information and building section

The subsurface conditions below the subterranean slab level were determined to consist of a 15-ft (4.6 m) thick layer of oolitic limestone of the Miami Formation with typical Standard Penetration Test (SPT) N-values, performed using conventional safety hammers, ranging from 15 blows per foot-bl/ft (blows/0.3 m) to 35 bl/ft, followed by a 12-ft (3.6 m) thick layer of sand with varying proportions of cemented sand and with typical SPT N-values ranging from 5 bl/ft to 10 bl/ft. Next, layers of sandstone and cemented sand of the Fort Thompson Formation were encountered to the termination depth of the borings at 40 ft (12.2 m) below grade. The authors' prior experience with unconfined compressive strength testing in the Miami Limestone suggest that the Miami Limestone at the project site would be expected to have unconfined compressive strengths ranging from 150 lbs/in² (1.0 MPa) to 250 lbs/in² (1.7 MPa). Borehole permeability testing, consisting of staged hydraulic conductivity testing to assess both vertical and horizontal permeability, was performed (Cedergren, 1989). The hydraulic conductivity of the Miami Limestone stratum was determined to vary from 1×10^{-3} cm/sec to 9×10^{-2} cm/sec. Hydraulic conductivity testing of the zones of sand and cemented sand beneath the Miami Limestone formation was attempted; however, a sufficient source of water could not be provided to maintain a positive head within the borehole, indicating that excessively high permeabilities are likely.

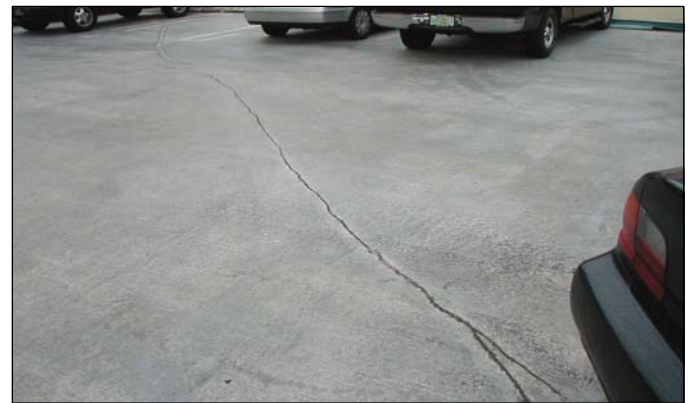
Photograph B – Observed cracks on elevated deck

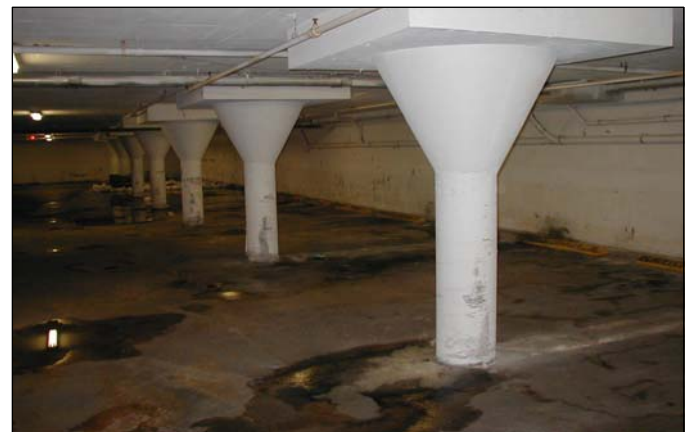
Reportedly, the subterranean slab became damaged and seepage began entering the subterranean level after Hurricane Irene in 1999. Because the ground floor level is located 2 ft (0.6 m) below the typical static groundwater level and up to 8.32 ft (2.54 m) below the flood water level recorded in 1999, significant pressure is expected to have developed on the slab during the flooding event. The high uplift pressures apparently caused the ground floor slab to heave and crack, and the outer footings to be raised, causing the cracking of the elevated parking deck, which wraps around the perimeter of the taller, more heavily loaded office structure. See photograph B, C, and D. The actual developed pressure can only be approximated based on historical groundwater monitoring wells located in the general vicinity of the project site. See the attached Fig. 3 for a schematic of the expected flood level conditions imposed on the structure's ground floor slab.

Photograph C – Observed seepage within subterranean level

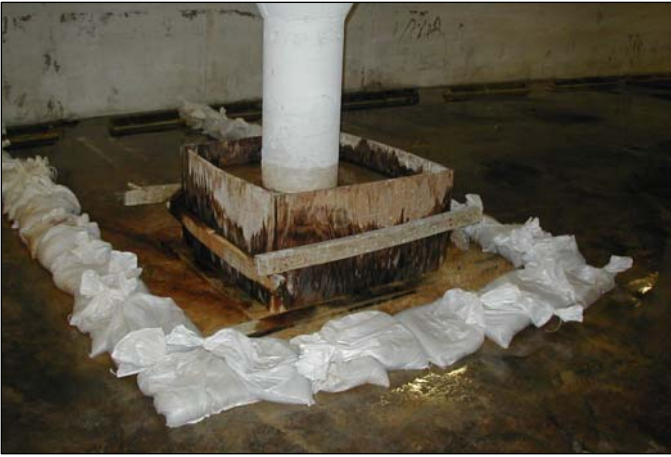
In late 2001, the authors' visited the subject project site and observed the conditions of the subterranean parking level. Extensive cracking and bowing-heaving of the ground floor slab were observed throughout the subterranean level. Additionally, the underside and exposed surface of the elevated concrete deck had extensive cracks. Ponded water was observed throughout the lower level and flowing water was observed through cracks within the slab and at the interfaces of the slab to the footings.

Photograph D – Observed seepage within subterranean level

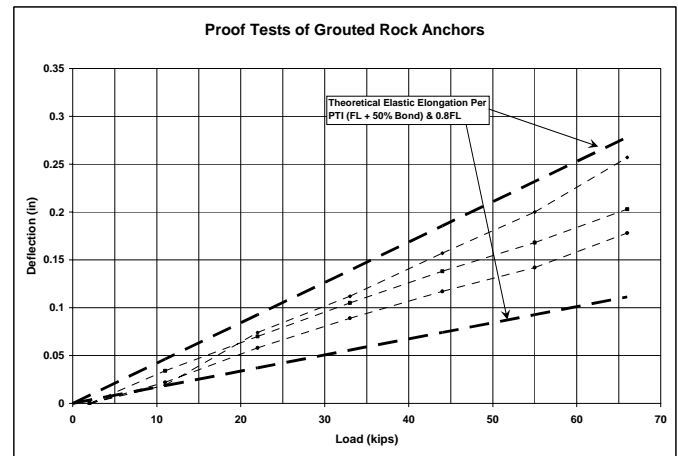
Fig. 5 – Plot of typical proof tested anchors

All production anchors were proof-tested prior to construction of the replacement slab. Typically, the rock anchors were proof-tested three days to seven days after installation. The results of the proof testing showed the anchor movement averaged 0.2 inch (0.5 cm) under the maximum test load. Ninety percent of the anchors tested moved less than 0.25 inch (0.64 cm) under the maximum test load. No excessive creep movement in excess of PTI guidelines was observed for the majority of the anchors during the ½ minute to 5 minute hold period. Where anchors moved excessively upon application of the test load (1.5 times the design load), replacement anchors were installed. See Fig. 5 for a graphical representation of the proof tests.

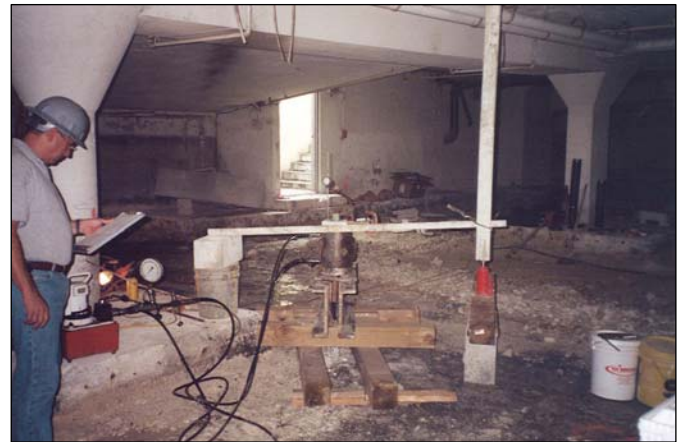
Photograph J – Anchor load test set-up

Four rock anchors were installed, prior to installation of production anchors, and performance tested to 1.5 times the design load. See Photograph J. Creep tests (i.e., 50-minute hold under maximum test load) were also performed under the maximum test load. The measured deflection of the top of the bar ranged from 0.176 inch (0.45 cm) to 0.369 inch (0.94 cm). Under the maximum test load, the anchors were observed to creep between 0.001 inch (0.0025 cm) to 0.014 inch (0.0356

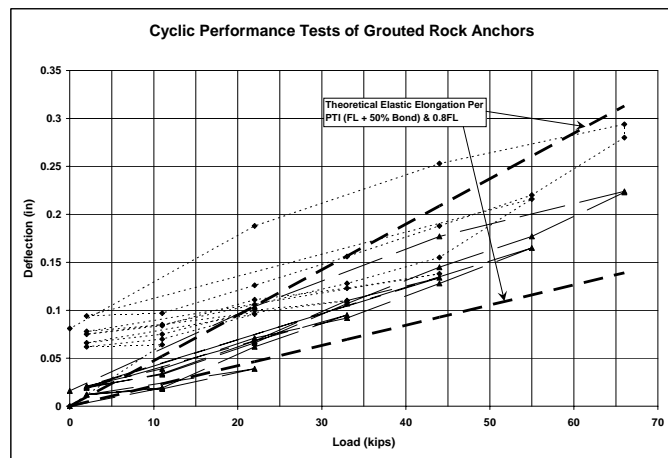
Fig. 4 – Plot of performance tested anchors

cm) during the 50-minute hold period. A graphical presentation of three of the performance load test results is presented in Figure 4.

The average mobilized bond stress for the soft rock to grout interface along the anchor bond zone was calculated to be 3.5 tons/ft² (0.34 MPa), under the maximum test load of 33 tons (294 kN). The resulting design bond stress used was 2.3 tons/ft² (0.22 MPa). The corresponding mobilized average transfer load along the bond length was determined to be 4.1 tons/ft (120 kN/m) with the design transfer load being 2.75 tons/ft (80 kN/m). These average mobilized load transfer values (4.1 tons/ft) are less than the values proposed for all categories of rock type material by various references for use in preliminary design (GEC #4, FHWA, 1999). The average mobilized bond stress is similar to the high end for fine to medium sand in a medium dense to dense condition (PTI, 1996) and in excess of PTI's preliminary ultimate bond stress values using 10% of the unconfined compressive strength of the rock.

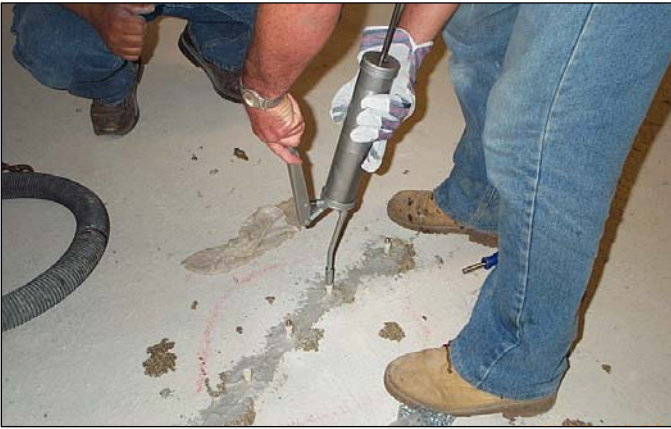
Photograph K – Underslab chemical grouting of joint

After constructing the replacement slab and cutting off the dewatering system, water leaks were observed at some cold joint locations where the original slab joined to the new replacement slab. These locations of observed seepage were sealed with chemical grout. The chemical grouting procedure consisted of injecting a proprietary chemical grout into injection ports, which were drilled and epoxied at the location of the observed seepage. The grout ports were installed at approximately 6 inches (15.2 cm) on center along the alignment of the observed seepage. See Photograph K.

Upon completion of the primary, secondary and tertiary grouting, no subsequent moisture or seepage was noted at the subject locations. Reportedly, three years after construction, no subsequent leaks or signs of seepage have been observed.
