Foundation Rehabilitation of Bridge over Danube: the Role of Pile Integrity Testing

FOUNDATION REHABILITATION OF BRIDGE OVER DANUBE: THE ROLE OF PILE INTEGRITY TESTING

The construction of the bridge near Pöchlarn over Danube, in Austria was begun 1998 and completed in 2002. The four middle piers of the bridge consist of sink caissons made of pre-cast reinforced concrete elements. Each caisson is founded on 18 bored piles of 1.2 m diameter. In a first step, two pilot piles of about 40 m length are installed for each caisson. After the pilot piles were completed, an accident happened in April 1999. A cargo ship collided with the pier no 3 and damaged the two pilot piles. Since the piles were below water level, it was very difficult to inspect the damage. Therefore, integrity tests were carried out to know the level of damage. The possible scenarios range from local repair to installation of new pilot piles. The paper describes a case study of the repair works of the damaged piles, where under water pile integrity tests were carried out.

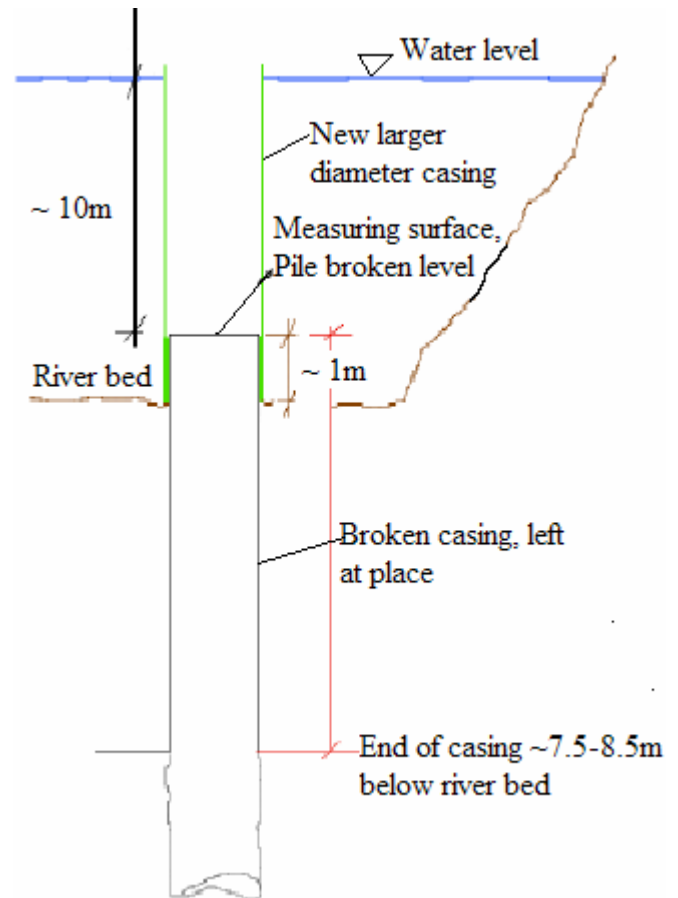
Fig. 2: Sketch showing the pile length and damage level

After the pilot piles were completed, an accident happened in April 1999. A cargo ship collided with the pier no. 3 and damaged the two pilot piles. The both pilot piles were broken at the level of about 1 m above river bed (see sketch in Fig.2).

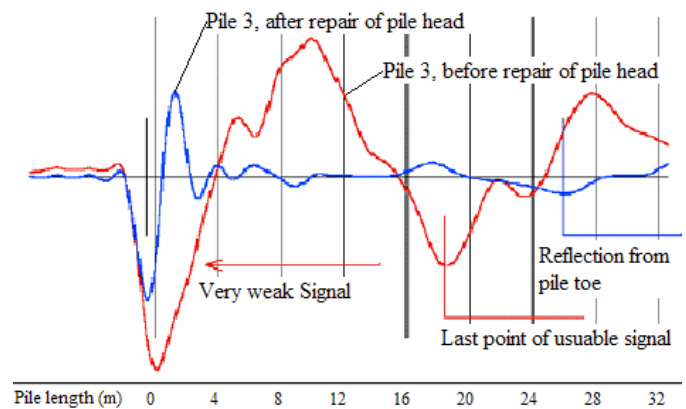
Fig. 5: Test results of the pile no. 3, signal 1

The test results (before repair of pile heads) showed that both piles were damaged near the top surface where the measurements were carried out. There were small cracks and changes in concrete structure. The damage to the structure was only partial. There were no damages below 4 m from the river bed. Due to difficulty in conducting tests under water, and due to damages at the measuring surface (pile heads), the interpretable pile length from the measured signal was only between 16.5 m and 17.5 m, measured from the broken pile level.

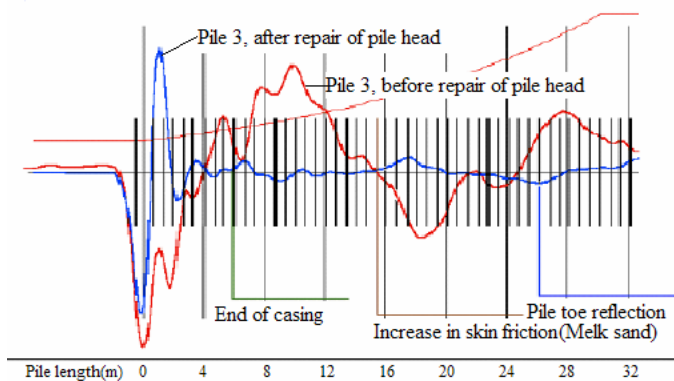
Fig. 6: Test results of the pile no. 3, signal 3

The test results of pile no. 3 after the repair of pile head showed a consistency in signal so that the interpretable length of pile was about 26.4 m (from broken level). Negative changes in impedances were not observed. For the length between 6.5 m and 9.0 m from the broken level, a reduction of cross section was observed (Fig. 9). The positive change in impedance at a level of 17.5 m is primarily due to increase in skin friction.

Our test showed that the damage was limited to the upper part of the piles. Therefore, the pile repair option was chosen. The repair works of the pilot piles were carried out in two stages. In the first stage, only pile heads were repaired. For this purpose a larger diameter steel casing was placed on the existing pile, the joint was sealed with concrete and the water inside the casing was pumped out. The pile heads were chiselled and cleaned. Then the fresh concreting was placed. After completion of the repair of the pile heads, new integrity tests were carried out.

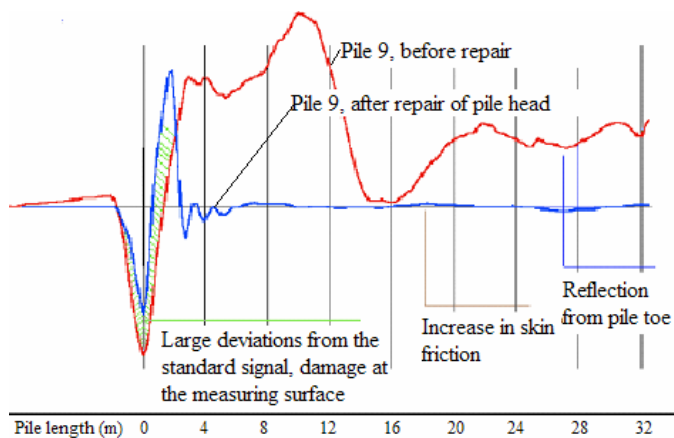
Fig. 8: Test results of the pile no. 9, signal 2

Similarly, the test results of pile no. 9 after the repair of pile head also showed a consistency in signal so that the interpretable length of pile was about 27 m from the pile broken level (Fig. 9). Negative changes in impedances were

not observed. For the length between 7 m and 10 m, a reduction of cross section was observed. The positive change in impedance at a level of 18.5 m is primarily due to increase in skin friction. This shows a high level of reliability in both measurements.

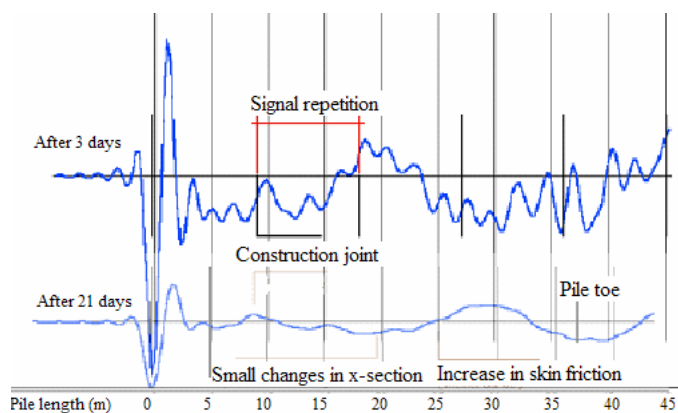
Fig. 10: Test results of pile no. 9 after the repair of piles, after 3 days and 21 days of concreting.

The results of the second phase tests (after the repair of pile heads) showed some minor changes in cross sections of both piles. The tests after the repair works of whole pile showed a sound integrity of the piles throughout the length. This integrity test guaranteed the quality of repaired piles so that these piles can be used for pier foundations without any limitations.

In the second phase of repair works, the broken pilot piles were reconstructed up to their final level above water. For the extension of broken piles, several holes were bored into the existing piles and high strength steel rods (GEWI rods) were

inserted into the piles. Then the top surfaces of the broken piles were cleaned and casings were placed in positions. Afterwards, reinforcement cage was placed and concrete was poured into the casing till the final level above water. Then new integrity tests were carried out in 3 days and 21 days after the concreting. The results of last integration tests after the complete rehabilitation of pilot piles are presented in Fig. 10 and Fig. 11.
