## Foundations on Expansive Soils in Mexico

Enrique Padilla-Corona  
COSIC - Consultants, Guadalajara, México

Padilla-Corona, Enrique, "Foundations on Expansive Soils in Mexico" (2008). *International Conference on Case Histories in Geotechnical Engineering*. 16.

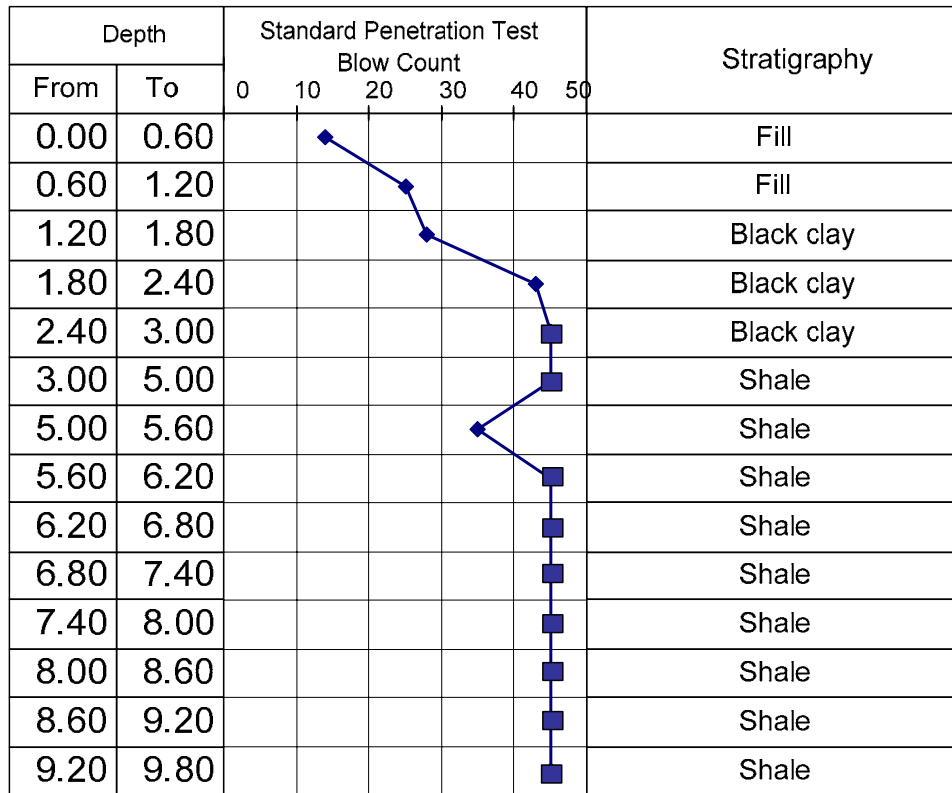
The results of previous and subsequent subsoil explorations in the buildings are shown in the stratigraphic profile in Fig. 1. This figure shows the next key information:

- The subsoil superior part is composed of more or less compact urbanization fillings with depth varying from 0.0 to 1.20m.
- The next layer is composed of black clay deposits with consistency and plasticity varying from medium to high and medium expansibility; this layer has a thickness varying from 1.20 to 4.20m. The volumetric changes that this layer suffered, according its natural moisture conditions, caused the damages that have been detected in the buildings.
- From the previous layer and down to the deepest sounding (10.2 m), the materials found included clayed silties and silty clays (shales) of color dark coffee to beige containing organic material, with medium plasticity, medium compressibility and with variable natural moisture.
- The phreatic water level was not in fount at the maximum depth exploration (10.2m).

Fig.1 Typical soil profile.

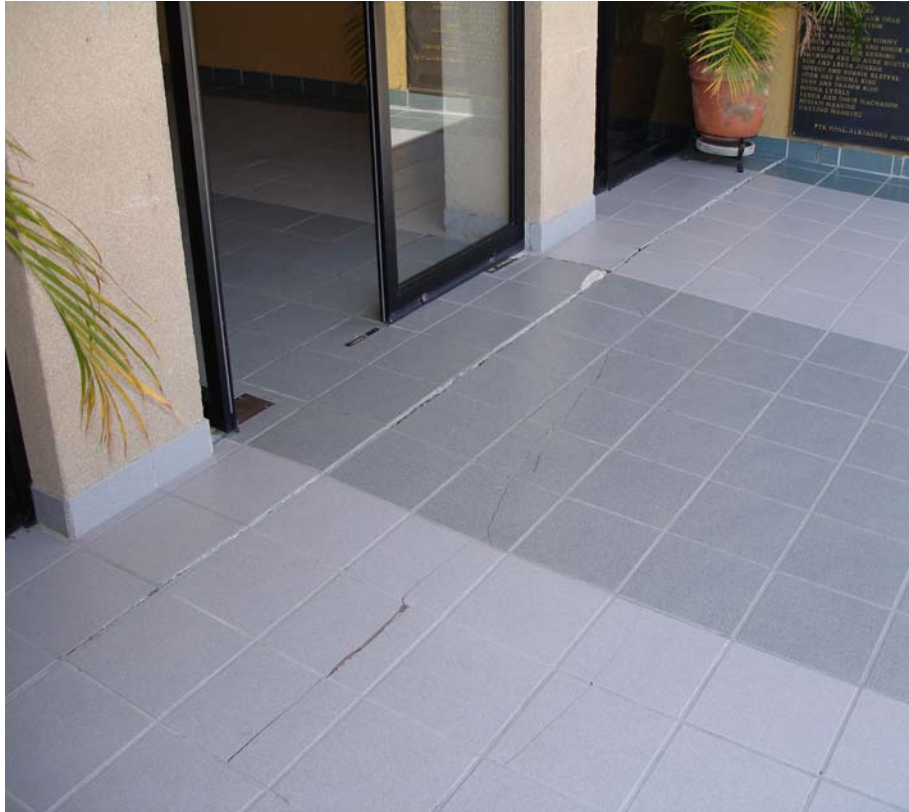
Damages produced by the volumetric changes of the subsoil began to appear in the damaged buildings at the beginning of their operation. The damage increased during the rain season due to changes in the expansive soils moisture conditions. After this rain period, the damage diminishes but the magnitude of the deterioration was increased. The main damages presented in the building after three years in operation are:

- Swelling of the floors with cracks in all directions; the deteriorations have caused problems in door operation, frames, and windows (Fig. 3).
- Displacement by swelling of the construction joints of floors (ground floor) with distortions throughout the joint and also atrophies to the door operation, frames, and windows.
- Vertical cracks in inner walls from the joint between columns and the wall, which deformed window frames, ironworks, and doors (Fig. 4). These damages are originated by the vertical movement which generated vertical cracks in facade walls, and columns.

*Fig.3 Cracking and deformation on the floor.*

It was recommended that the previous five actions were performed simultaneously to start the reduction of moisture variations under the buildings; at the same time, it was recommended to inspect damages in the buildings, especially distortions in damaged iron works. The “cosmetic” repairs of cracks and deformations in floors and walls must be postponed until the described conditions become stabilized.

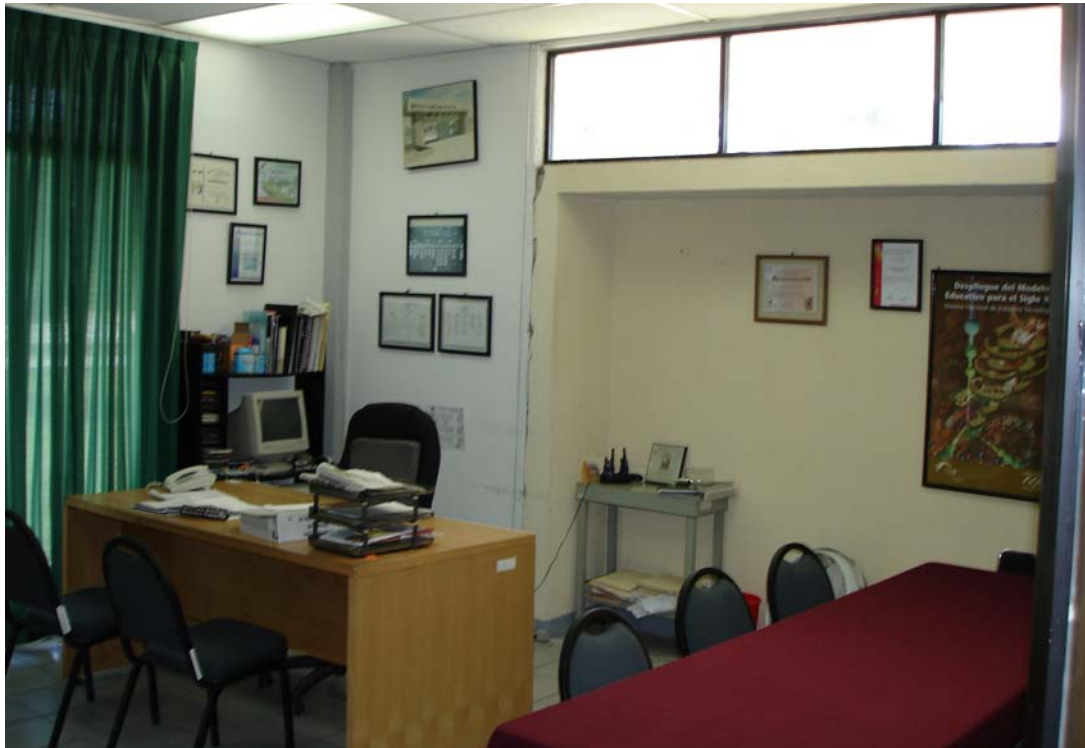
*Fig.4 Vertical cracking joint between the wall and the column in the library cubicle.*

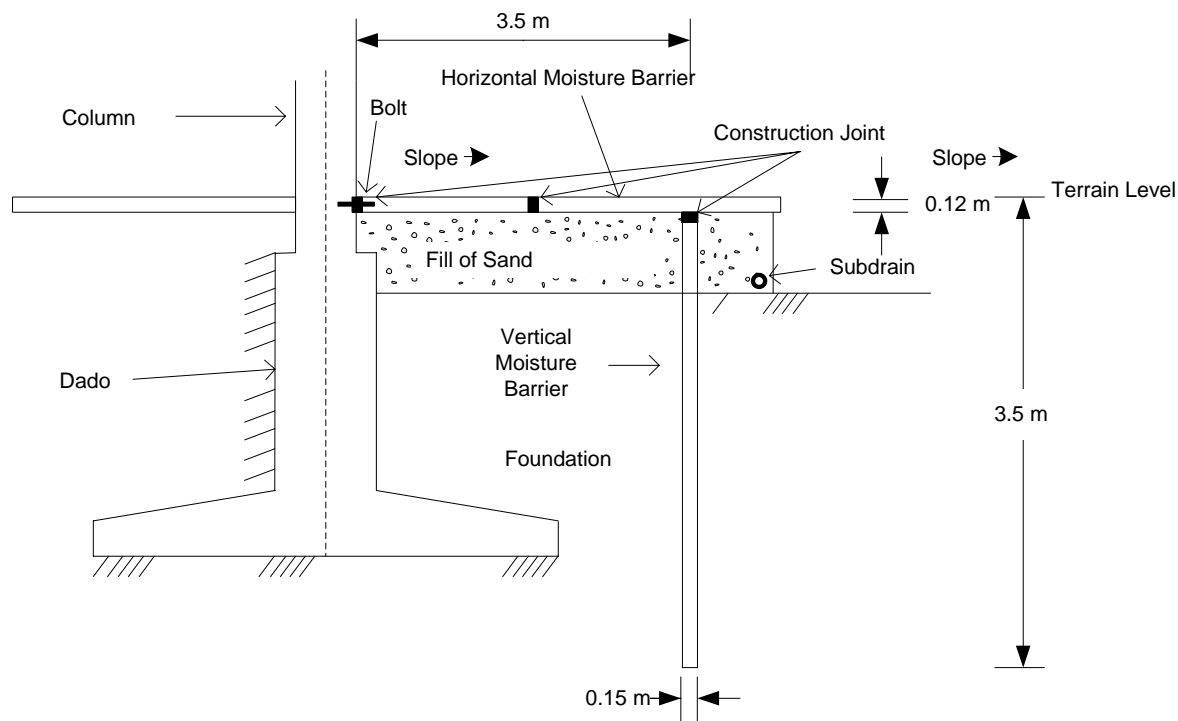
Fig. 5 Protection structures using the vertical and horizontal moisture barriers system.

One solution, which has been used successfully in the affected buildings, is the use of the horizontal and vertical moisture barrier system. This system offers a feasible solution since its basic principle is that they move outside the building the moisture from the foundations and floor borders. Another advantage of this system is that they reduce the seasonal variations of the subsoil water content located directly under the building, avoiding additional damages. This solution was selected after reviewing other alternatives and considering its cost medium and reduced maintenance (Fig. 5).

In order to enable a better and efficient operation of the horizontal and vertical moisture barrier system, it is necessary to avoid as much as possible the superficial water deposits that can cause rainwater infiltration. Then, it is necessary to modify the slope in green areas, walking areas, etc., so that these buildings emerge from the land and they do not store water. Additionally, it is necessary to design the channels and culverts that are required to take the rainwater to places where it could be eliminated.
