Tank Settlement Due to Highly Plastic Clays

TANK SETTLEMENT DUE TO HIGHLY PLASTIC CLAYS

Settlement during hydro-testing of two 30-m diameter oil tanks was generated mostly by a layer of highly plastic clay at about 10 m depth. Based on about 5 months of readings on one of the tanks, the total predicted settlement at the tank perimeter was about 300 mm (with little differential movement) and at the center was closer to 550 mm. The settlement of a 7-m diameter water tank located close to the oil tanks followed quite a different pattern during hydro-testing. Within about 6 days, the tank had settled about 130 mm on one side, but only about 20 mm on the other. The water tank was only about half the height of the oil tank, and the diameter was less than one quarter, resulting in loading at the depth of the plastic clay layer of less than 15% of that of the oil tank. Yet, settlement rates were much faster than those of the oil tank, and differential settlement was not anticipated based on the depth of the clay layer. This paper describes the settlement measurements and computations made for the oil tanks and describes the efforts made to determine the reasons for the unanticipated sett

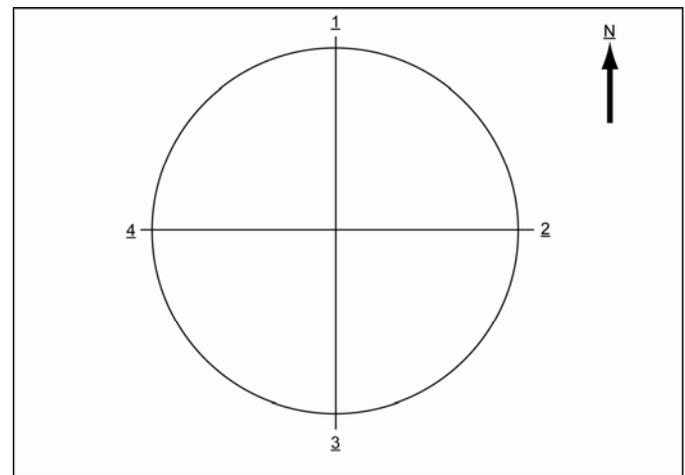
Fig. 1 Locations of settlement monitoring points on 30-m diameter tank.

Figure 1 shows the locations of the settlement monitoring points on the perimeter of the 30-m diameter tank. The settlement of each of these points during hydro-testing of the tank is plotted against a natural time scale in Fig. 2. The percentage of hydro-test load applied is also shown in Fig. 2. Maximum (100%) hydro-test load was estimated as 127.5 kPa at foundation level. It took approximately 40 days to fill the tank with water, and the tank remained full for about 4 months. At that point, the total amount of settlement around the tank perimeter ranged from 190 to 230 mm, with an average of 210 mm. Figure 3 shows the detailed loading and unloading schedule for the hydro-testing.

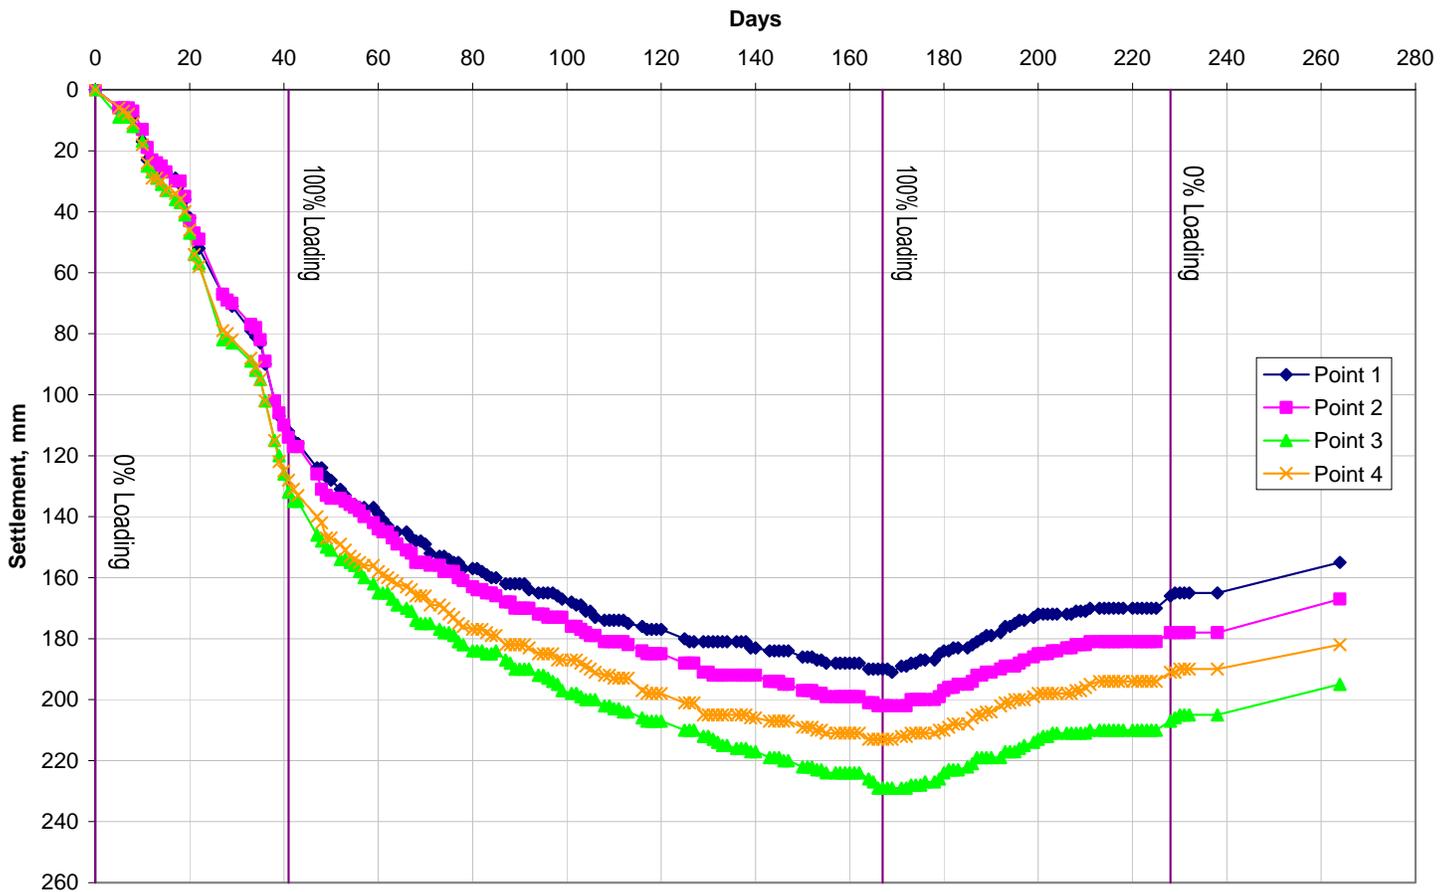
Fig 2. Settlement of monitoring points vs. time.

Note that the total rebound shown in Fig. 2 after 2 months of draining the tank and then another month of sitting unloaded is about 35 mm for all four settlement points.

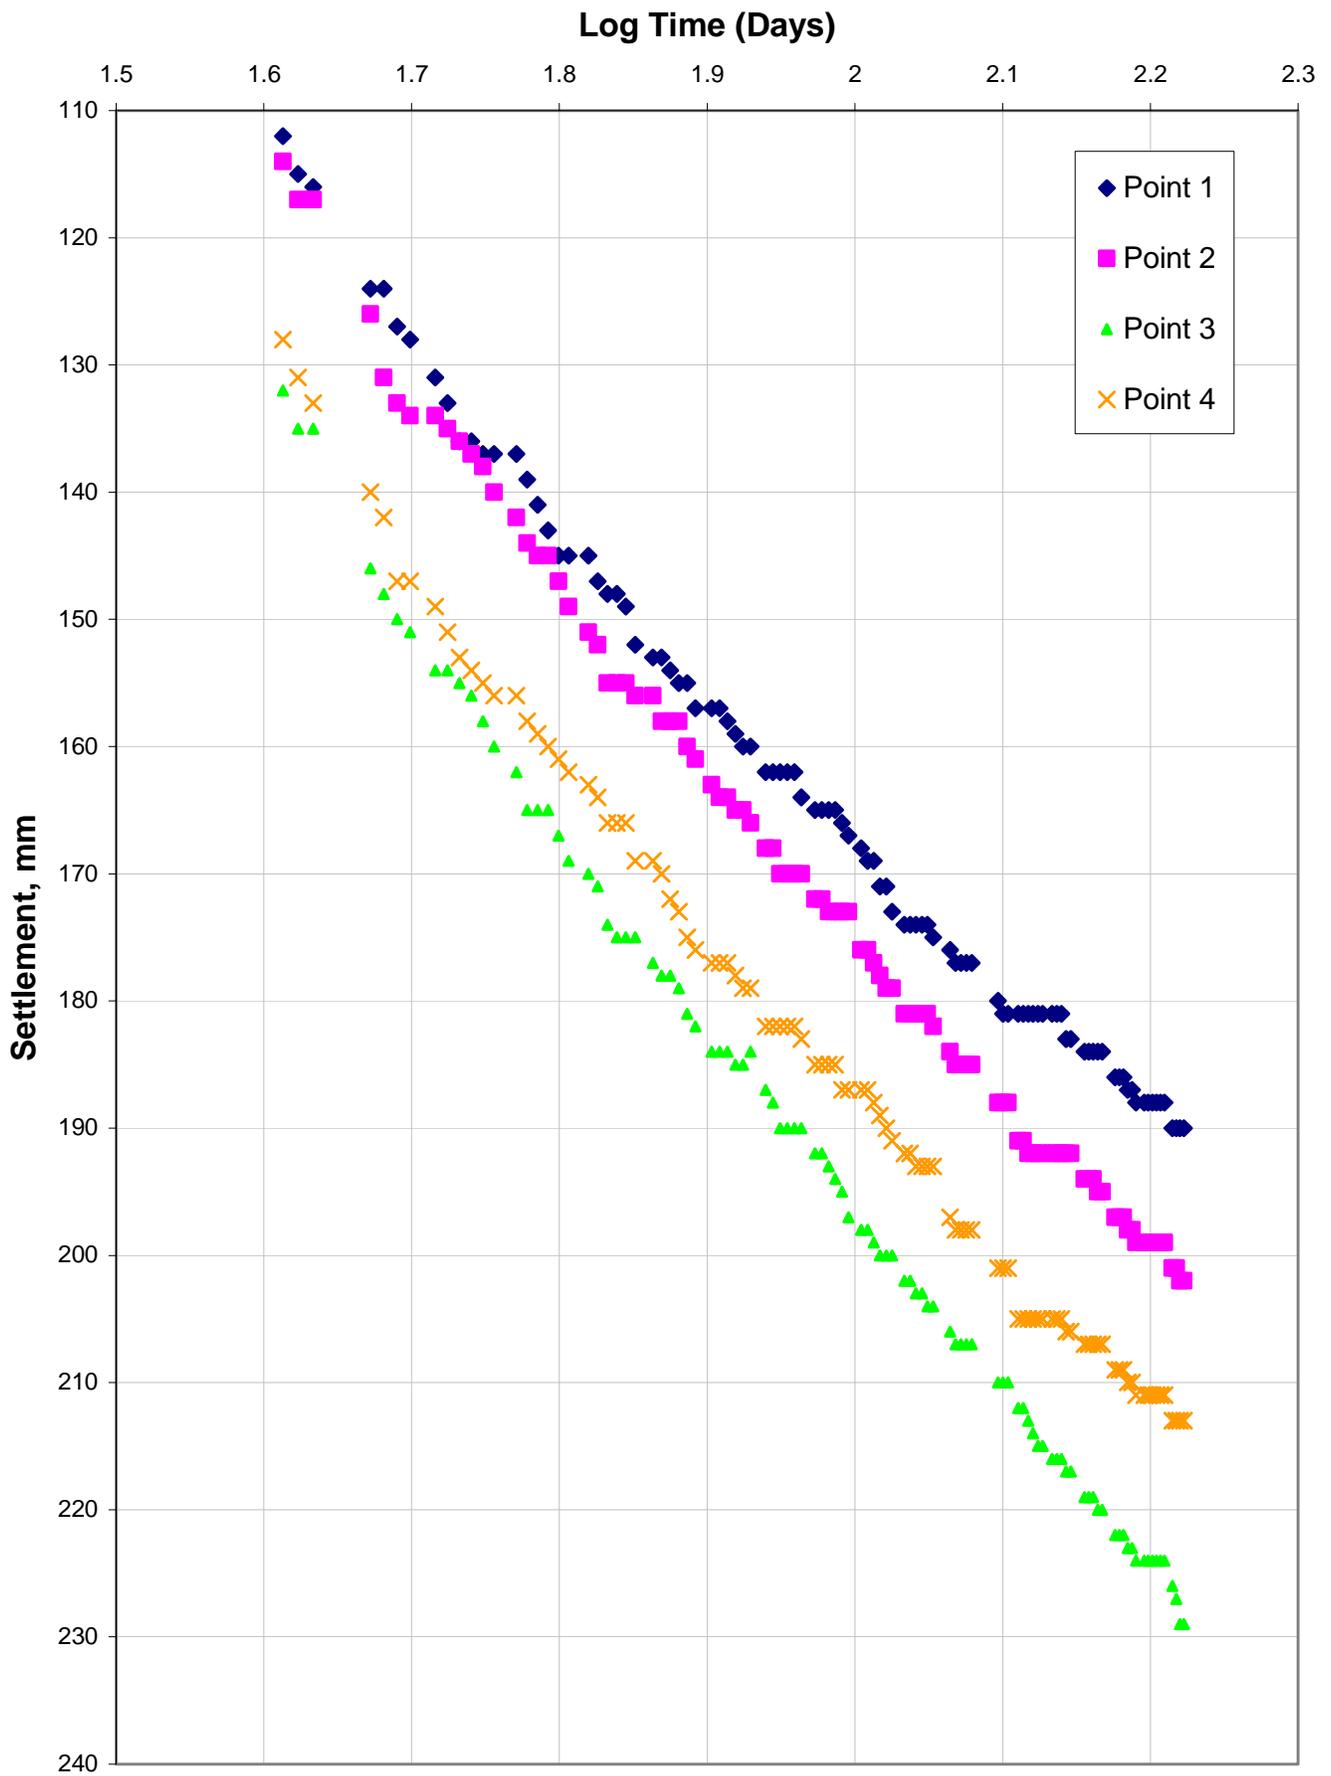
Fig. 4. Settlement vs. log time at 100% loading.

The settlement of the four monitoring points plotted against log time during the 4 months at 100% hydro-test load is shown in Fig. 4. Since the layer causing most of the settlement (Layer III) was assumed to be normally consolidated or close to that

state, the relatively linear relationship between settlement and log time was anticipated. During the second 2 months at maximum loading, the plots of Point 1 and, to a lesser extent, Point 2 indicate a decrease in the log rate of settlement. This is not the case for the other two settlement points.

The plots in Fig. 4 can be used to obtain an approximate estimate of the total settlement of the tank. (Assume here that 95% settlement is a reasonable approximation of total settlement.) Although there is not a great deal of differential settlement across the tank compared with total settlement, Point 3 consistently shows the most settlement. Based on the slope of the settlement-versus-log-time line for Point 3, it would take an estimated 1.4 years to reach 300 mm settlement. For Point 1, which consistently shows the least settlement, the time to reach 300 mm settlement would be 2.75 years, based on the slope of the settlement-versus-log-time line over the first 2 months. Based on the reduced slope for the second 2 months, this time increases to almost 10 years. Although only an approximation, it seems reasonable to adopt 300 mm as the average total settlement (95% consolidation) around the perimeter of the tank. Although the curves in Fig. 2 provide only a picture of the early stages of settlement, an average value of 300 mm extrapolated from these curves appears reasonable and possibly conservative.
