Rapid repair of severely damaged RC columns under combined loading of flexure, shear, and torsion with externally bonded CFRP

RAPID REPAIR OF SEVERELY DAMAGED RC COLUMNS UNDER
COMBINED LOADING OF FLEXURE, SHEAR, AND TORSION
WITH EXTERNALLY BONDED CFRP

A DISSERTATION

CIVIL ENGINEERING

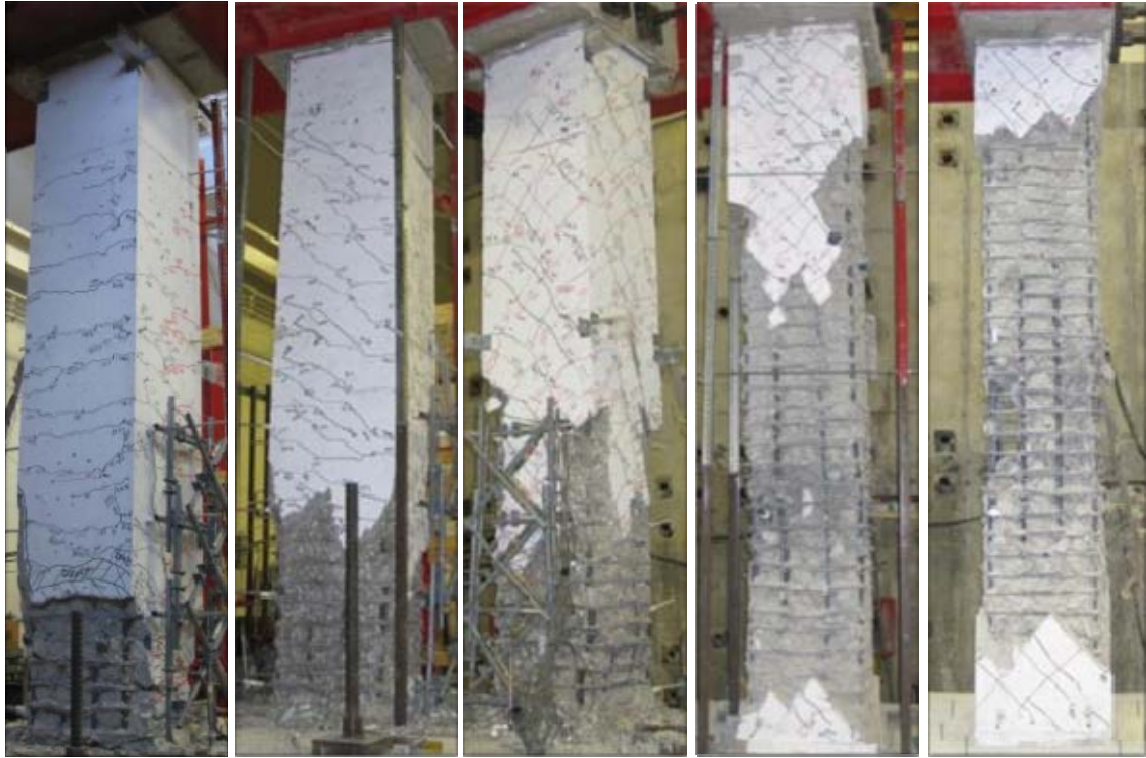
Fig. 2 Damage conditions of the original columns after previous tests.

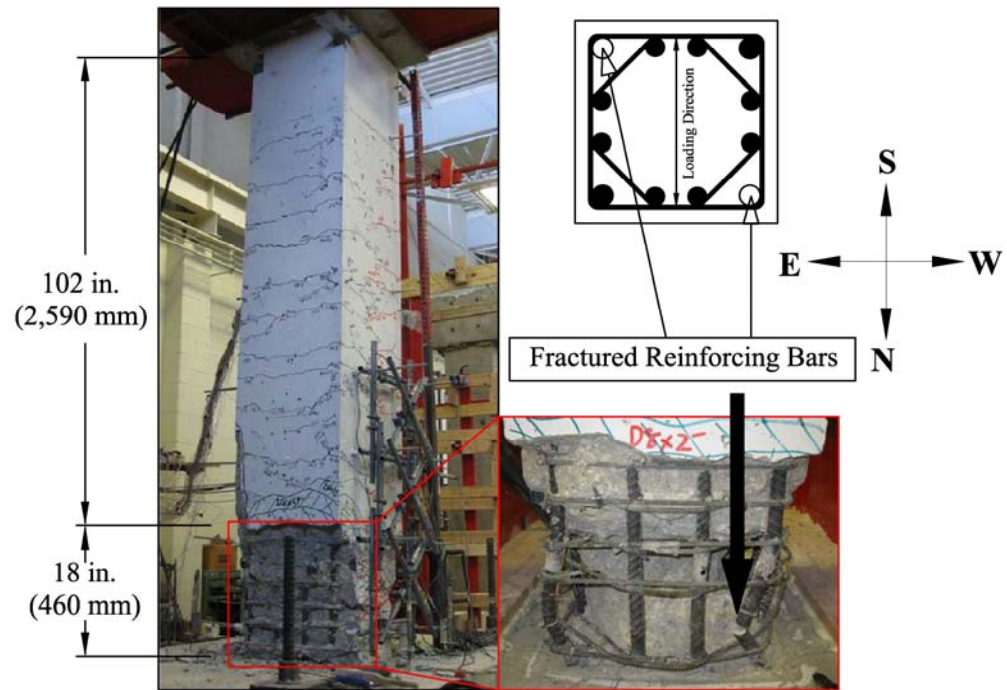
Fig. 2. Damage to Column 1 ($T/M=0$).

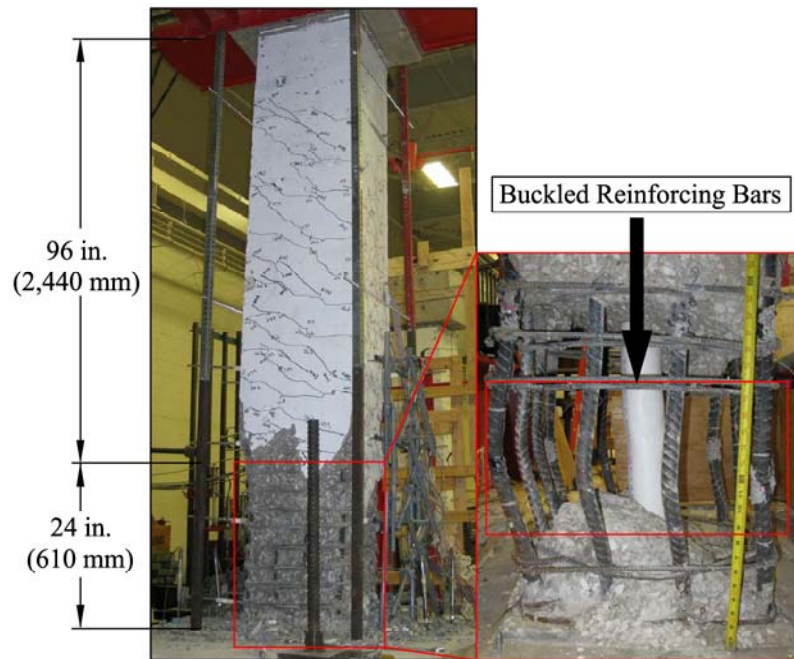
Fig. 3. Damage to Column 2 ($T/M=0.2$).

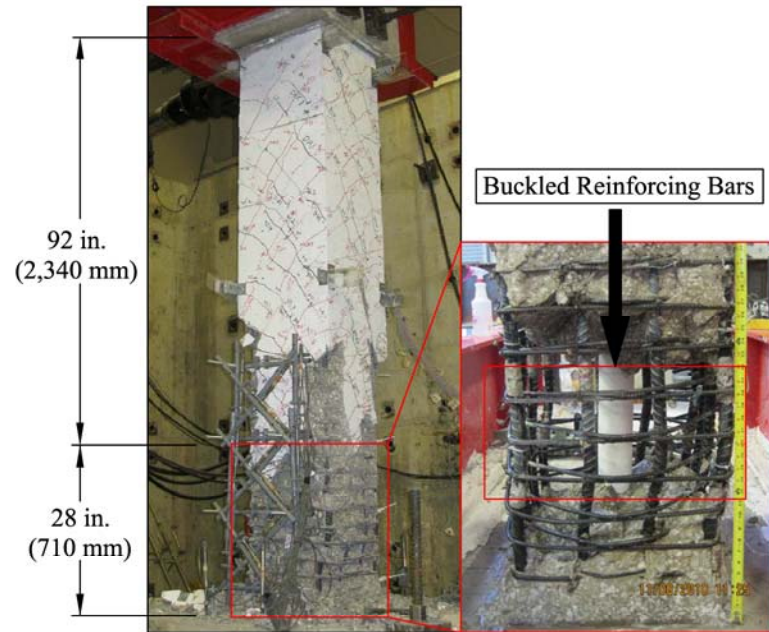
Fig. 4. Damage to Column 3 ($T/M=0.4$).

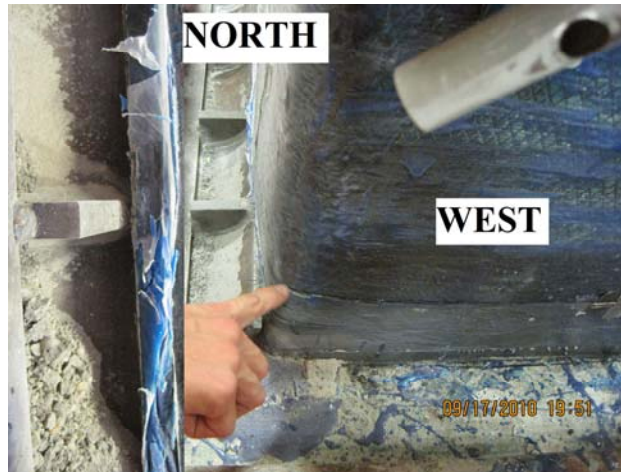
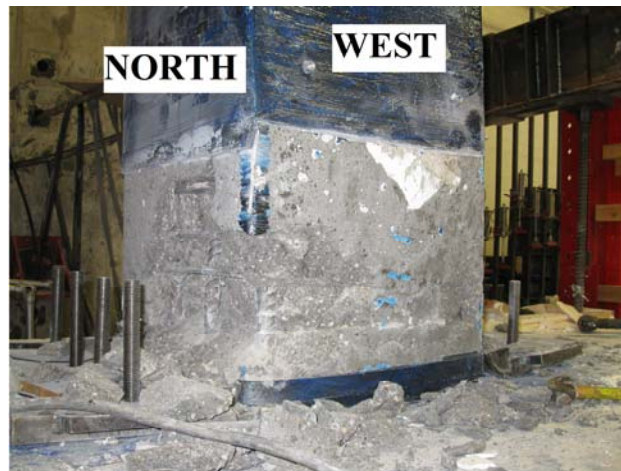
Fig. 14. Failure of repaired Column 1-R ($T/M=0$) - northwest corner.

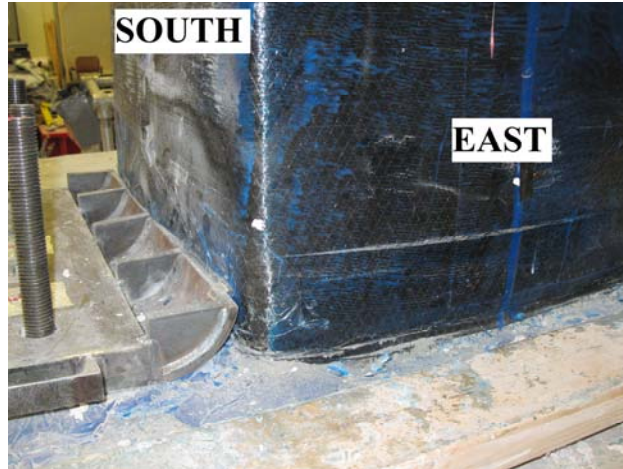
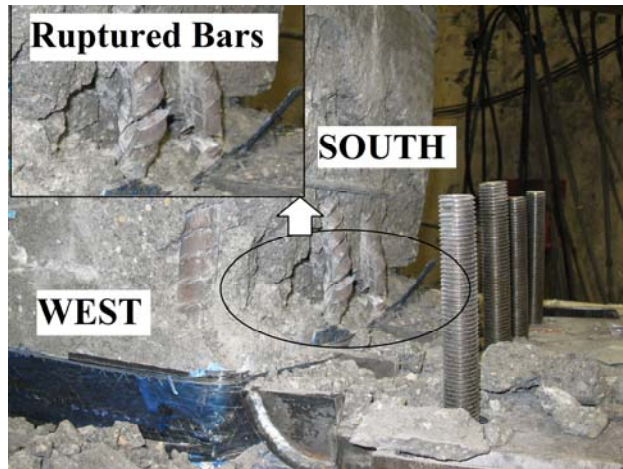
Fig. 15. Failure of repaired Column 1-R ($T/M=0$) - south side.

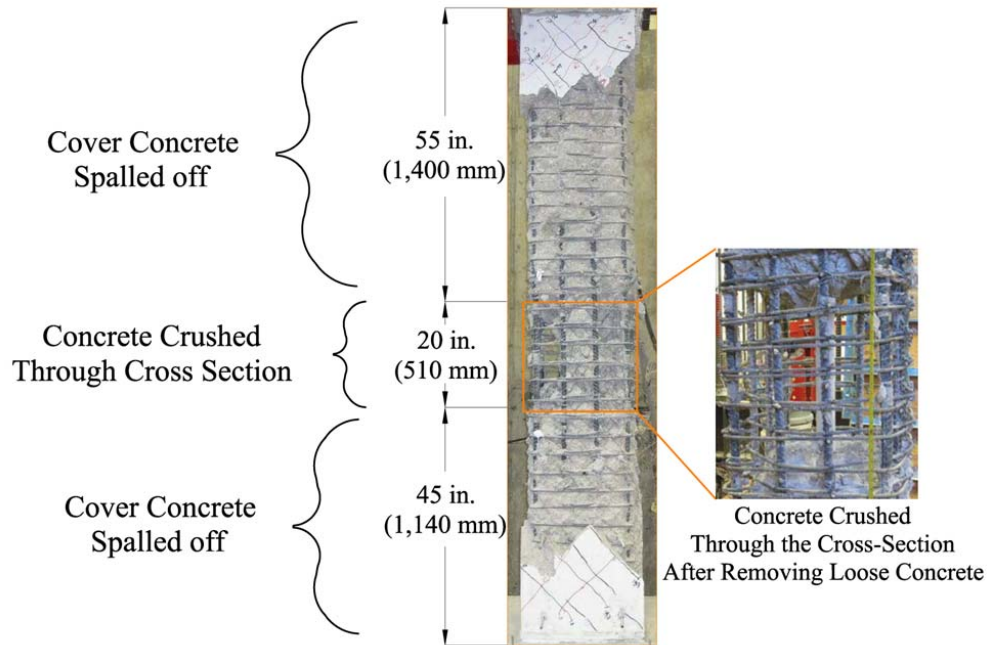
Fig. 2 - Damage condition of concrete in original column.

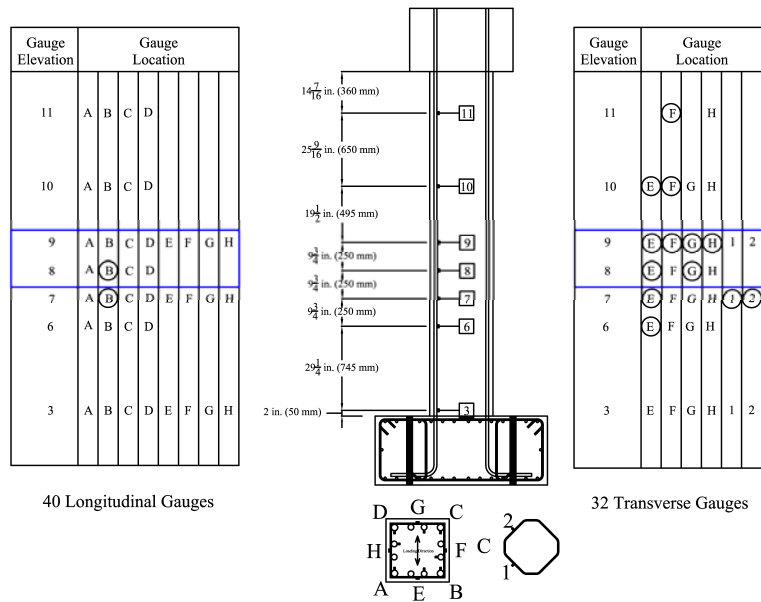
Note: Gages Circled Indicate Reinforcement Yielded In That Location
 Region In The Rectangular Box is Where Concrete Crushed Through Cross Section After Previous Test

Fig. 3 - Damage condition of reinforcing steel in original column.

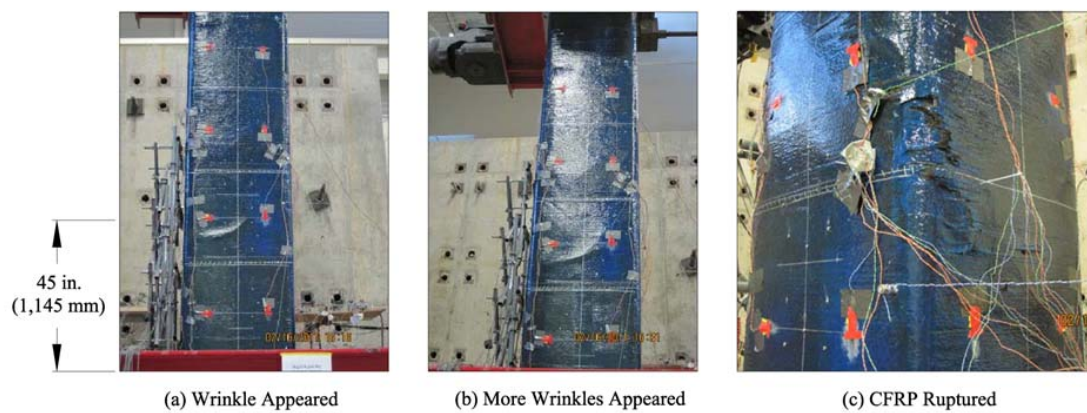
Fig. 5 - Failure of repaired column.

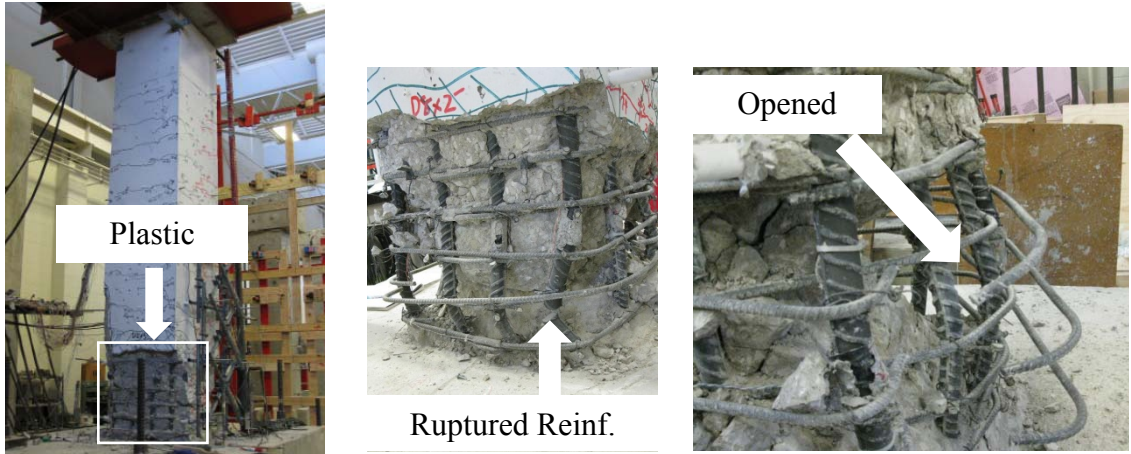
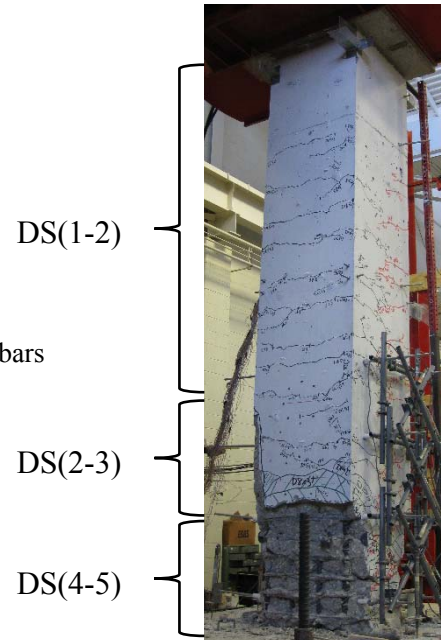
(a) Damaged column (b) Longitudinal reinforcement rupture (c) Failure of ties

- DS1: Flexural cracks
- DS2: First spalling and shear cracks
- DS3: Extensive cracks and spalling
- DS4: Visible lateral and longitudinal bars
- DS5: Imminent failure

Fig. 6. Damage to original column prior to repair
