LIQUEFACTION-INDUCED DAMAGE IN THE 2010-2011 CHRISTCHURCH (NEW ZEALAND) EARTHQUAKES

Misko Cubrinovski

University of Canterbury
Christchurch 8140, New Zealand

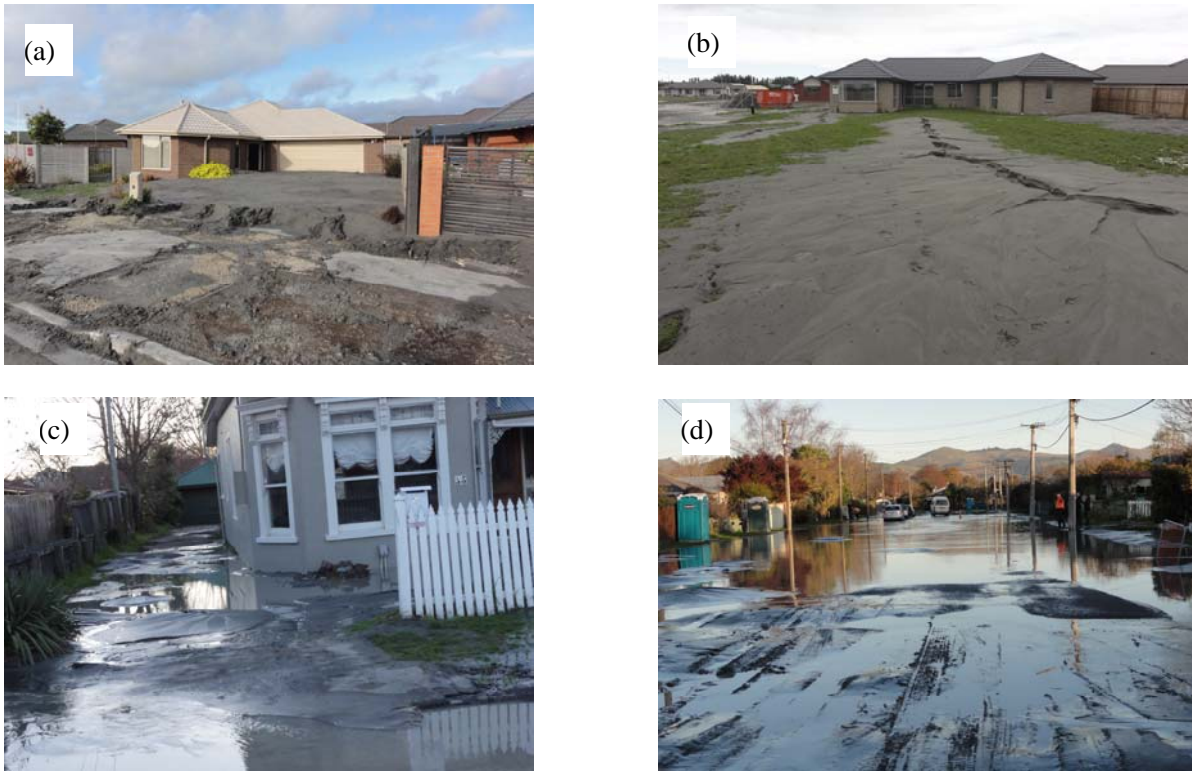
Fig. 5 Severe liquefaction in residential areas (suburbs along Avon River in the abandoned “red zone”)

Figure 5 illustrates typical manifestation of severe liquefaction in the eastern suburbs of Christchurch. There was widespread and very large in volume (thickness) sand/silt ejecta covering the residential properties and streets in these suburbs. In numerous cases the entire area of the property was covered by 50-60 cm thick silt/sand ejecta (Fig. 5a), and massive in size sand boils (Fig. 5b) indicated very severe (and often extreme) liquefaction of loose to very loose soils. In the worst affected areas, extreme liquefaction occurred with mud and water covering entire streets and adjacent properties and even larger neighborhoods encompassing several streets within a suburb. Following the 22 February 2011 earthquake, over 400 000 tons of silt/sand ejecta were removed in the clean up of streets and properties which indicates both the extreme severity and extent of the liquefaction. While the 22 February event caused the most severe liquefaction, a complete flooding of streets and very severe liquefaction occurred in these areas also during other earthquakes, as illustrated in Figs. 5c and 5d where substantial sand boils and effects of liquefaction are seen in the suburbs of Avonside and Avondale after the 13 June earthquakes.

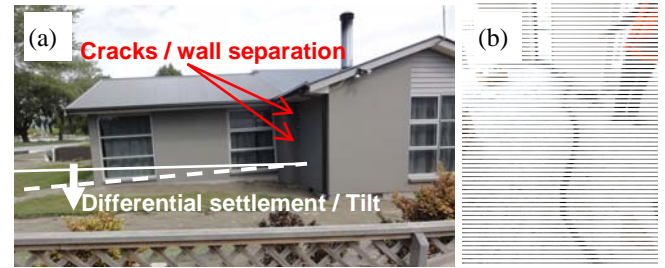
Fig. 8 Characteristic liquefaction-damage to house foundations: (a) differential settlement resulting in tilt and damage to house; (b) large crack in a concrete slab

The liquefaction often led to large global and differential settlements of the buildings. In the worst cases, the total settlement exceeded 40-50 cm. Differential settlement resulted in permanent tilt of houses, and often caused foundation and structural damage (Fig. 8a) because of the inadequate stiffness and strength of the foundation. Concrete slabs suffered serious damage including wide cracks (Fig. 8b), and non-uniform deformation such as dishing (sagging) and hogging. A number of different deformation modes could be identified for the perimeter footing foundations including humping of floors (often in individual rooms) due to larger settlement beneath the heavier walls, dishing caused by heavy brick chimneys founded on isolated footings in the interior of the floor plan, and racking/twisting of the superstructure caused by differential settlement/movement of corners/parts of the foundation due to its inadequate stiffness.

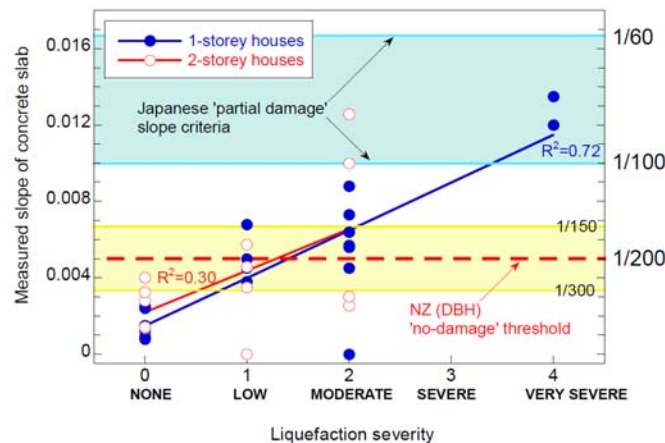
Correlation between the residual slope of concrete slab foundations (a proxy for the tilt as well) and observed liquefaction severity (0=none, 1=low, 2=moderate, 3=severe, 4=very severe, extreme liquefaction) is shown in Fig. 9. Here, the maximum floor slope is shown based on approximately 15-20 floor elevation measurements across the footprint of a building. The plot also indicates several recently developed damage criteria in New Zealand (DBH, 2011) and Japanese practices (Yasuda et al., 2012) based on experiences from the 2010-2011 Christchurch earthquakes and 2011 Great East Japan earthquake respectively. The shaded (yellow) area

(1/300 to 1/150 slope) indicate the typical range of slope found in newly constructed concrete floor slabs (the average slope between two points 2m apart), (DBH, 2011). In the DBH guidelines for repairing and rebuilding of houses affected by the Christchurch earthquakes, differential settlement (floor slope) and cracks width have been adopted as criteria to evaluate whether the foundation damage requires repair or not. The 1/200 slope is indicated in Fig. 9, as a reference 'no-damage' threshold. It is apparent in Fig. 9 that the measured slope of concrete slabs shown with the symbols was clearly related to the severity of liquefaction. In general, in areas of no or low liquefaction manifestation, the measured slope was within the construction tolerance or allowable slope. In areas of moderate and particularly severe liquefaction, however, the residual slope of concrete slabs was often above the allowable threshold slope of 1/200.

Fig. 9 Correlation between liquefaction severity and residual slope of slab foundations for 32 houses in Christchurch

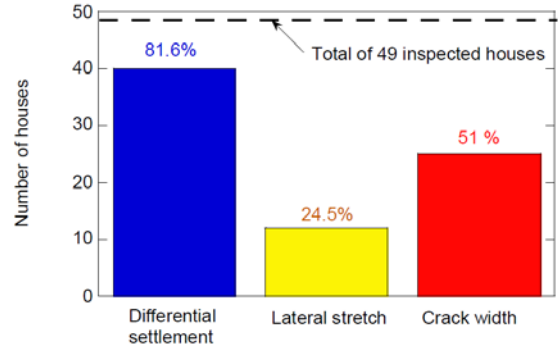
The 49 inspected perimeter footing foundations were scrutinized against the abovementioned DBH damage criteria. Since most of the foundations/houses in the inspected area were old (pre 1930, 1930-1959, 1960-1979) and of poor quality (often without any reinforcement), they suffered very high proportion of damage (as summarized in Fig. 10): 82% had tilts exceeding 1/200, 25% had total width of cracks exceeding 20mm and 51% max width of a single crack over 5mm. The damage for these foundations was poorly related to the liquefaction severity, and eight foundations showed damage greater than at least one of the no-damage thresholds despite being located in areas where liquefaction was not manifested on the ground surface.

Fig. 10 Damage to concrete perimeter foundations (49 inspected houses) indicating percentage of foundations exceeding the DBH no-damage thresholds

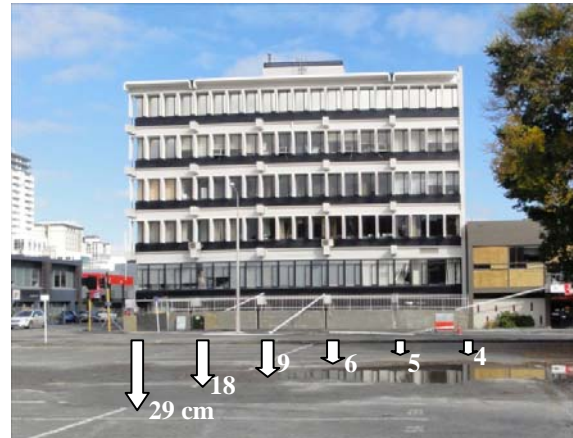
Many buildings on shallow foundations were affected by severe liquefaction resulting in substantial total and differential settlements or lateral movements. An example of significant differential settlement of a 6 storey reinforced concrete building is shown in Figure 12. Part of the shallow foundations of the building (the corner where the maximum settlement occurred) was affected by very severe liquefaction which was manifested with extensive surface cracks, fissures, depression of the ground surface, and water and sand ejecta in a well-defined narrow zone approximately 50 m wide. The differential settlement was about 30 cm, with consequent tilting of the building, and damage to the foundations and superstructure in addition to structural damage induced by the ground shaking itself; the building has been demolished because it was considered uneconomic to repair.

Fig. 12 Liquefaction-induced differential settlement of a CBD building on shallow foundations

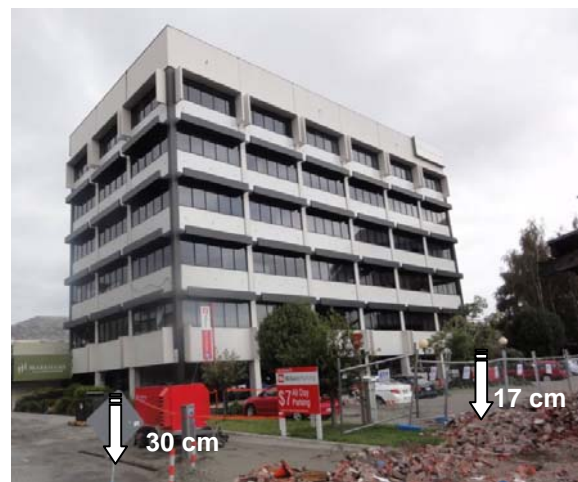
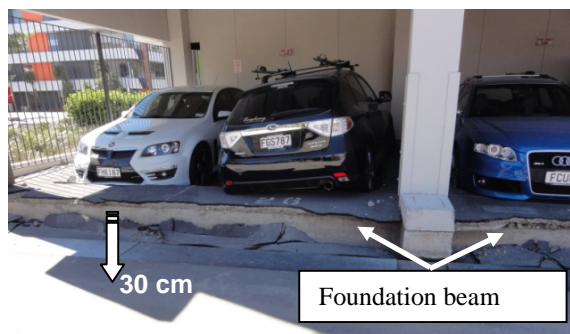
Several pile-supported buildings were located in the areas of severe liquefaction. Although significant ground failure occurred and the ground surrounding the structures settled, the buildings supported on piles typically suffered less damage, though substantial settlement of the ground relative to the building occurred. The building shown in Figure 13, was on pile foundations approximately 15 m to 16 m deep, and exhibited negligible settlement since the piles reached the underlying non-liquefied bearing strata. The surrounding soils, however, suffered severe liquefaction and consequent settlement of the ground of about 30 cm on the north side of the building and up to 17 cm on its south side during the Christchurch earthquake. The first storey structural frame of the building that was supported by the pile foundation with strong tie-beams did not show significant damage from these liquefaction-induced ground settlements. In the 13 June 2011 earthquakes, the settlement of the surrounding soil at the north side of the building further increased to about 50 cm. This building was also deemed uneconomic to repair and was demolished.

Fig. 13 Building on pile foundations in area of severe liquefaction showing large settlement of the surrounding soils relative to the foundation beams

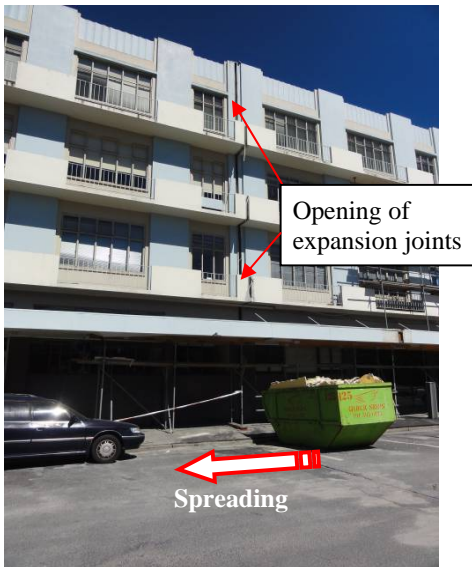
m from the Avon River. Even in the cases when the spreading displacements were larger and extended up to 150 m from the banks, the permanent lateral displacements beyond the distance of 50 m were less than 10 cm. Structures and foundations within the spreading zone were greatly impacted by the horizontal ground strains causing stretching of the ground, foundations and then the building itself. Typical stretching of the foundations resulting in damage of the structure (opening of expansion joints) is shown in Figure 14.

Fig. 14 Stretching of foundations due to lateral spreading resulting in opening of the expansion joints of a CBD building

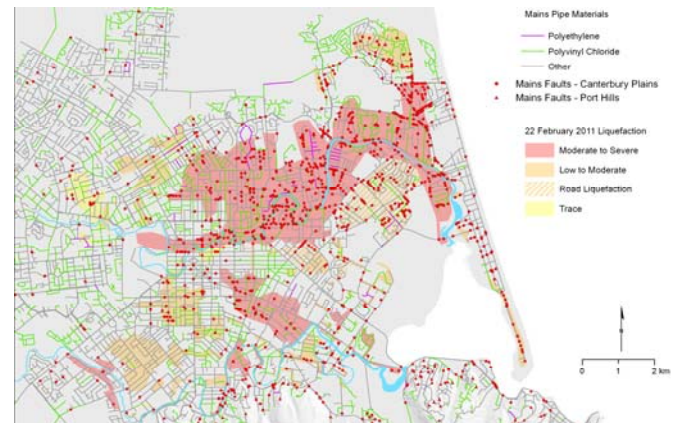
Figure 15 shows the location of repairs/faults on the watermains network (red symbols) following the 22 February 2011 earthquake. Superimposed in the background of the figure (with red, orange and yellow colours) is the liquefaction map (Cubrinovski and Taylor, 2011) indicating the severity of liquefaction (and associated land damage) induced by this earthquake. Preliminary GIS analyses (Cubrinovski et al., 2011) using the pipe network damage data and liquefaction observation maps show a clear link between the damage to the pipe network and liquefaction severity. Approximately 58% of the damaged pipes were in areas of moderate to severe liquefaction, 20.2% were in areas of low to moderate liquefaction, 2.5% in areas where traces of liquefaction were observed and the remaining 19.3% in areas where no signs of liquefaction were observed.

Fig. 15 Liquefaction map and locations of damage to the potable water network of mains (red symbols) of Christchurch due to the 22 February 2011 earthquake (Cubrinovski et al., 2011)

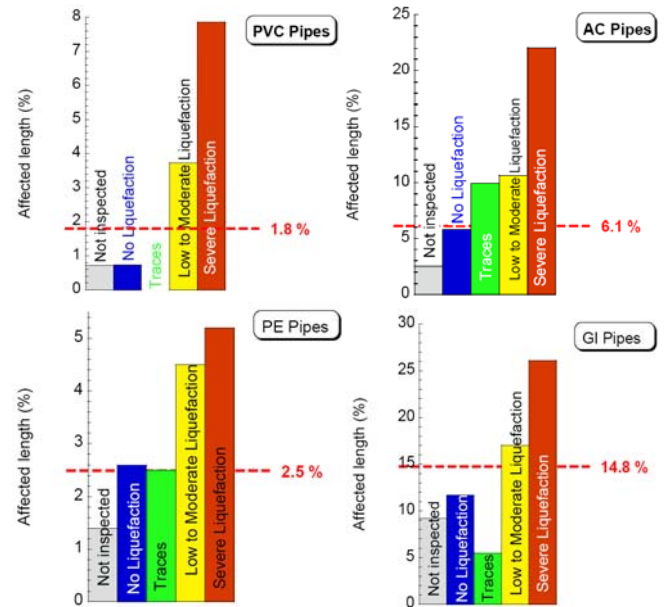
These analyses also revealed that more ductile PE pipes and PVC pipes suffered significantly less damage (three to five times less on average) than brittle AC, GI and other material

pipes. Figure 16 summarizes the performance of different pipe materials (PVC and AC pipes for the watermains; PE and GI pipes for the submains) and clearly indicates the difference in the performance of different pipe materials and the increase in the pipe network damage with increasing liquefaction severity.

Fig. 16 Summary of damage to water pipes due to the 22 February 2011 earthquake indicating performance of different materials in relation to liquefaction severity
