Caverns in the Ground Under Thermal Power Plant, Caused by Static Electricity and Chemically Aggressive Water

Chavdar Vassilev Kolev
University of Transport "Todor Kableshkov", Bulgaria

Gergana Vassileva Gevezova
Foundations Ltd St., Bulgaria

CAVERNS IN THE GROUND UNDER THERMAL POWER PLANT, CAUSED BY STATIC ELECTRICITY AND CHEMICALLY AGGRESSIVE WATER

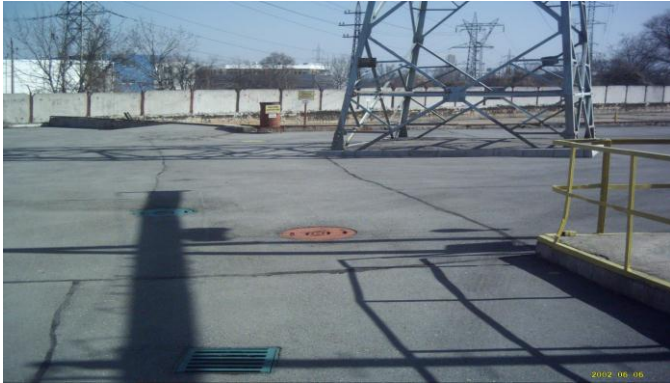
And so it is about the site of the Water Treatment Plant of the largest Thermal Power Station in Sofia, the capital of Bulgaria. Noticeably increasing deformations in the laid asphalt occurred there. They were happening in different spots and were threatening the stability of neighboring facilities. A danger of demolishing of large settling ponds of contaminated water was also spotted. Rolling and steel poles for high

voltage in the middle of the site were in danger as well (Photo 1).

Photo 1: Rolling and steel poles for high voltage

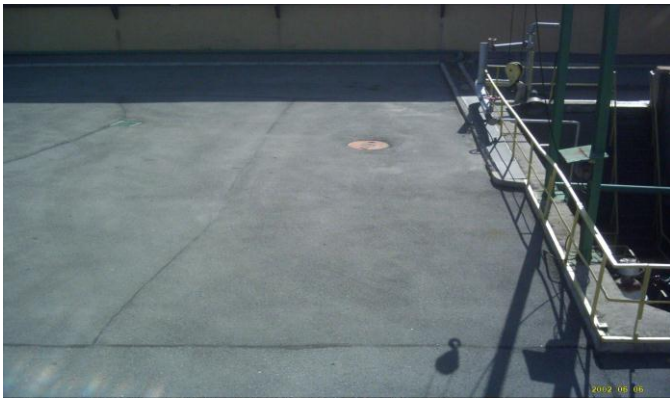
The site of the plant has size of 2000 m² and is located on flat terrain on the banks of a small river. The old flooring was of concrete and it was cracked in many places (Photo 2), while a few spots have experienced gaps underneath.

Photo 2: Old flooring cracked in many places

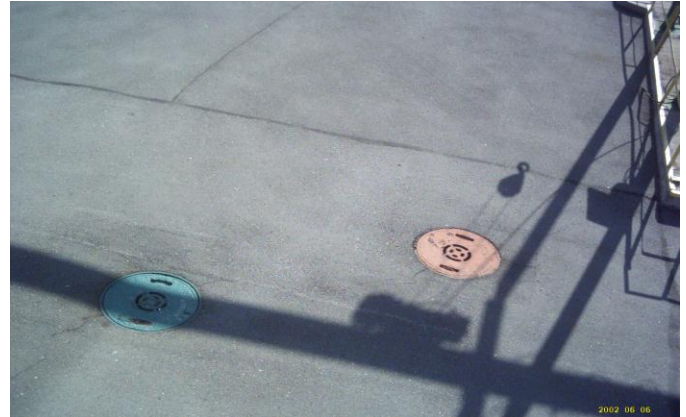
Recently, the site was coated with asphalt and shaft covers of the canals were painted in different colors according to the flow diagram of the facilities to which they belong (Photo 3).

Photo 3: Channel with shaft covers, painted in different colors

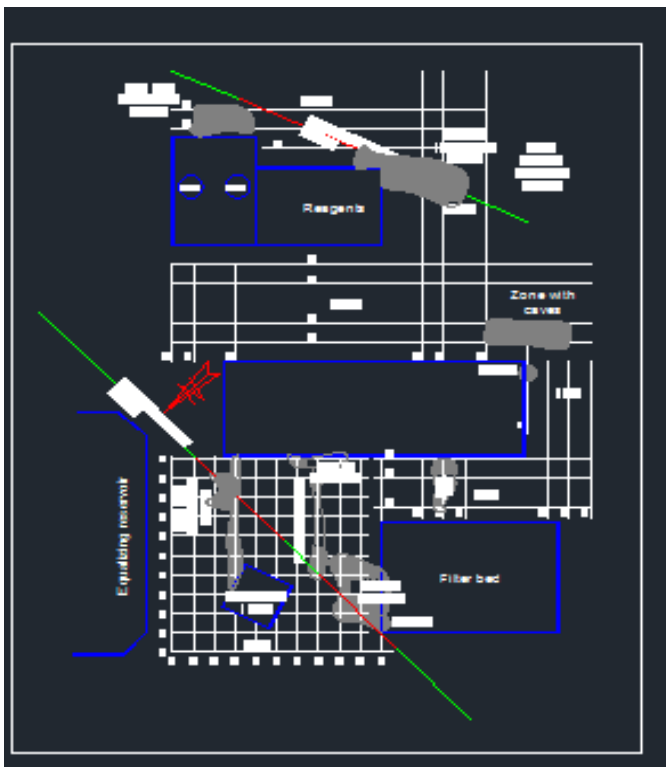
Fig.4: Problematic zones draught

After inspection of the site, consecutive series of geophysical surveys were executed. First site was studied with geo-radar. Afterwards, a plan with contours of the in gasket zones was prepared for the site (Fig. 4).

The analysis of the electro-tomographic profiles and georadar study (Fig. 4) shows the same results and gives a more accurate picture of the shape, location and extent of the density of problem areas.

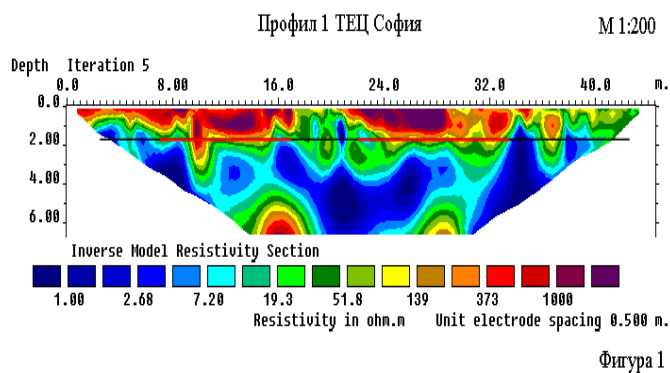
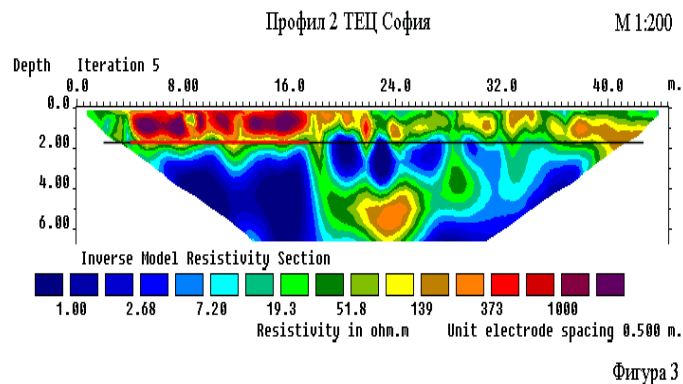
The findings of the preliminary geo-radar study, and namely the one about the zones with decreased density in the ground, which are also unevenly situated, are confirmed in more details by the electro-tomographic profiles (Fig. 5 and 6). They naturally lie down below the studied pavement and reach a depth of about 2m.

These zones are caverns and probably a result from both geology (silt and inconsistent water level in hydraulic gradient adjacent to the river) and chemical aggression occurring in the wastewaters composition of acids and bases. This water, most probably, has penetrated the site from the tanks surrounding the plant. Obviously, a layer of silt lies under the surface, and it is very thin, very sensitive to water and responsible for the surface subsidence. As an additional factor for the reduced density we can point out the suffusion caused by the hydraulic gradient at high underground water level adjacent to the river that naturally drains the shore.

The gaps from the round openings of the tubes, which are located at a depth of 5-6 m. are visible on electro-tomographic profiles (Fig. 5 and 6). These low-lying holes have no influence on the reported falls.

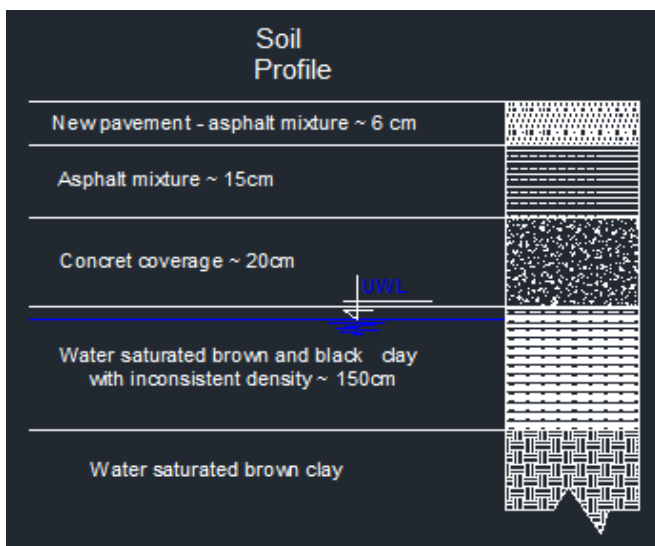
Fig. 7: Profile of ground foundation

Further to these analyses, all of the most typical places with lower density at the site were tested with exploratory drilling, deep 2m. It was found (Fig. 7), that under the pavement there are saturated plastic clay and silt in a liquid consistency with a capacity of approximately 130cm. The layer is located at a level of approximately 70cm to 200cm below the ground. Another powerful layer of plastic clay is available beneath the low silt at a depth of 2m - moist, in plastic consistency, relatively homogeneous, with normal density zones, which reaches a depth of more than 6m.
