Geotechnical Damage Due to Bihar Earthquake of August 1988

SYNOPSIS: The Bihar-Nepal earthquake of August 21, 1988 (magnitude 6.6) caused significant loss of life and property. Besides the epicentral area, two distant places (Munger in India and Bhaktapur in Nepal) suffered significantly. This was also the case in the 1934 earthquake (magnitude 8.4) and is due to peculiar geology of the area. Geotechnical damage in the affected area includes liquefaction, cracking and subsidence of embankments, and cracks in bridge abutments and wing walls. Besides, in the hilly regions of Sikkim, landslides and rockfalls disrupted road network significantly. Extensive damage took place in the eastern Nepal also. This paper describes the geotechnical damage to the Indian areas only.

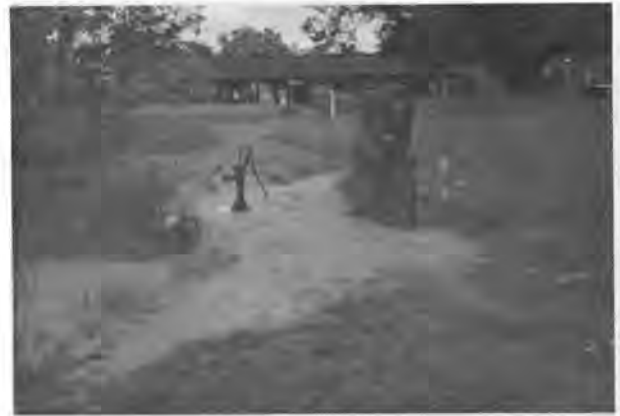
Darbhanga, was found choked with sand. A hand pump was mounted on the top cover slab of the well. The upward thrust on the pump punctured the top brick slab and a big heap of sand brought by the springing water was lying all around the well (Fig. 3). A typical sand dune due to liquefaction inside the premises of the Bihar Public Works Department rest house is seen in Fig. 4.

FIG. 3 Sand Boil, Around Hand Pump Inside the Residence of the Superintendent of Police, Darbhanga.

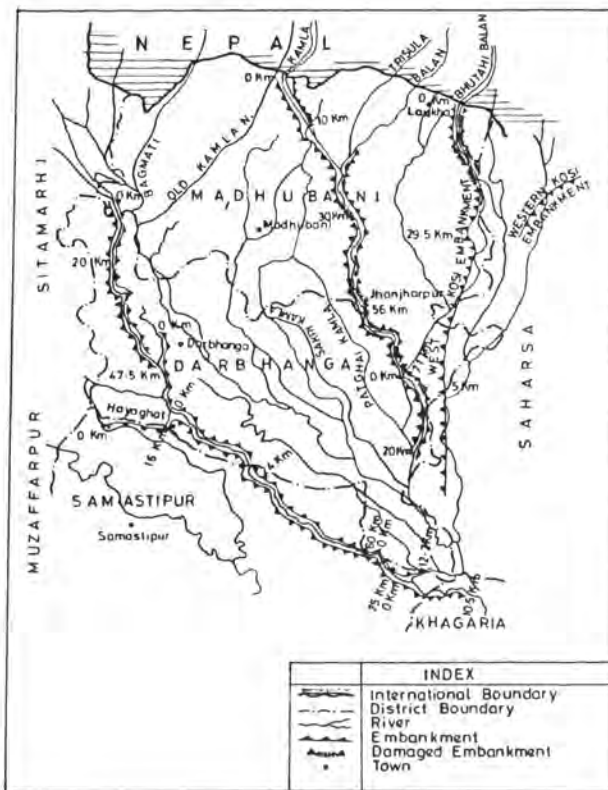
Northern Bihar is prone to devastating floods. An extensive network of flood control embankments exists along the rivers for flood protection. The quality of construction of these embankments is very poor as no compaction is usually done during the construction. The location of damaged embankments in Flood Control Circle Darbhanga are indicated in Fig. 5. The prominently damaged embankments are as follows.

FIG. 5 The Damaged Embankments in Flood Control Circle, Darbhanga.

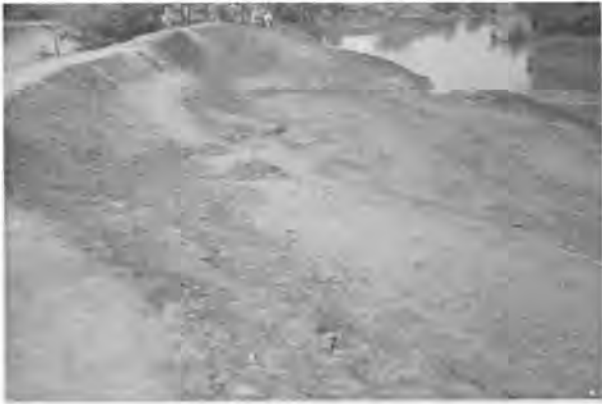
This embankment subsided very significantly at 67.0 km point (Fig. 5) near Jhanjharpur. The damaged site is about 22 miles from Darbhanga. This embankment is 18 feet wide at the top and approximately 18 feet high, having 1:2 slope on the river side and 1:3 slope on the other side with brick pitching on both the slopes. The embankment was reconstructed in August 1987 after a breach and washing away of the earlier embankment. The top of the newly constructed embankment subsided by about 8 feet (Fig. 7). The pitching on the river side slope bulged out, while on the other side it became wavy after subsidence. Longitudinal cracks on top of the embankment and sand boils brought by the liquefaction were also observed. Since construction practice in the area does not include compaction of the embankments, the embankment itself being loose and saturated underwent liquefaction resulting in large slumping.

FIG. 7 Subsided Embankment of Kamala River.

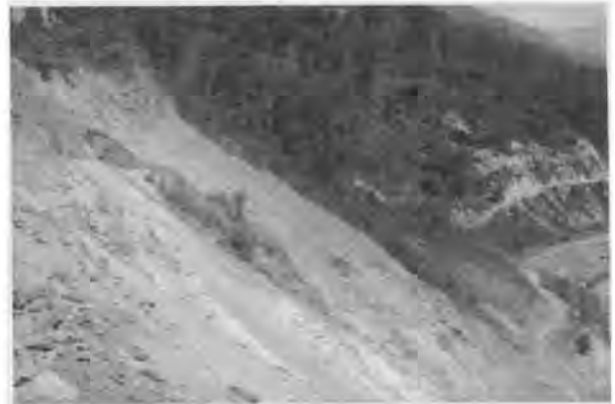
The hill slopes in Sikkim are known for their land-slides. The tremor triggered numerous land slides which was compounded by heavy rains, before and after the earthquake. The slides disrupted communications in many cases and also caused widespread damage to the roads, bridges and the other structures. An initial slip at Kumrek got aggravated due to the earthquake and washed away about 0.6 miles long state highway

FIG. 8 Kumrek Landslide, Sikkim.

(Fig. 8). Construction of a new road on a different alignment became necessary in order to restore the traffic. At Narak, initial slope failure occurred due to the earthquake which was aggravated subsequently by rains (Fig. 9). Several other land-slides have been reported to have damaged the road formations in the state. Three major bridges were damaged mainly due to rock-falls and abutting slope failures. Damage also took place to the hilly roads in Darjeeling district of the state of West Bengal.

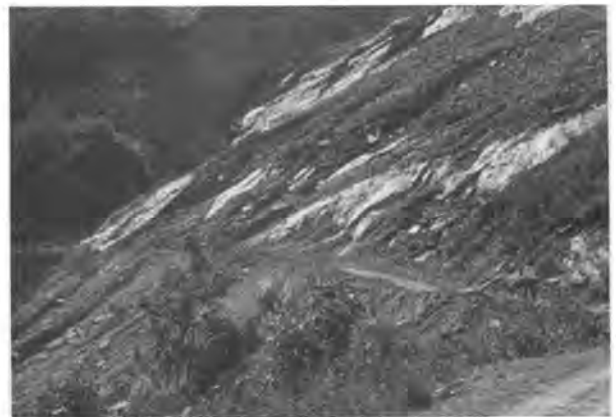
FIG. 9 Narak Landslide, Sikkim.

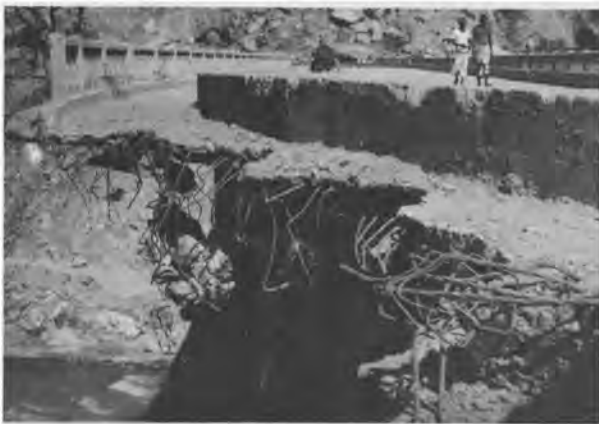
This is a newly constructed prestressed concrete bridge of about 200 feet span (Fig. 10), on river Kalej Khola near Legship Bazar town (about 58 miles from Gangtok). Hill slope on the Legship Bazar end failed and soil mass including huge boulders fell on to the bridge deck. Approximately half lane wide deck slab was completely smashed near abutments due to impact of the huge rocks (Fig. 11). The bridge however

FIG. 11 The Damaged Deck of the Legship Bazar Bridge.

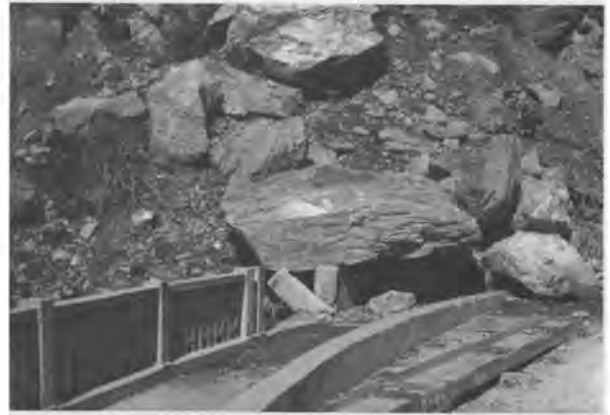
was opened for traffic immediately after removing the debris. The other end did not receive much damage and only some portions of reinforced concrete railing were affected due to the impact of rolling boulders (Fig. 12). There was no apparent damage to piers and abutments.

FIG. 12 The Damaged Railings of the Legship Bazar Bridge.

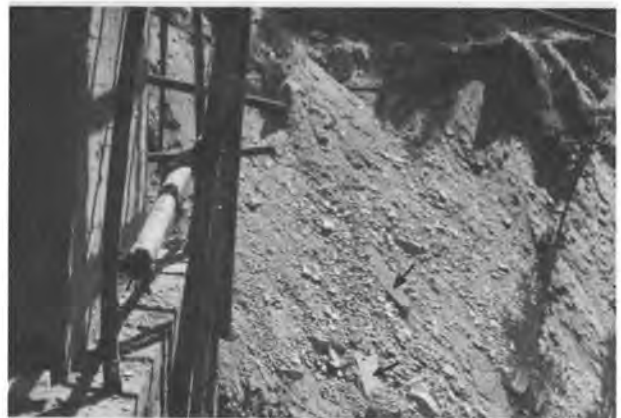
This bridge site is also located on river Kalej Khola at about two miles upstream from the Legship Bazar and is on Legship-Tashiding road. Bridge was under construction and its towers and cable anchors were complete at the time earthquake occurred. Proposed bridge is of suspension type with a span of about 450 feet. Legship end abutment cum suspension tower of reinforced concrete was situated just by the side of a high hill-cliff. During the quake, a huge soil cum boulder mass from the cliff came down and washed away the whole construction on Legship end (Fig. 13). The other end was however intact. An old suspension bridge with wooden

FIG. 13 The Landslide that Damaged the Tashiding Bridge (arrows show pieces of the suspension tower).

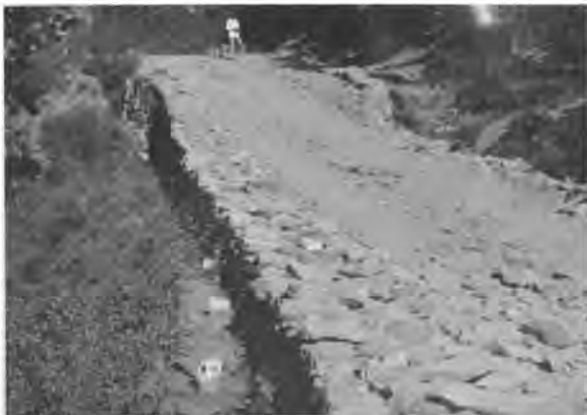
Damaged site is located about half a mile short of the Legship Bazar township on Gangtok-Legship state highway in the state of Sikkim. At a few places significant subsidence of road, one foot to 10 feet, was observed (Fig. 15).

FIG. 15 Subsided Stretch of Gangtok-Legship State Highway (partly repaired).
